**FACILITY COMPLIANCE INSPECTION REPORT**  
**Division of Waste Management**  
**Solid Waste Section**

**Date of Site Inspection:** January 20, 2012

City of Raleigh/Wake County - Raleigh MSW Transfer Station  
 820 Corporation Parkway  
 Raleigh, NC 27610

Follow-up Inspection

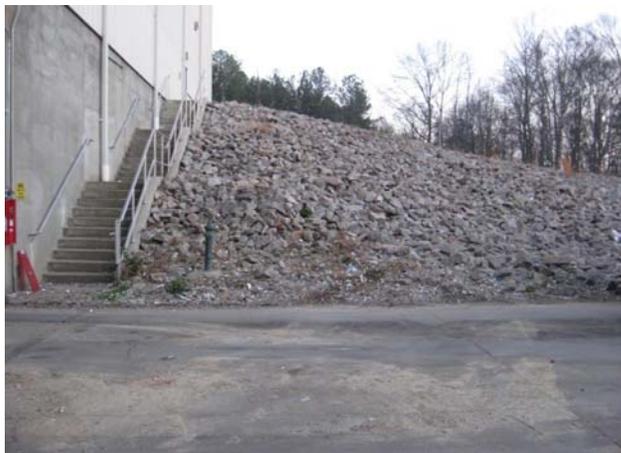
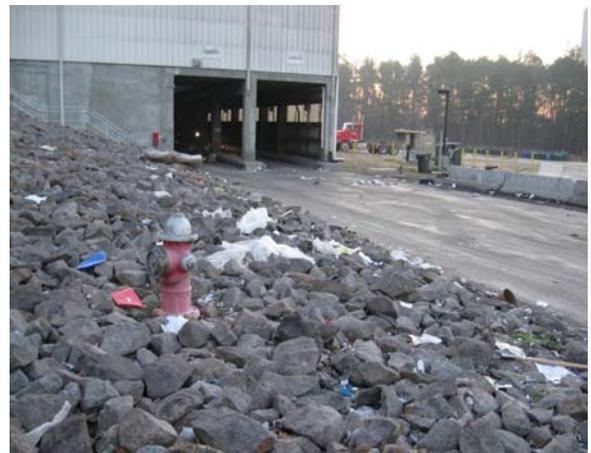
14. The facility has two 100 gpm fire hoses, one on each side of the tipping floor, and several heat detectors and fire extinguishers for fire control. The City of Raleigh fire department will address emergencies.

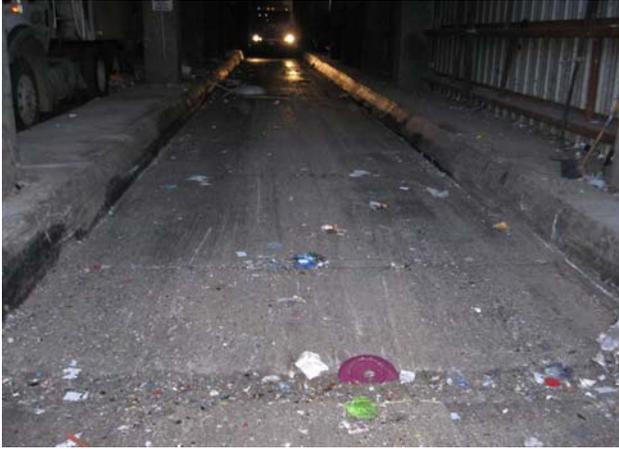
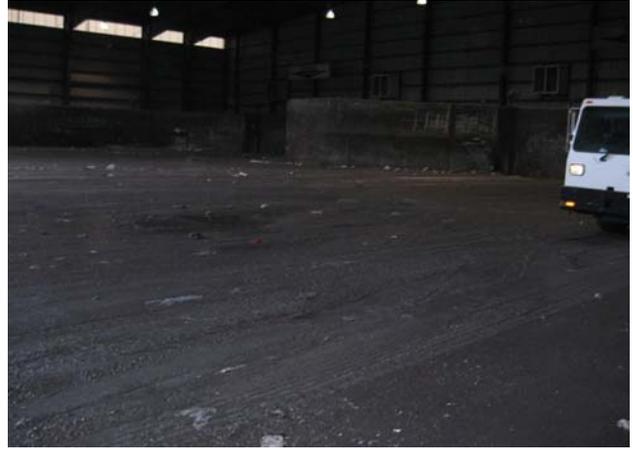
18. Additional proposed improvements include resurfacing of the tipping floor.

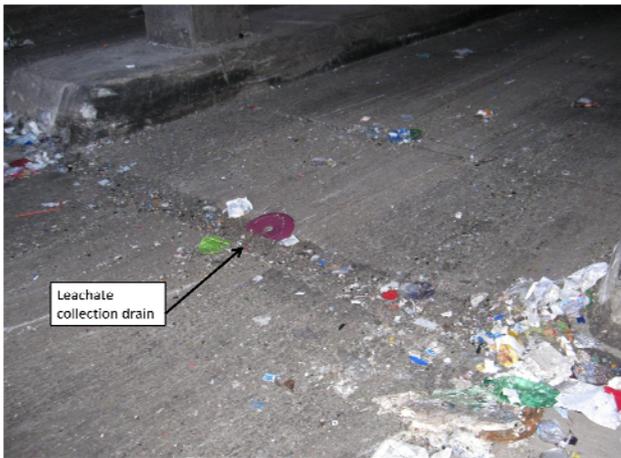
19. The leachate drains across both bay openings on the west and east sides of the facility are easily clogged by waste and debris. Proposed upgrades would expand the collection trench and facilitate easier system maintenance.

Drain on west side of bay (exit).

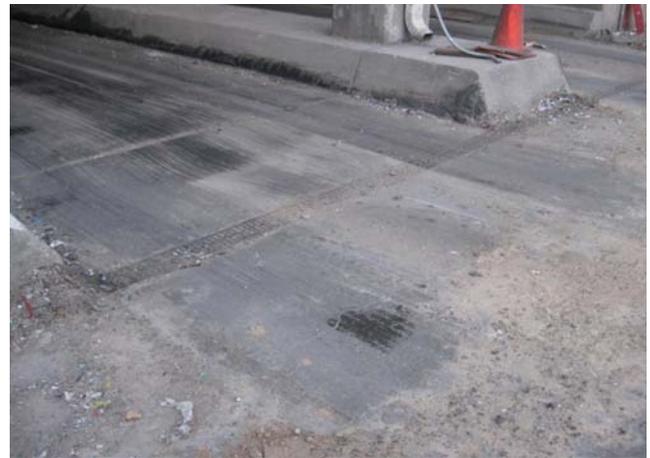
Drain on east side of bay (entrance).
