FACILITY COMPLIANCE INSPECTION REPORT
Division of Waste Management
Solid Waste Section

Date of Site Inspection: 9 January 2012

Larry Styron LCID Landfill
Herring-Smith Road
Newport, NC 28570

Site visit to review continued measures taken in response to 2 January 2012 fire event

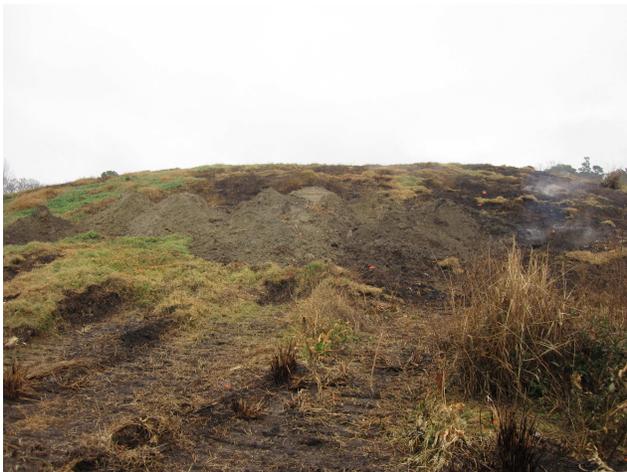
- 9) Soil has been stockpiled on-site for use in cover maintenance adjacent to the old landfill access ramp.
- 10) Soil has been placed in the voids and areas of settlement where smoke was observed emanating from the landfill during the previous audit.

- 11) Continued smoke emanations were observed from around the repairs made in the landfill cap. *As is safely practicable, please continue to cover and compact all areas of the cap where the smoke was observed with soil to smother any fire

Soil placed in settlement area-note continued smoke emanation

- that may have begun inside the landfill.
- 12) *Due to the danger of cave-in, special care should be taken with any heavy equipment use on or around the landfill.

- 13) *Plans need to be made for the installation of a portable pump and spray system in the event that the fire is not suppressed with these recommended actions.

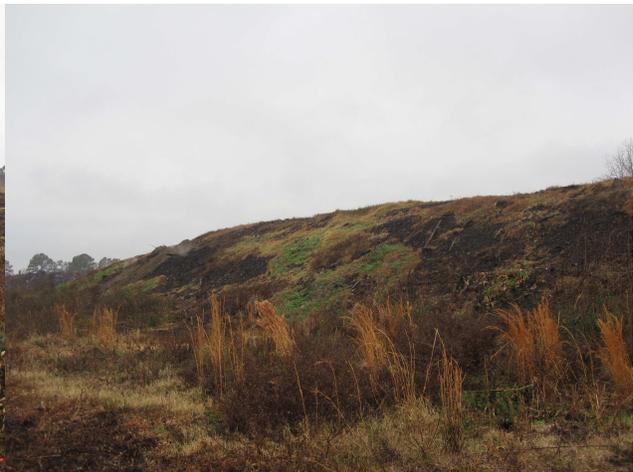
Landfill cover crop damaged by fire

- 14) *Please continue monitoring the entire landfill for further evidence of fire and take appropriate actions if such evidence is found.
 - 15) *As soon as is safely practicable, repair any areas of your cover crop and cap that were damaged by the fire and any fire suppression activities. Once the repairs have been completed, all sideslopes should be graded at a slope not greater than 3:1 and seeded and mulched to establish a groundcover suitable to prevent erosion.
