FACILITY COMPLIANCE AUDIT REPORT

Division of Waste Management Solid Waste Section

Date of Audit: 19 August 2011

Coastal Dragline Services LCID Landfill
 175 Brown Farm Road
 Vanceboro, NC 28586

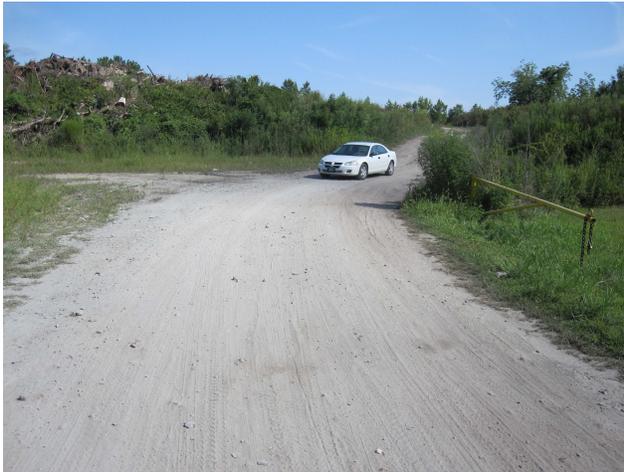
You are in violation in that: The facility access gate was open and there was no attendant on-site.

Facility access gate open with no attendant on-site

- 1) **15A NCAC 13B .0566 (8)** The facility shall be adequately secured by means of gates, chains, berms, fences, etc. to prevent unauthorized access except when an operator is on duty. An attendant shall be on duty at all times while the landfill is open for public use to assure compliance with operational requirements and to prevent acceptance of unauthorized wastes.

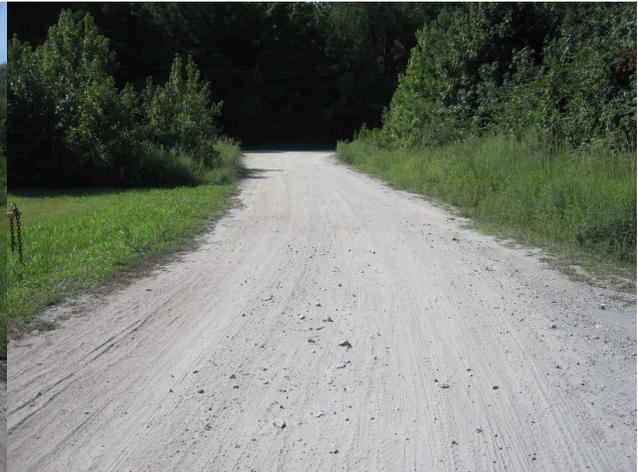
- 8) The facility access road is of all weather construction and is being well maintained.
- 9) Concrete is being staged adjacent to the LCID landfill for future grinding and re-use. *Please note that the State rules regarding recovered materials state that for a material to qualify as a recovered material, the majority of the material (51% or more) must be sold, used, or re-used within twelve months.

Well maintained access road

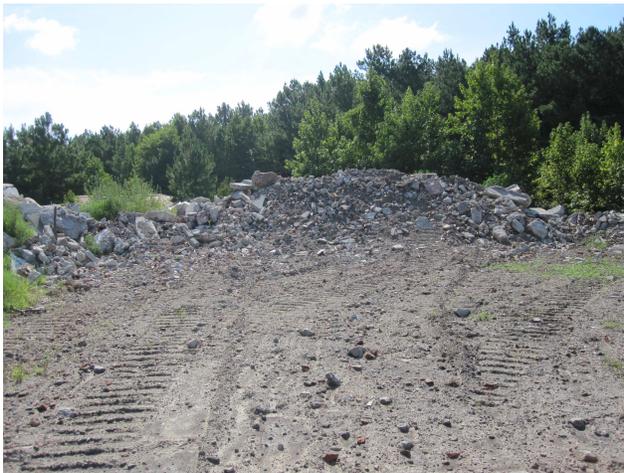
Concrete storage area

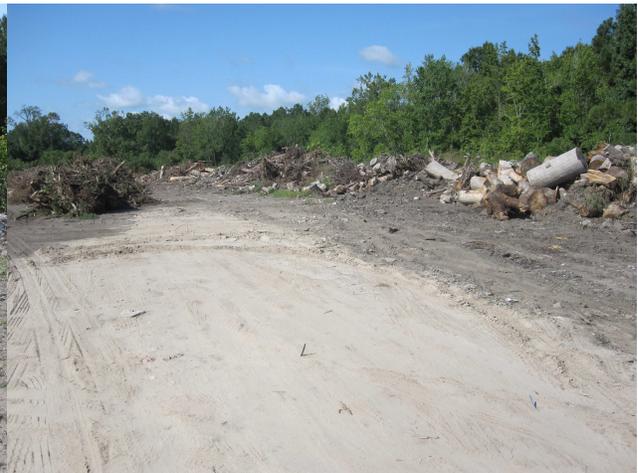
- 3) The facility has one active working face. Please continue to ensure that the active working face is properly compacted and maintained in the smallest feasible area possible. *Please ensure that the active working area is covered monthly or when it reaches one acre in size whichever occurs first.

Working area on upper landfill lift
