**FACILITY COMPLIANCE INSPECTION REPORT**  
**Division of Waste Management**  
**Solid Waste Section**

<b>UNIT TYPE:</b>											
Lined MSWLF	<b>X</b>	LCID		YW		Transfer		Compost		SLAS	<b>COUNTY:</b> Bertie <b>PERMIT NO.:</b> 08-03 <b>FILE TYPE:</b> COMPLIANCE
Closed MSWLF		HHW		White goods		Incineration		T&P		FIRM	
CDFL		Tire T&P / Collection		Tire Monofill		Industrial Landfill		DEMO		SDTF

**Date of Site Inspection:** February 5, 2013

East Carolina Environmental  
 1922 Republican Road  
 Aulander, North Carolina 27805

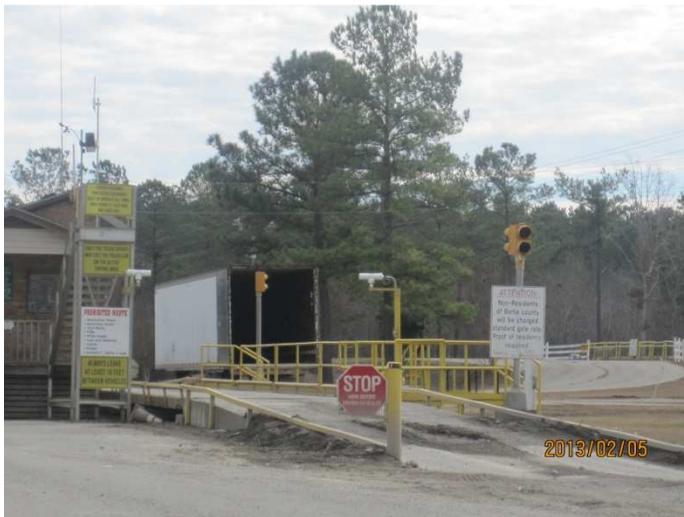
Sign at entrance

- 5) Signs at the entrance are consistent with permit and rule requirements.
- 6) East Carolina is currently receiving 1800 TPD. Waste is being accepted in Phase 4 cell 12. Cell 13 is under construction by Glover Construction. The total approved gross volume that can be accepted is 24,000,000 cu yds.

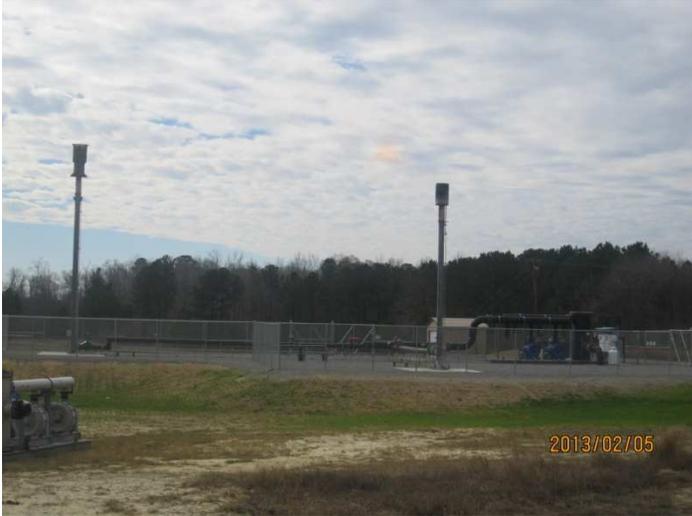
Flares

- 24) Flairs are monitored monthly and records kept as required.
- 25) Waste screenings are being conducted as required in the permit and records are being kept.

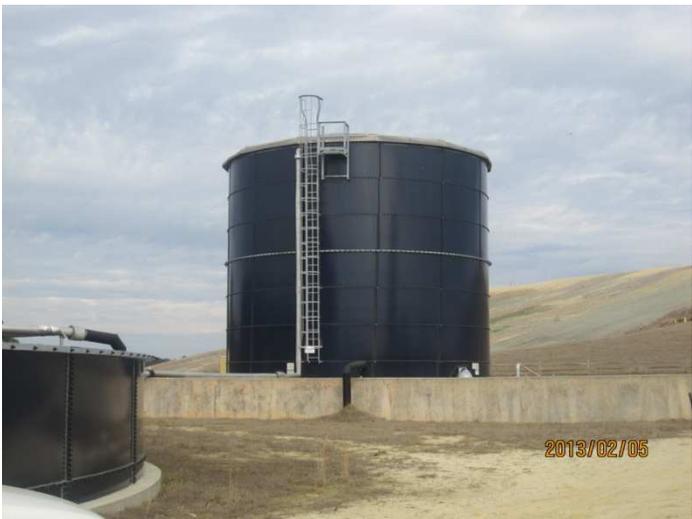
Leachate storage tanks

- 12) Leachate flows by gravity to a leachate penetration assembly and leaves the lined landfill via gravity to a leachate sump where it is pumped through a force main into a leachate manhole located west of cell 11. From there via gravity mains to existing leachate pumping stations two storage tanks. One 250,000 gallon and one 162,000 gallon.

- 17) Leachate tank logs include: level, gallons, available gallons, secondary containment, rain amounts, low and high temperature and are kept daily. The Ops Plan specifies weekly, totals can be tabulated if necessary.

- 18) Leachate tanks are being inspected weekly and within 24 hours of a storm event. A log of these inspections is being kept.
- 19) On April 18<sup>th</sup> the Section received a letter from Hodges, Harbin, Newberry & Trimble re a Leachate Evaporation System Demonstration Project. This project is to be located on the top of cells 7 through cell 12. This demonstration project was approved and this was memorialized in a letter from the Section dated April 19, 2012. This demonstration project was for 180 days. A request for extension was granted by the Division for the project on October 17, 2012 the project not having been started. The project has still not started as of the date of this inspection but Matt East has indicated that AEG has ordered the necessary equipment.

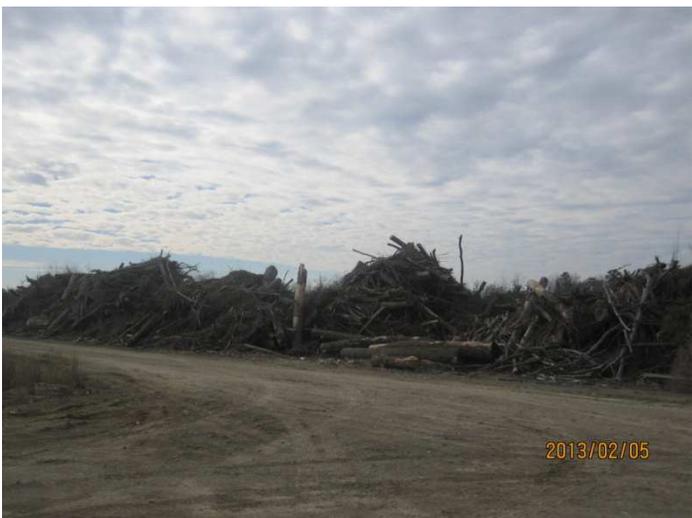
Waste from Hurricane Irene, to be ground

- 10) The latest Financial Assurance was dated 5/10/12, guaranteed by Travelers Casualty and Surety Co.
- 11) Debris from Hurricane Irene is still on site, plans are for Glover Const. to ground the waste.

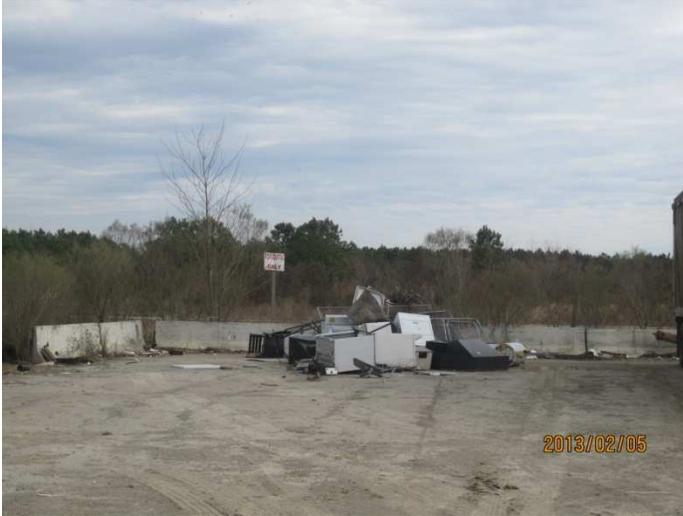
White goods staging area

- 27) White goods are stored on a concrete pad Freon containing white goods are marked and stacked neatly to prevent damage and leaking. Liverman's Metal Recycling, Kelford, NC is handling the Freon removal and records.

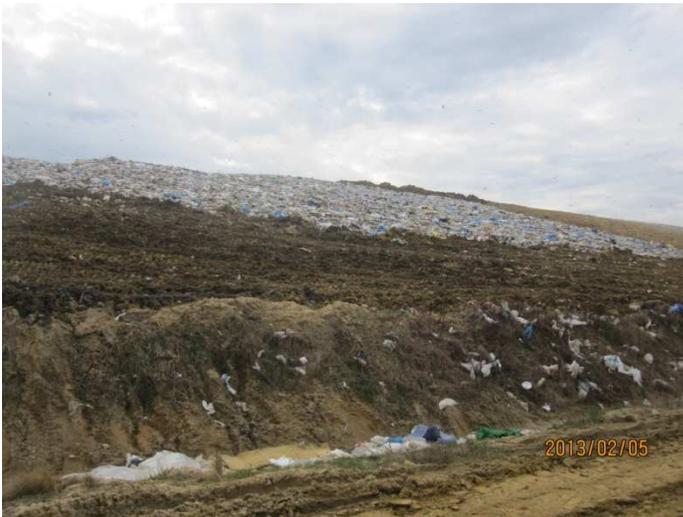
- 20) The working face is fairly large and located at the edge of the slope making control of blown waste difficult.
- 21) The facility has extensive wind screens/fences but repairs are needed in some of these. **Blown waste was observed on the North side of the landfill. East indicated that Bull Fences have been ordered and should arrive within 2 weeks.**

Part of the working face

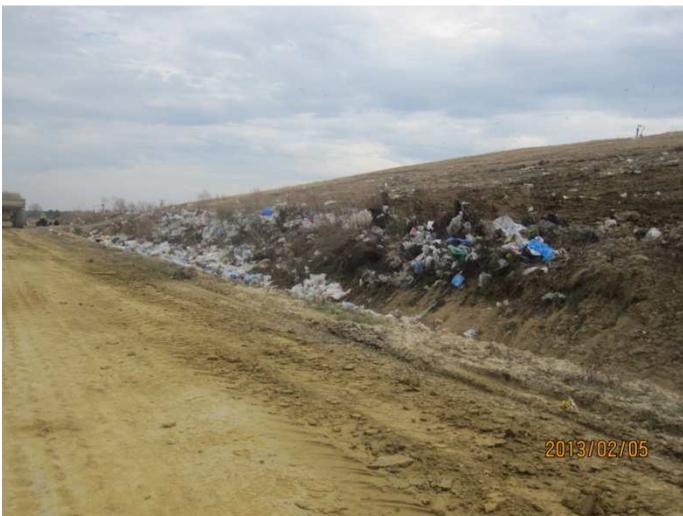
Blown waste below working face
