Subject: Buncombe County Solid Waste Management Facility  
Phase 5 C&D Landfill Expansion Project  
Permit No. 11-07  
Construction Certification

## **Construction Certification**

**Appendix C**  
**Construction Photographs**

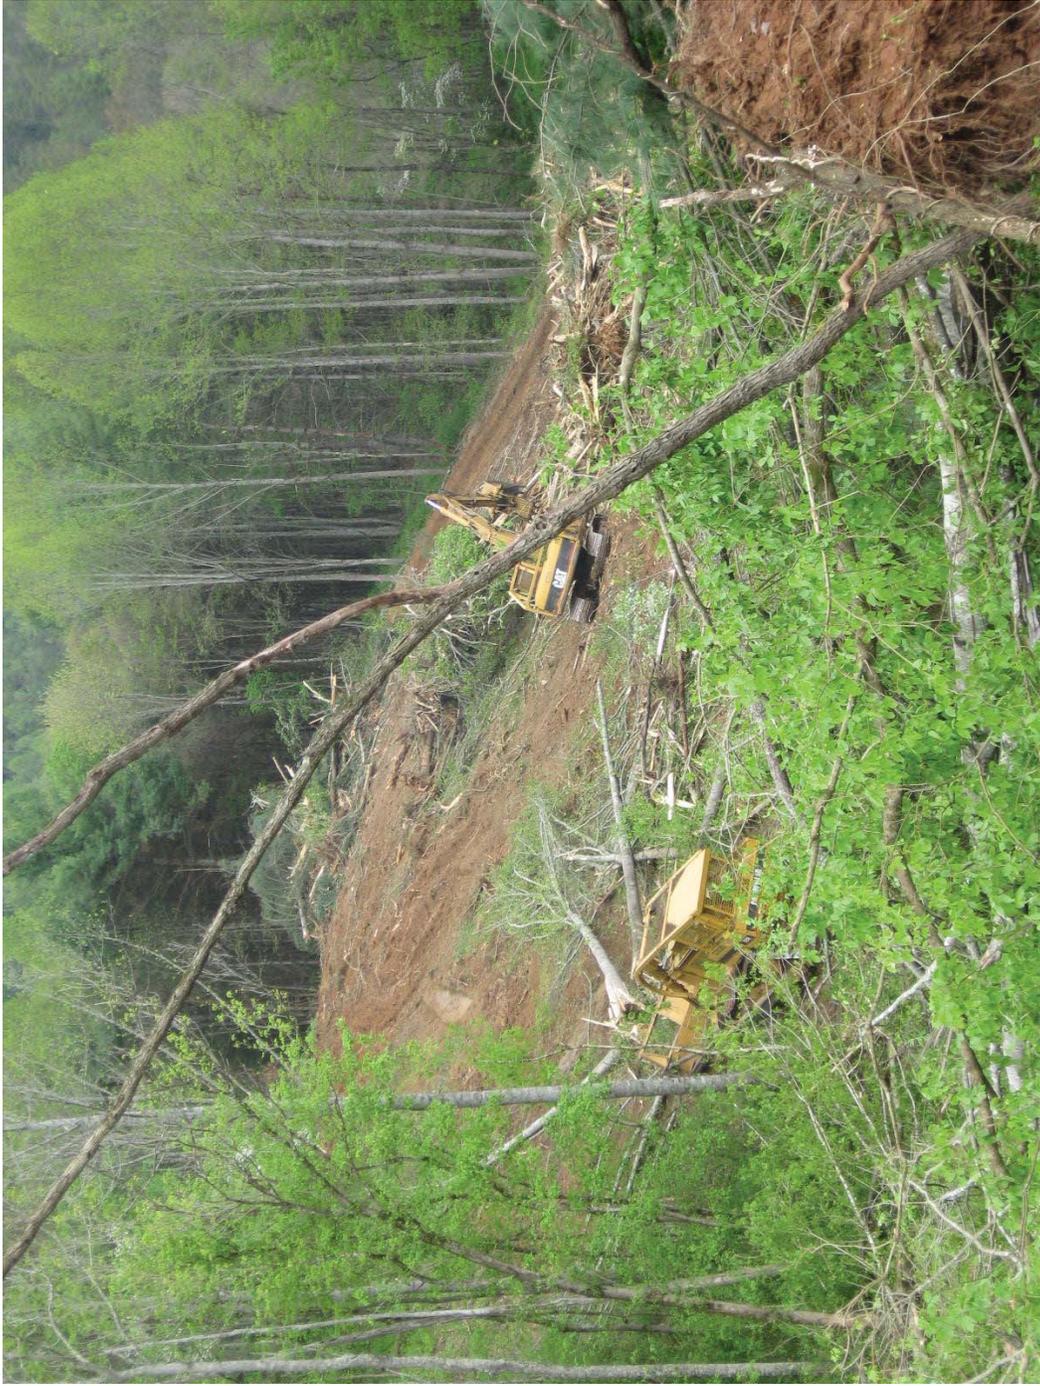
Clearing Phase 5/Sediment Pond 12 Area

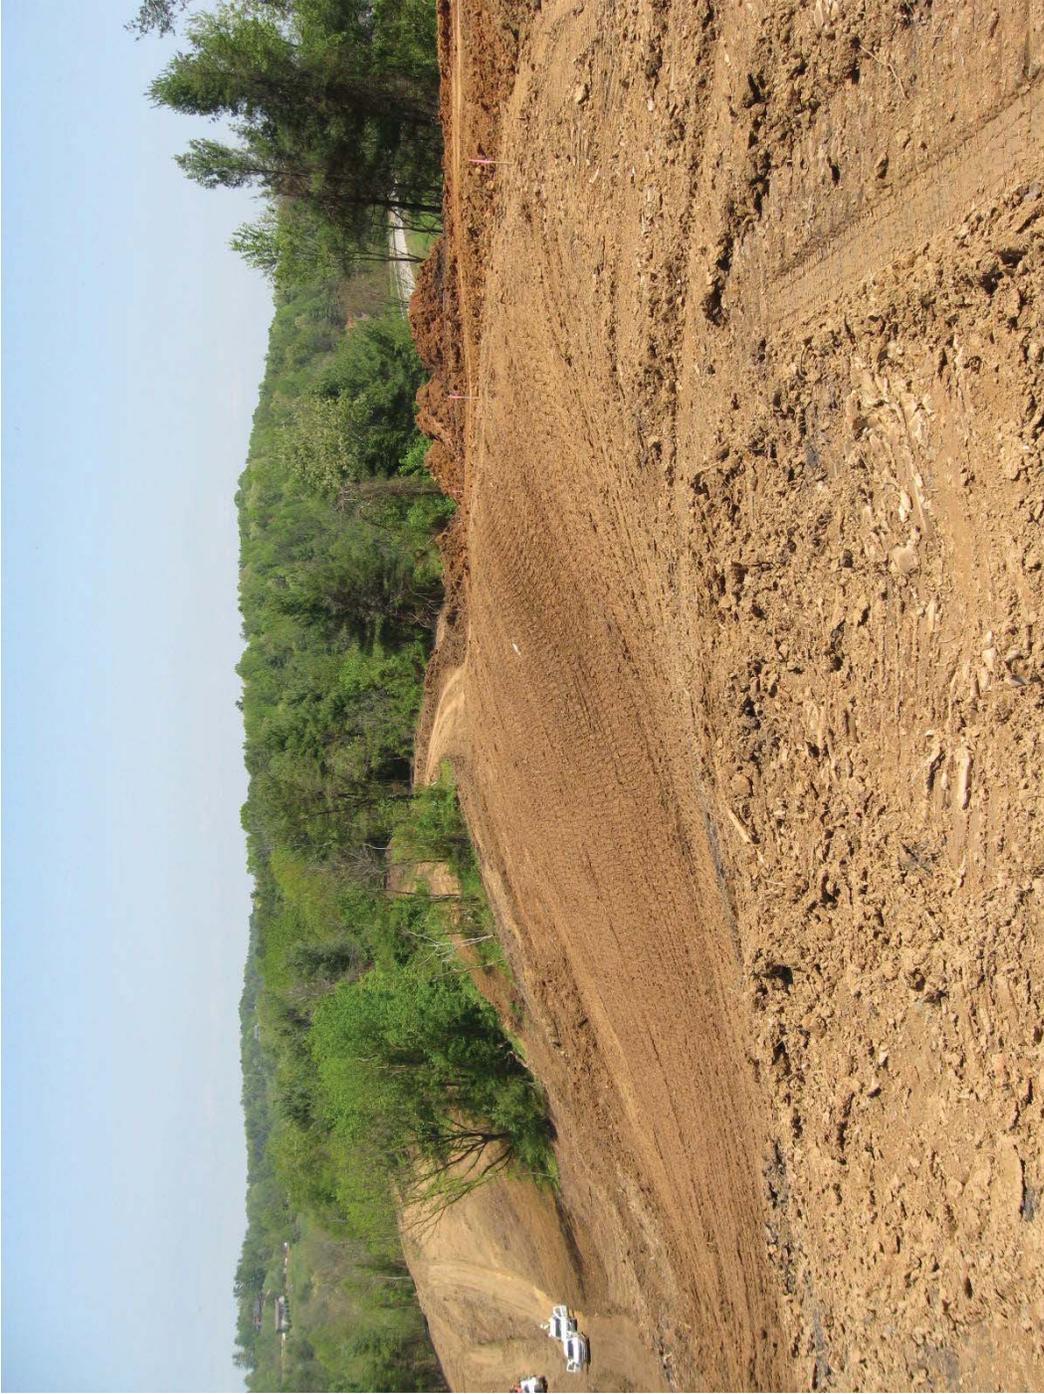
Shaping Phase 5 Area and Access Road

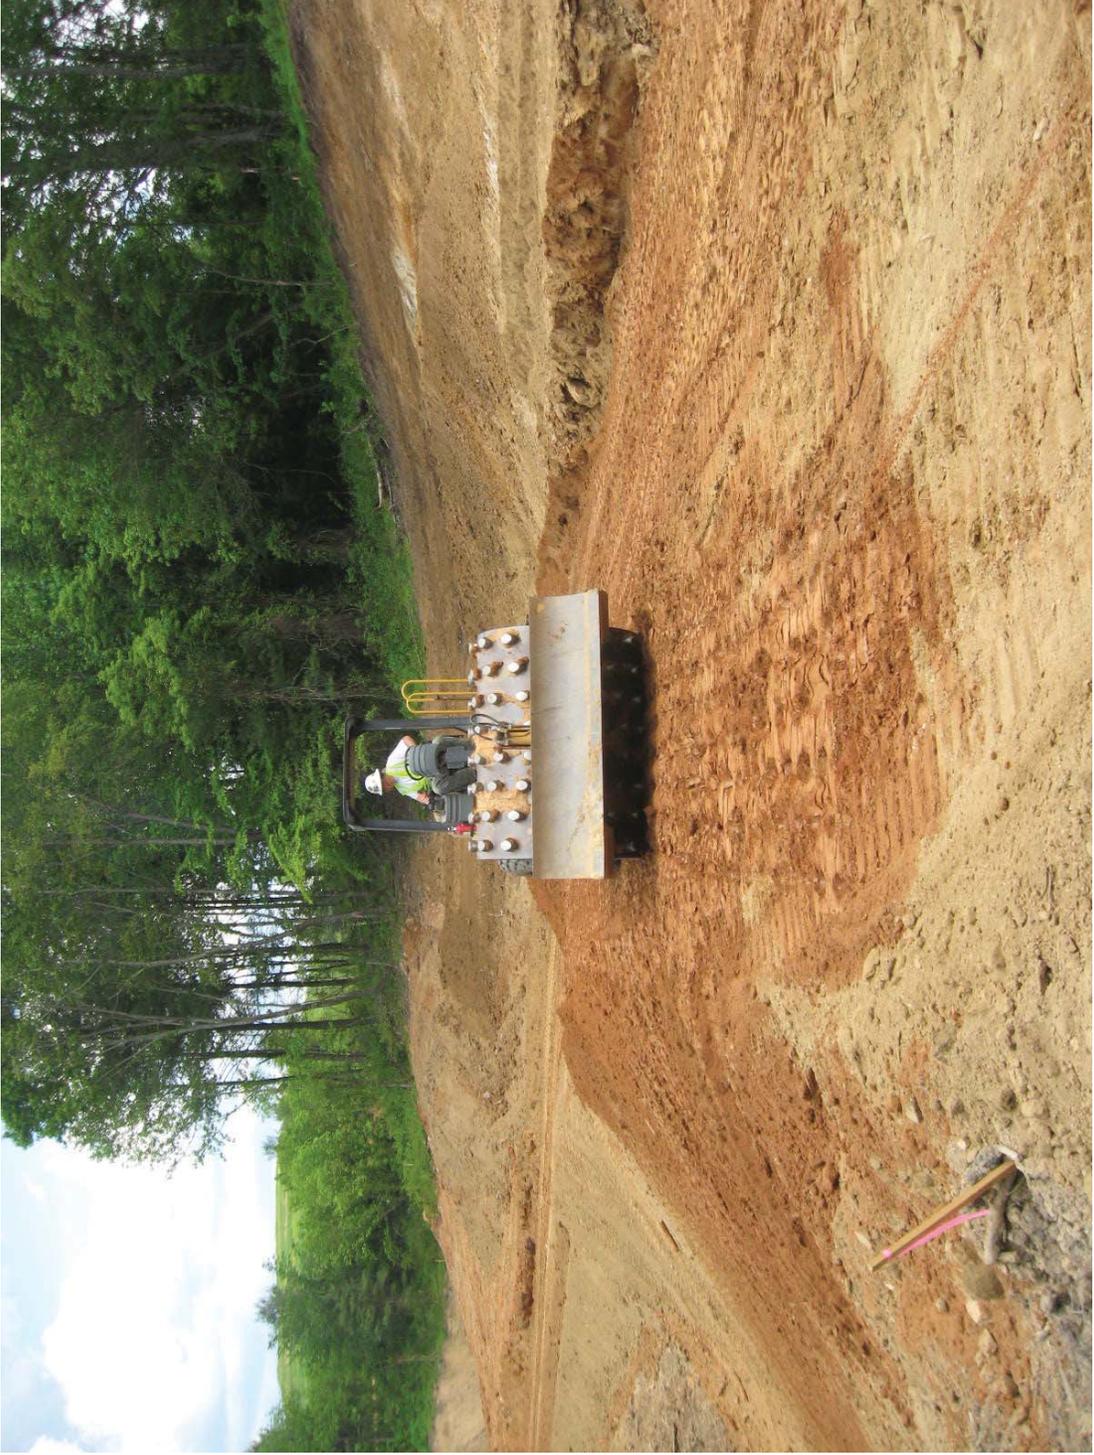
Compaction of Access Road

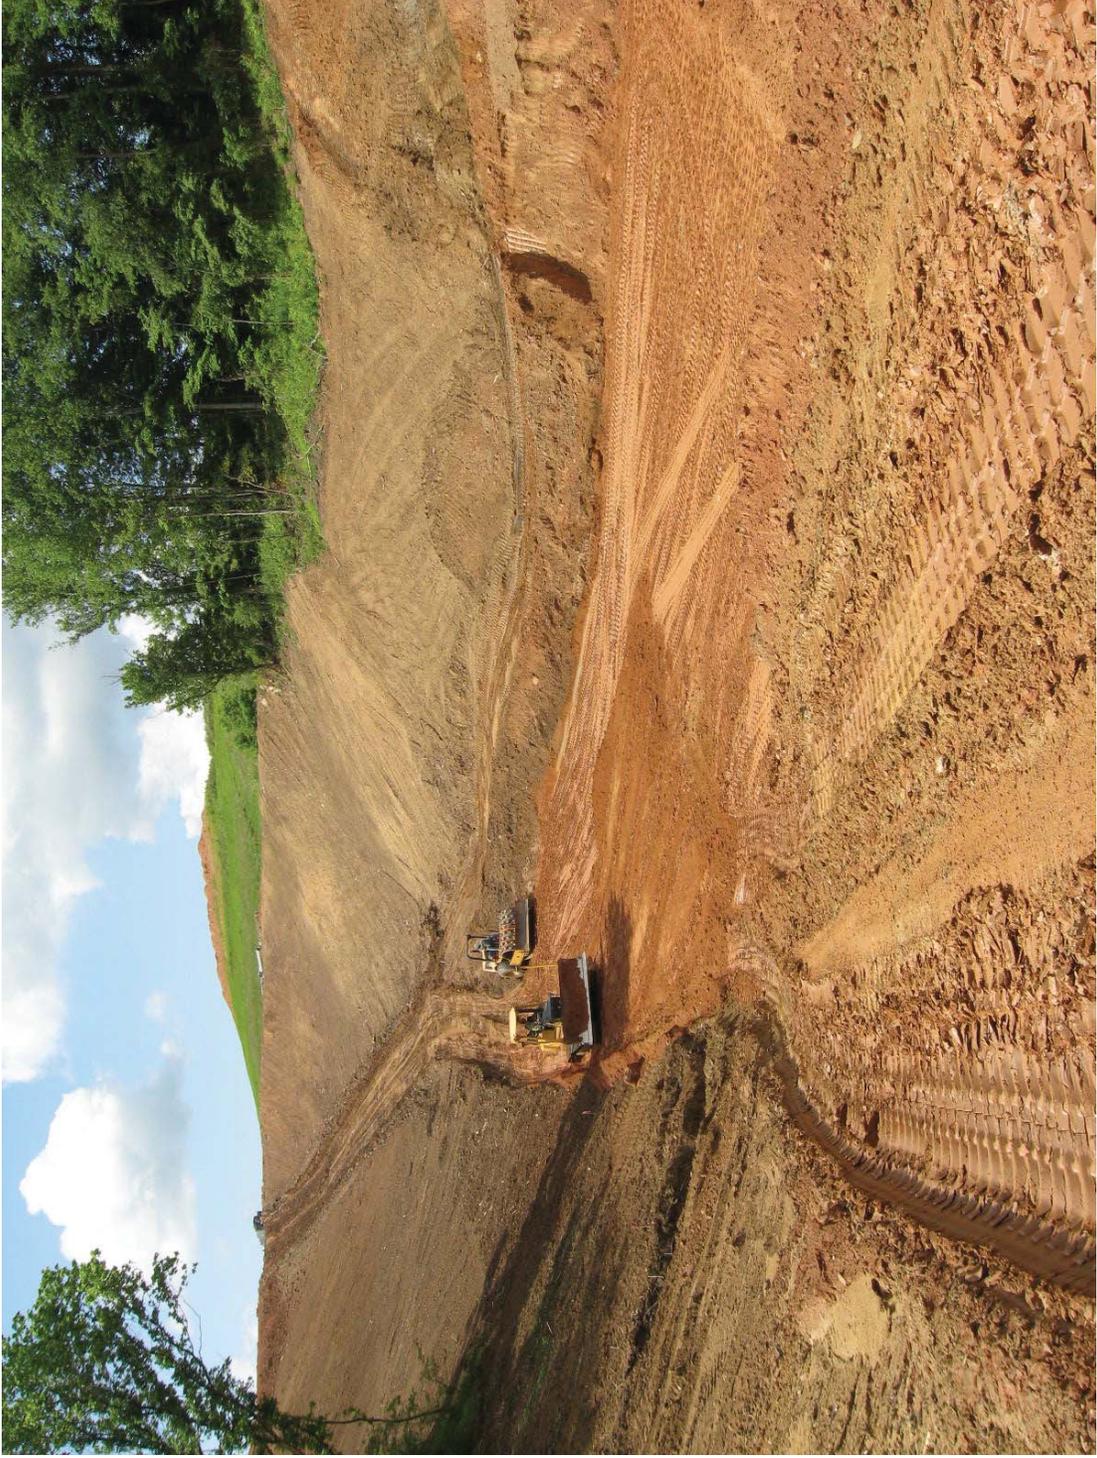
Compacting Sediment Pond 12 Bottom

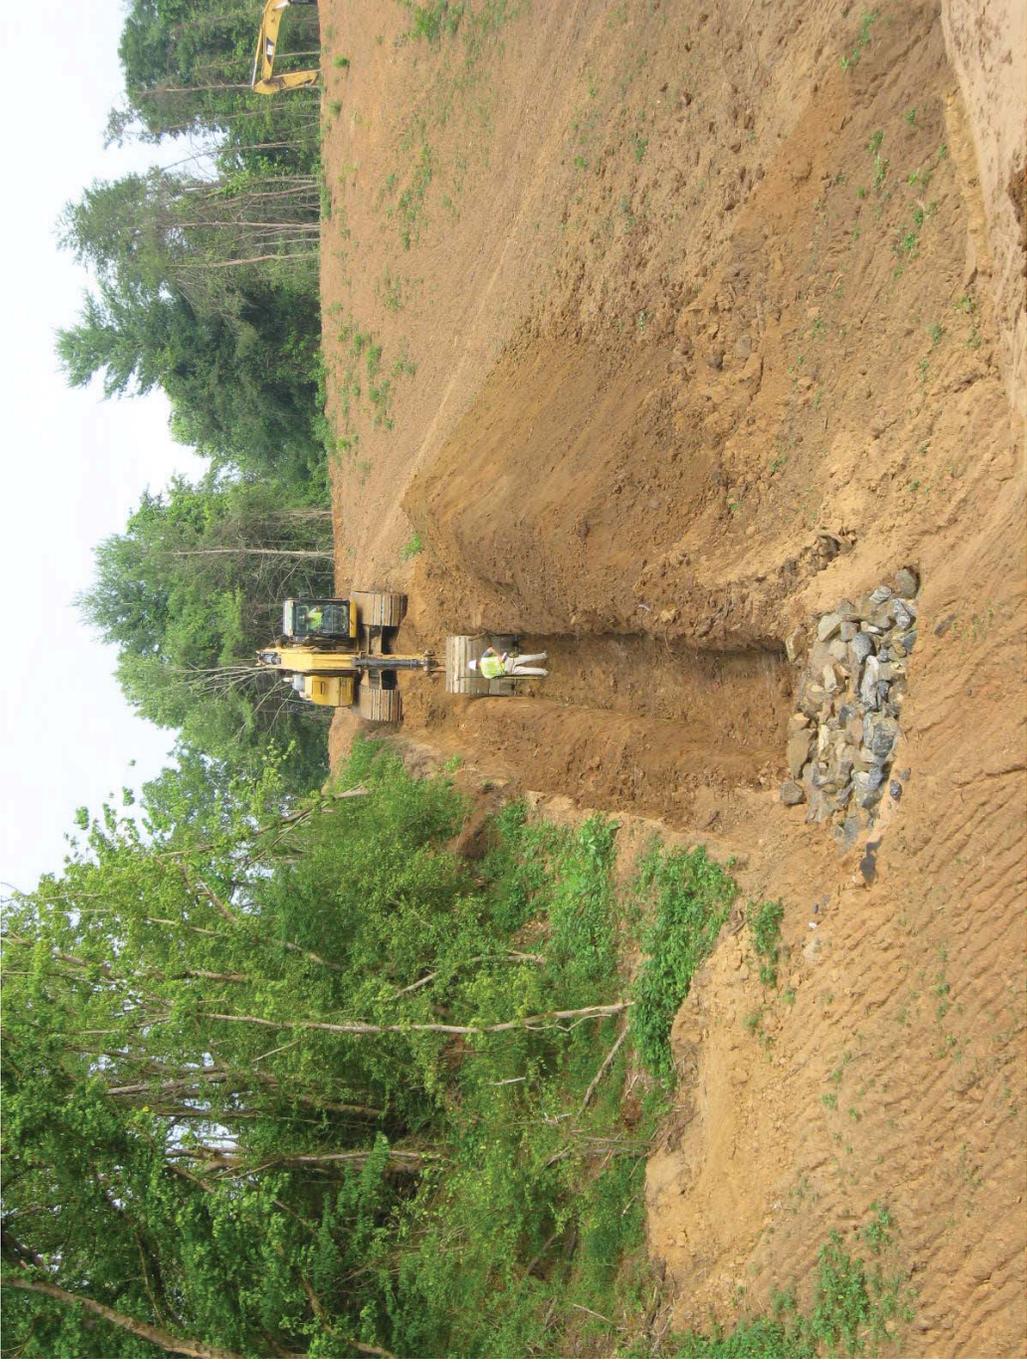
Stormwater Pipe Construction

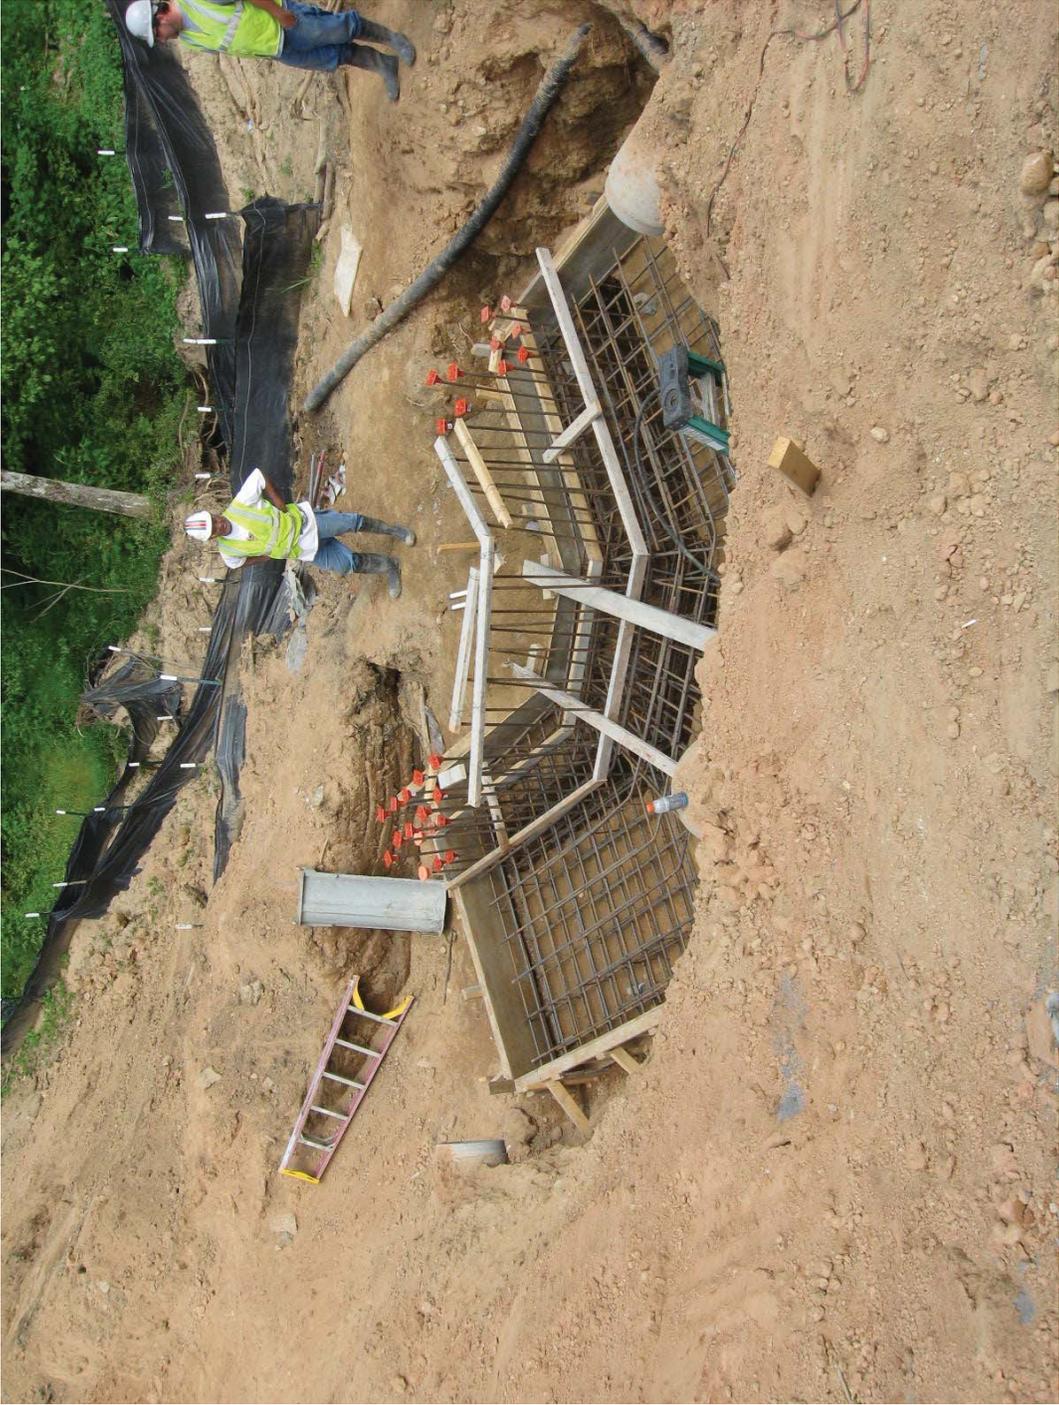
Sediment Pond 12 Endwall Structure

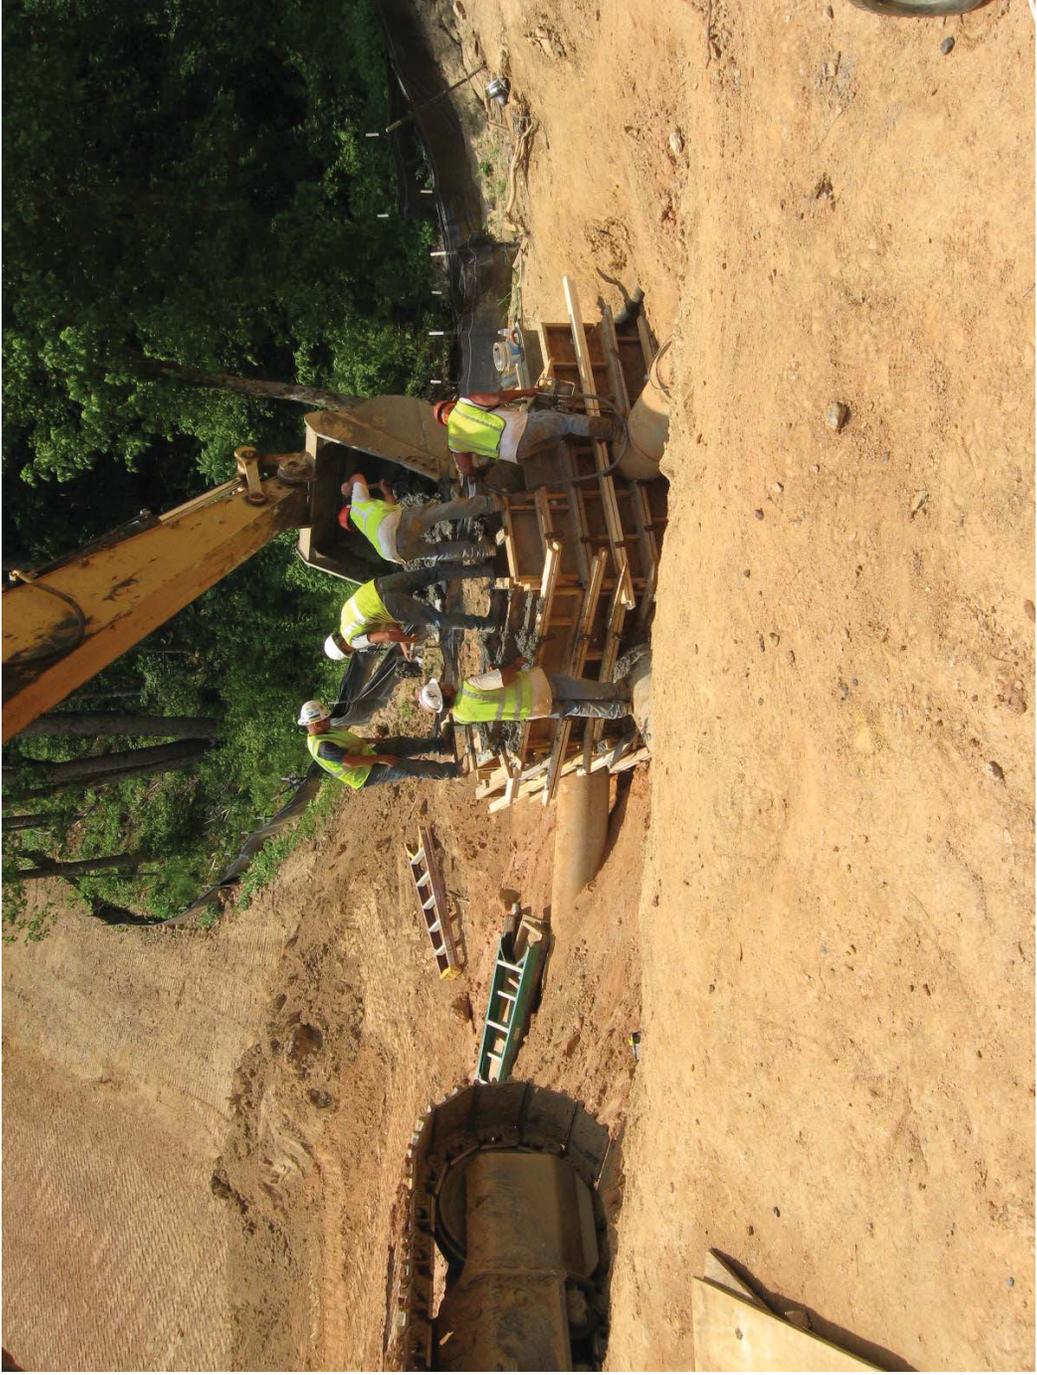
Pouring Endwall

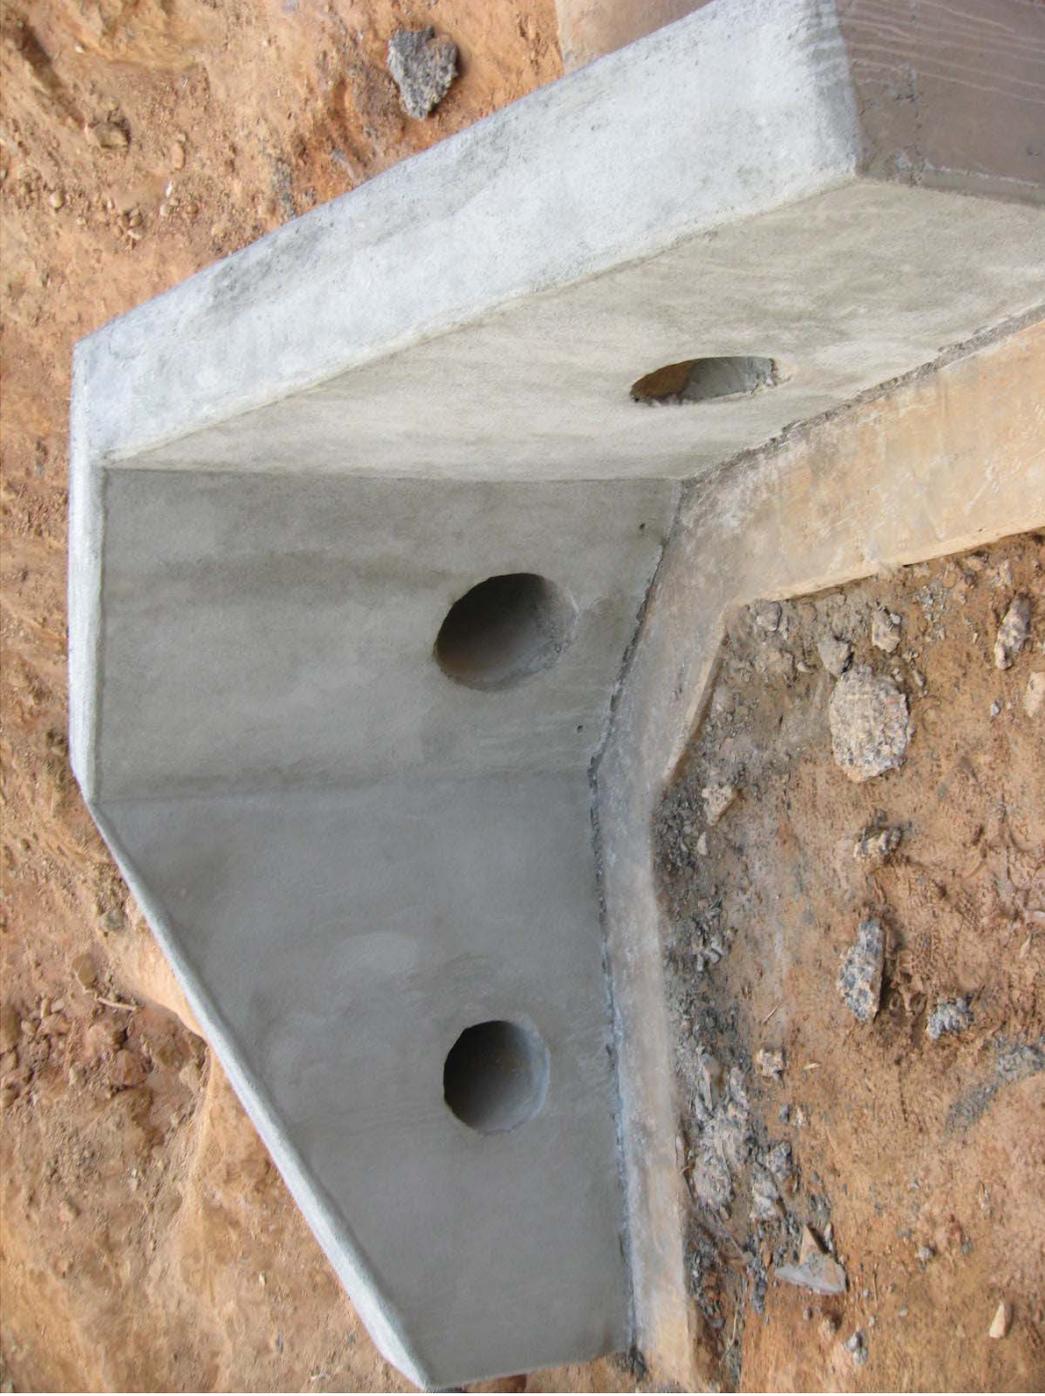
Completed Endwall

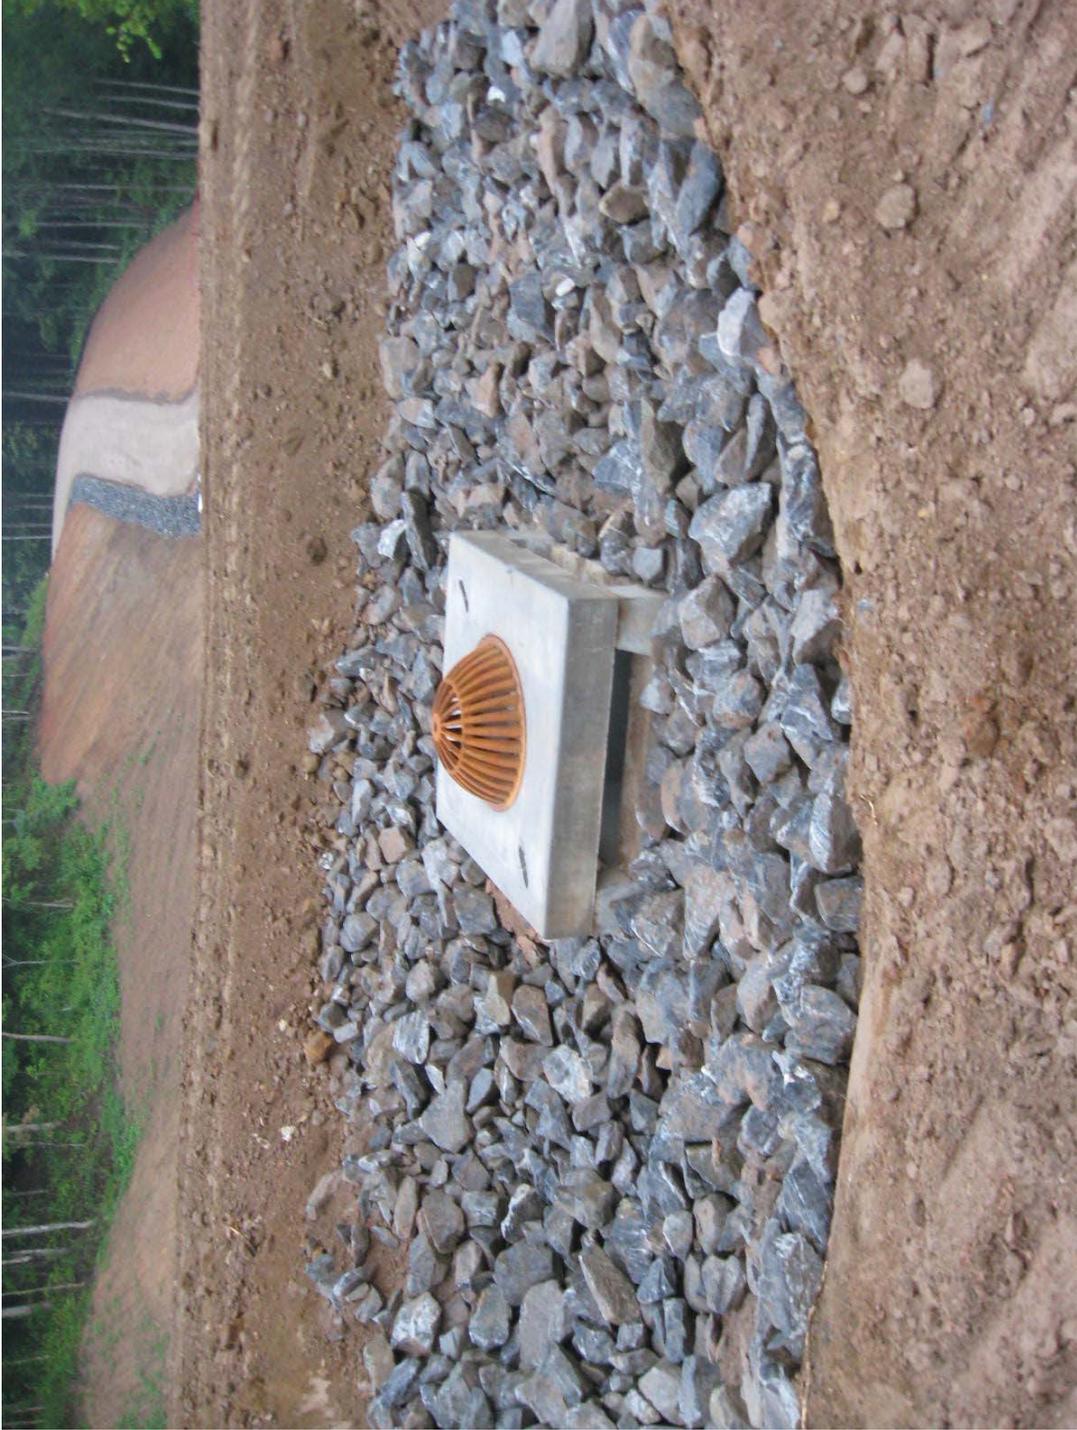
Completed Yard Inlet

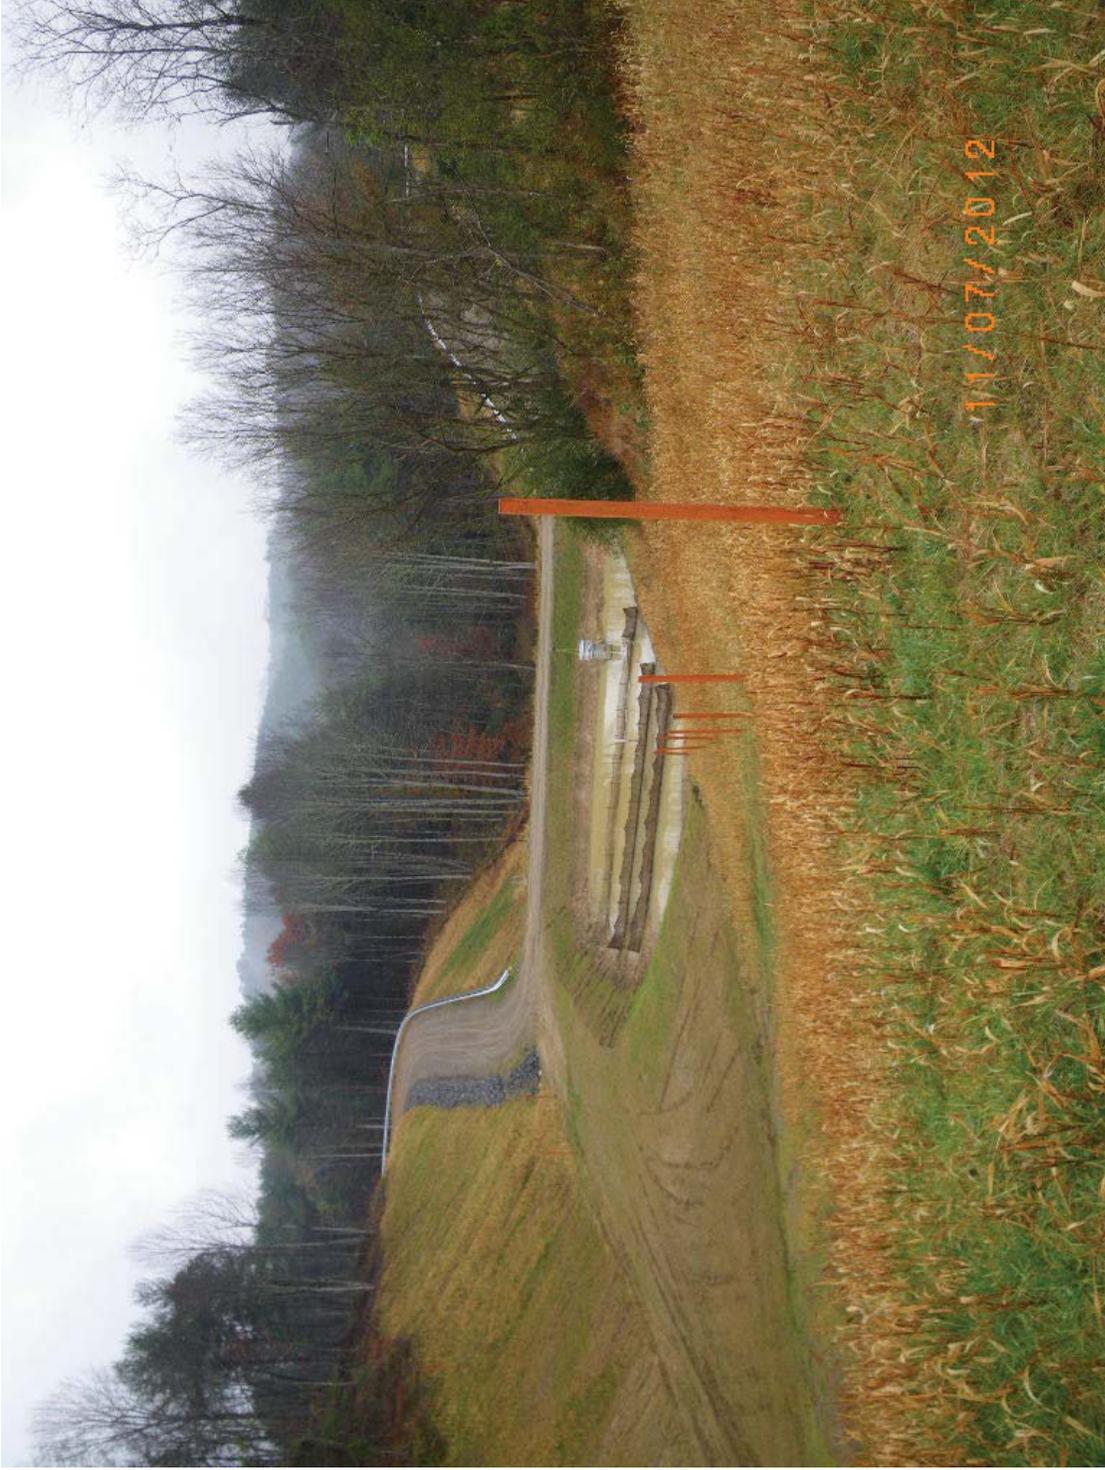
Completed Phase 5 Area/Sediment Pond 12

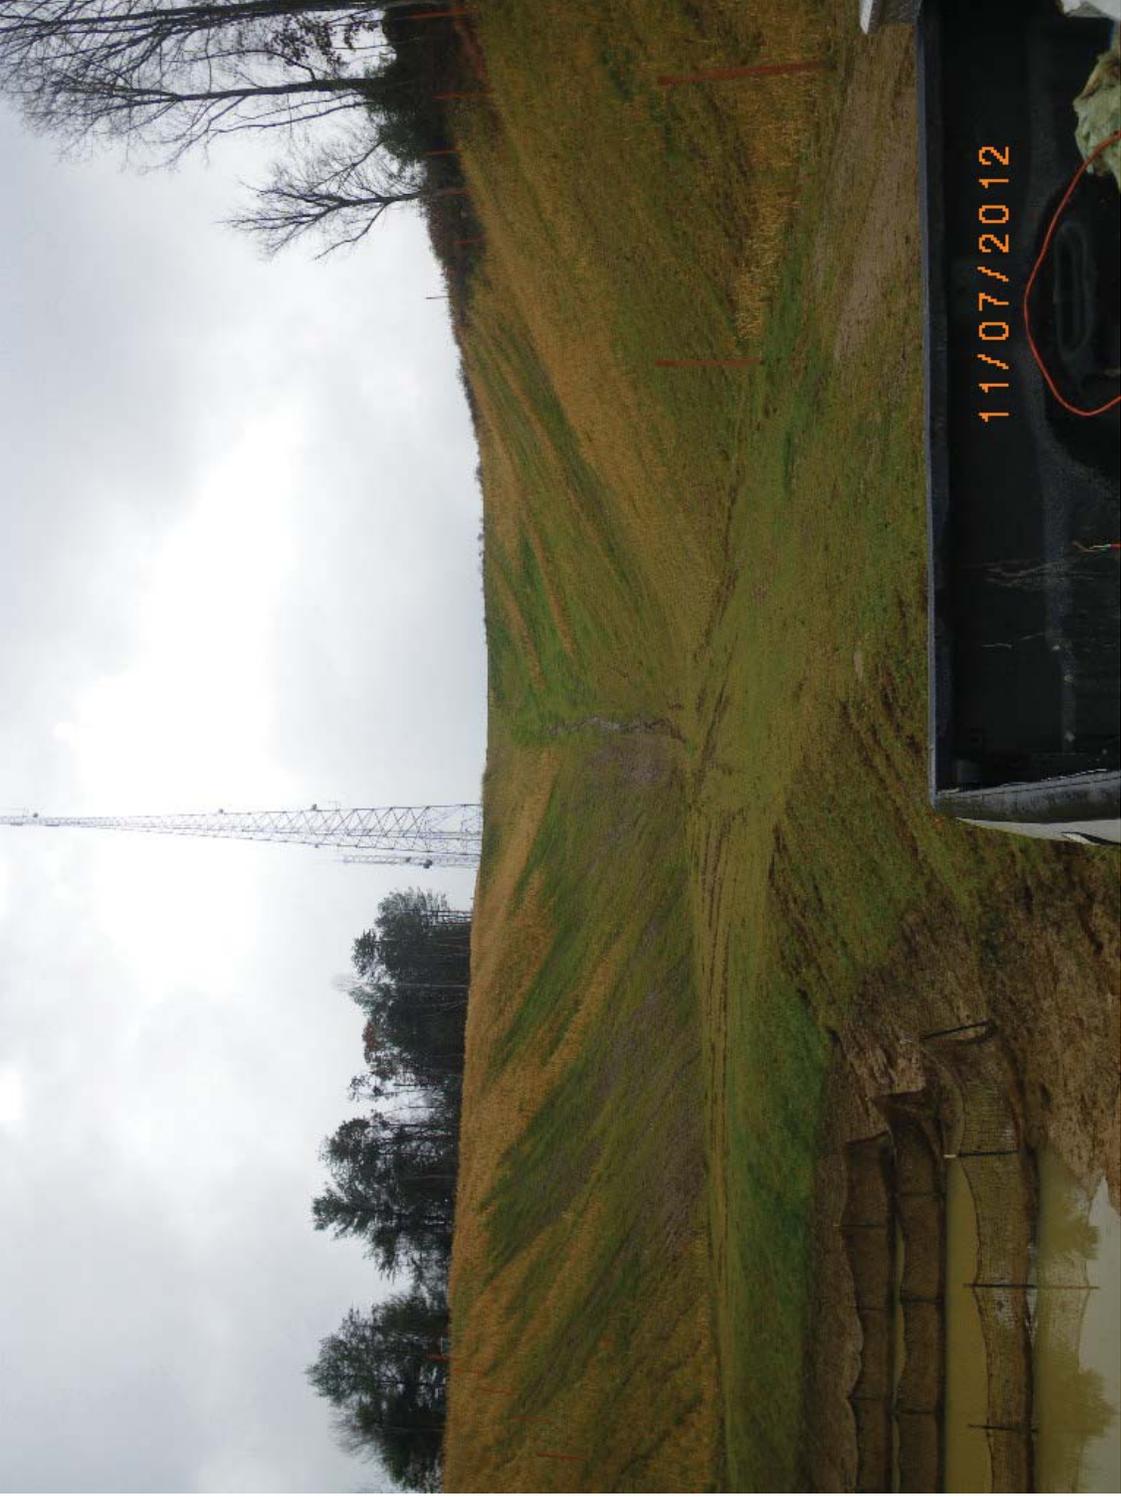
Completed Phase 5 Area

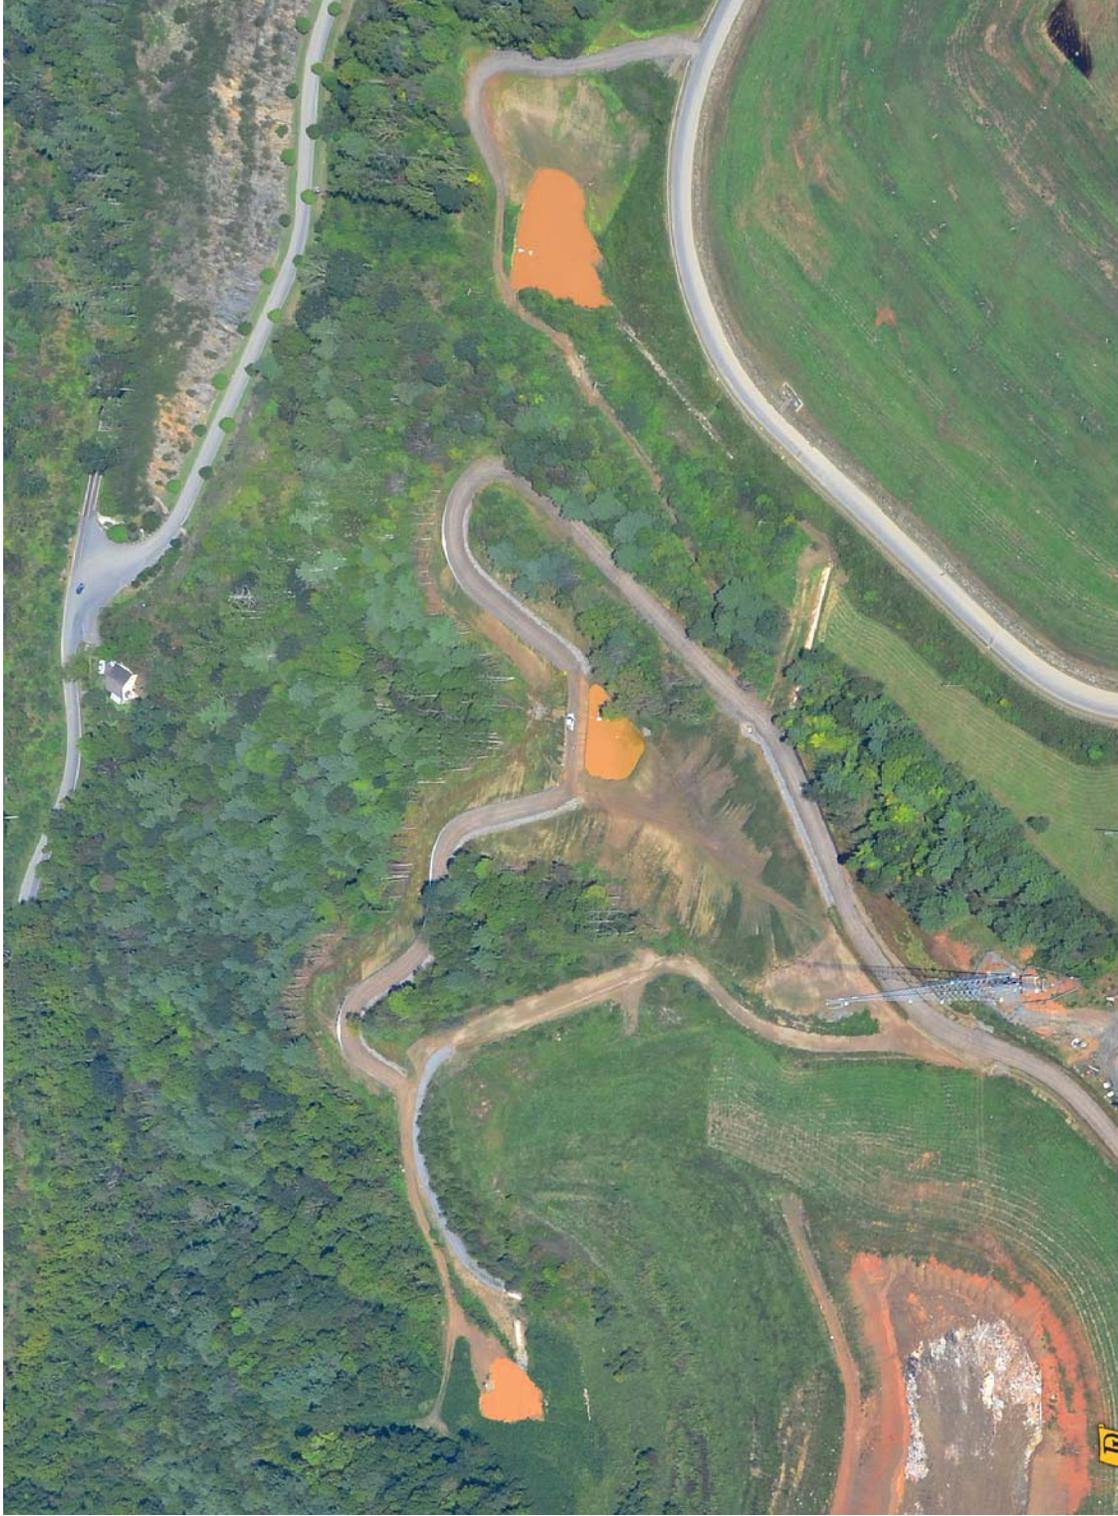
Buncombe County C&D Landfill Ph 5-1 9-19-12

Completed Aerial
