FACILITY COMPLIANCE INSPECTION REPORT
Division of Waste Management
Solid Waste Section

Date of Site Inspection: December 6, 2012 **Date of Last Inspection:** January 26, 2012

Stone Company LLP LCID Landfill
 Big Woods Road
 Chapel Hill, NC 27517

Comprehensive Inspection

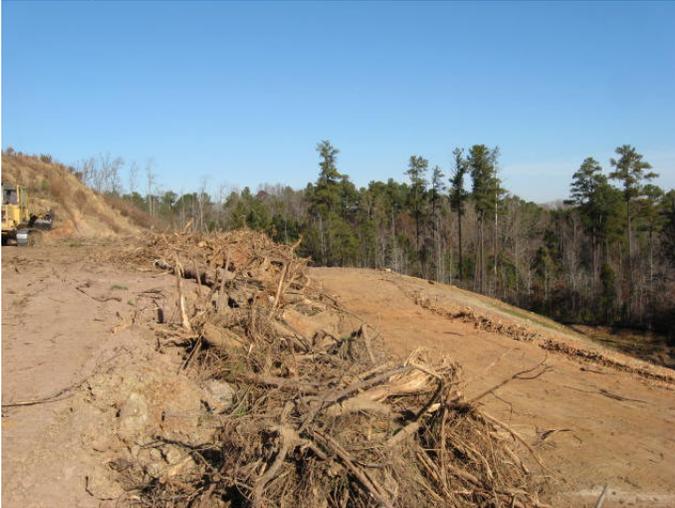
Working face (LCD)

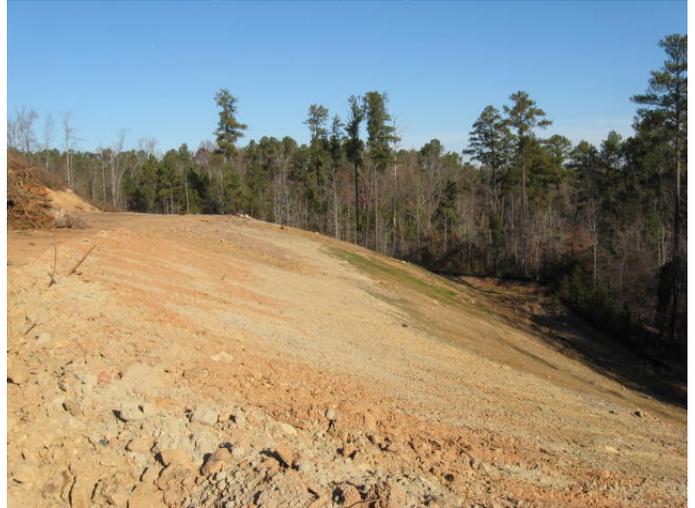
18. Mr. Stone stated that the new area of the LCID landfill is filled laterally, such that the exterior side slope is benched. When an area is near completion fill material is added to the benched area such that the exterior side slope is uniform and re-graded as a continual side slope.

Exterior side slope (abutting "step" at working face)

19. A portion of the graded side slope has been sown with grass seed.
20. Excavation, grading, and fill material side slopes must not exceed a ratio of three horizontal feet to one vertical feet (3:1).

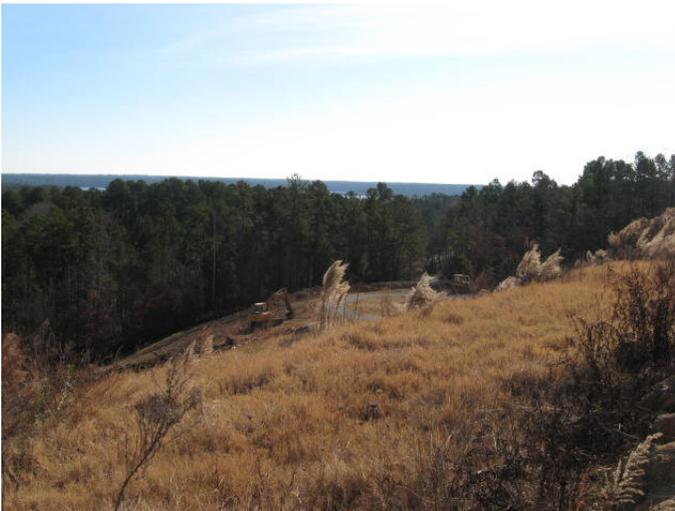
Atop old portion of LCID landfill, view towards working face/active area

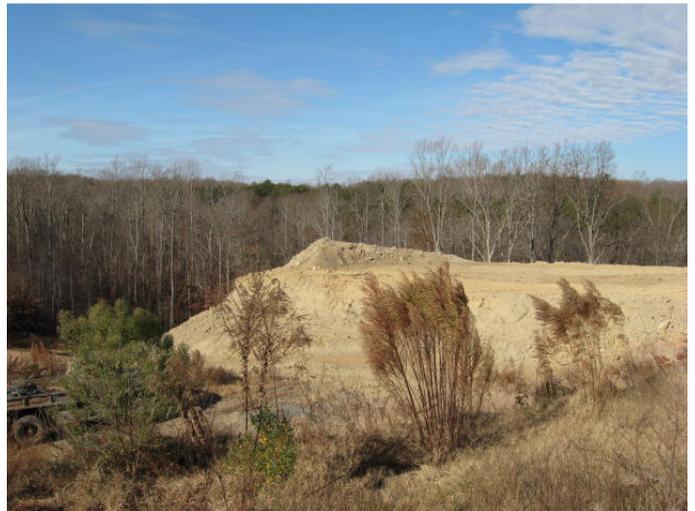
10. The facility also receives clean soil, stockpiled for cover material at the north-west edge of the landfill. The amount of soil accepted from January through November 2012 is: 2,479 tons.

Soil stockpile area, adjacent to old portion of landfill
