FACILITY COMPLIANCE INSPECTION REPORT
Division of Waste Management
Solid Waste Section

Date of Site Inspection: April 8, 2013 Date of Last Inspection: April 3, 2012

Cherokee County MSW Landfill
 10160 US 19/74/129
 Marble, NC 28905

Comprehensive Audit of MSW Landfill

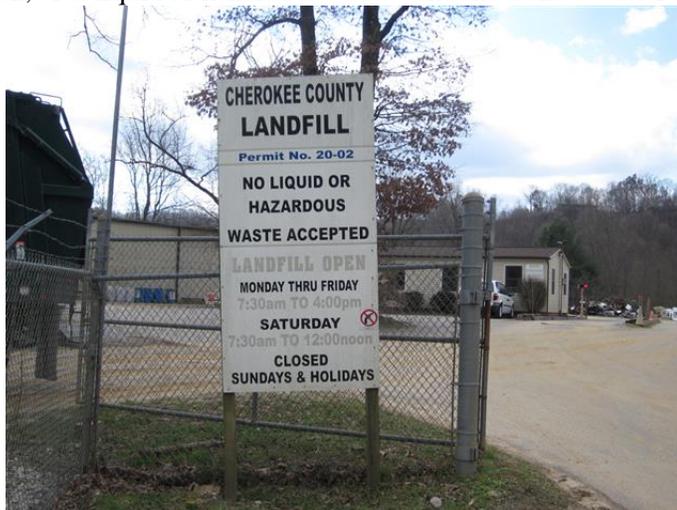
9. Fire extinguishers were located in several areas on the property.
10. The waste screening forms were reviewed. All screening was being done at the working face.
11. All public roads were well maintained. A sign was placed at the entrance to the facility which stated the hours/days of operation, “No liquid or hazardous waste” and the Solid Waste Permit Number.

Entrance Sign

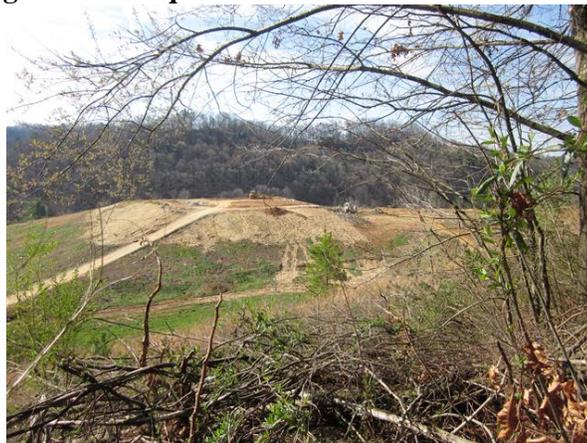
Looking South at Cherokee Co. MSW Landfill

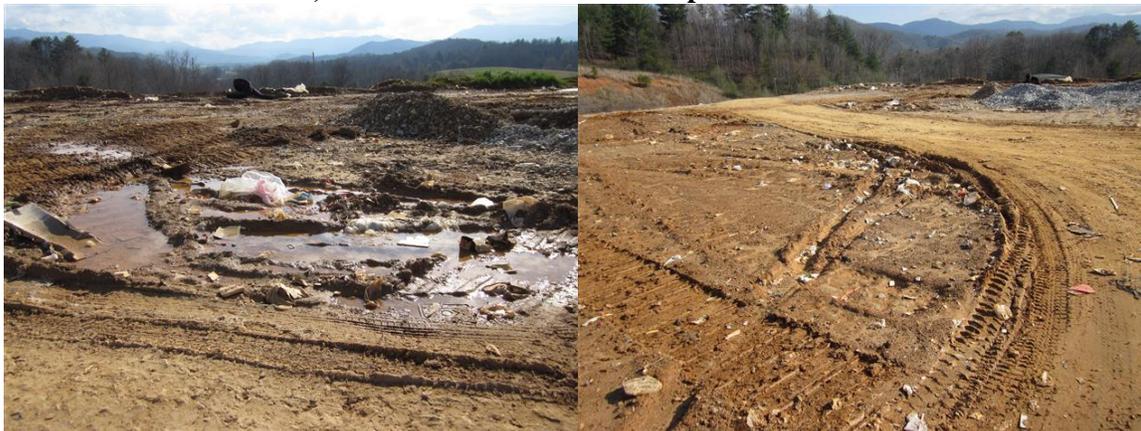
Cherokee County MSW Landfill (Cherokee County) was in violation of 15A NCAC 13B .0626(2)(a) in that on April 8, 2013, solid waste was observed improperly covered in the daily cover areas of the landfill.

Cherokee County MSW Landfill (Cherokee County) was in violation of 15A NCAC 13B .0626(8)(b) in that on April 8, 2013, surface water was impounded over waste in areas with daily cover. The water was in contact with waste and was considered leachate.

17. **The area covered with daily cover had several areas with exposed solid waste. There were a few areas with a small amount of ponding water on the top of the landfill. It had been several days since the last rain storm. As a reminder, surface water shall not be impounded over water.**

Areas with ponded water and improperly covered waste in the daily cover area.

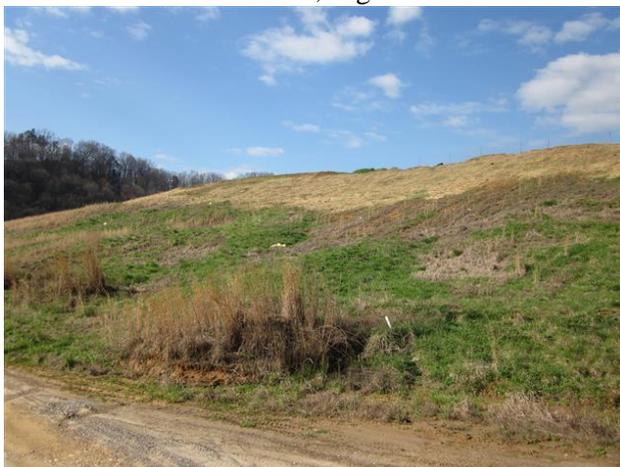
18. No leachate breakouts were observed. The facility does not recirculate leachate, according to staff.
19. The intermediate cover was observed with very little erosion. The facility has taken steps to minimize erosion which has been noted in previous inspections. The areas of the landfill with vegetative cover were being well maintained. In other areas, vegetative cover was being established.

Eastern slope of landfill

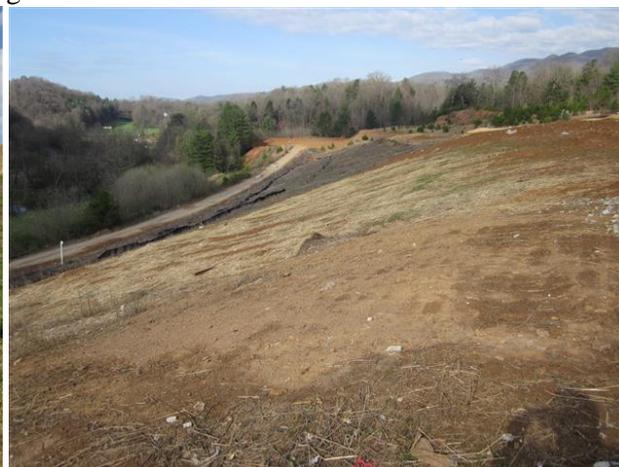
Southern Slope of Landfill
