REMEDIAL ACTIONS AT HAZARDOUS WASTE SITES

Survey and Case Studies

N. Neely, D. Gillespie, F. Schauf, J. Walsh
SCS Engineers
Covington, Kentucky

This final report EPA-430-9-81-005 describes work performed for the Municipal Environmental Research Division of the U.S. EPA Office of Research and Development under Contract No. 68-01-4885 and is reproduced as received from the contractor

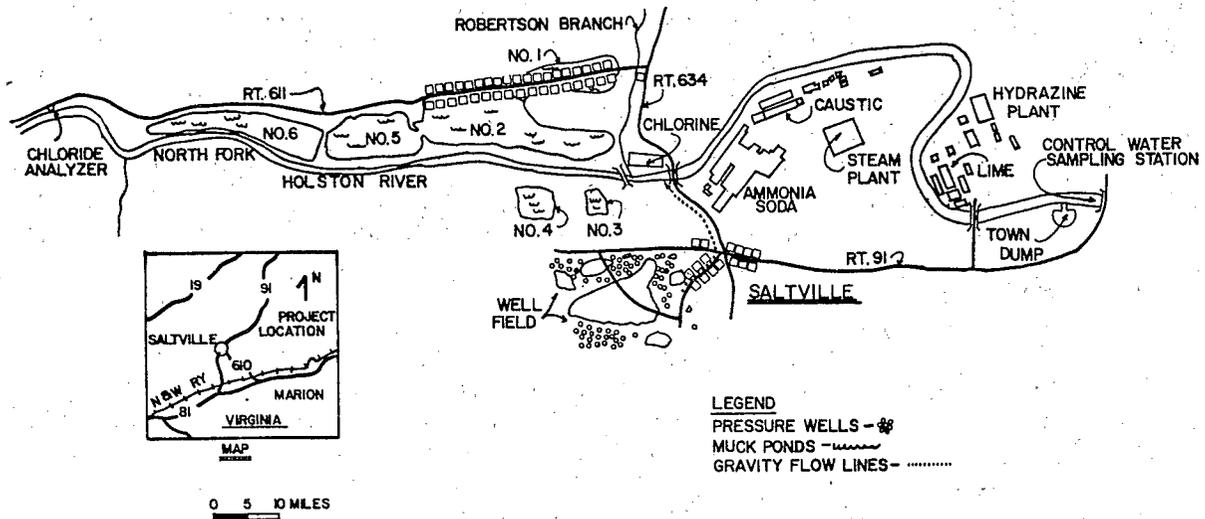
Figure 2-2. Site layout of Olin Chemical complex. [2-2]

The Olin Chemical complex is located in the Saltville Valley in southwestern Virginia. The plant location is shown in an aerial photograph included as Figure 2-1; the layout of facilities at the complex is shown in Figure 2-2.

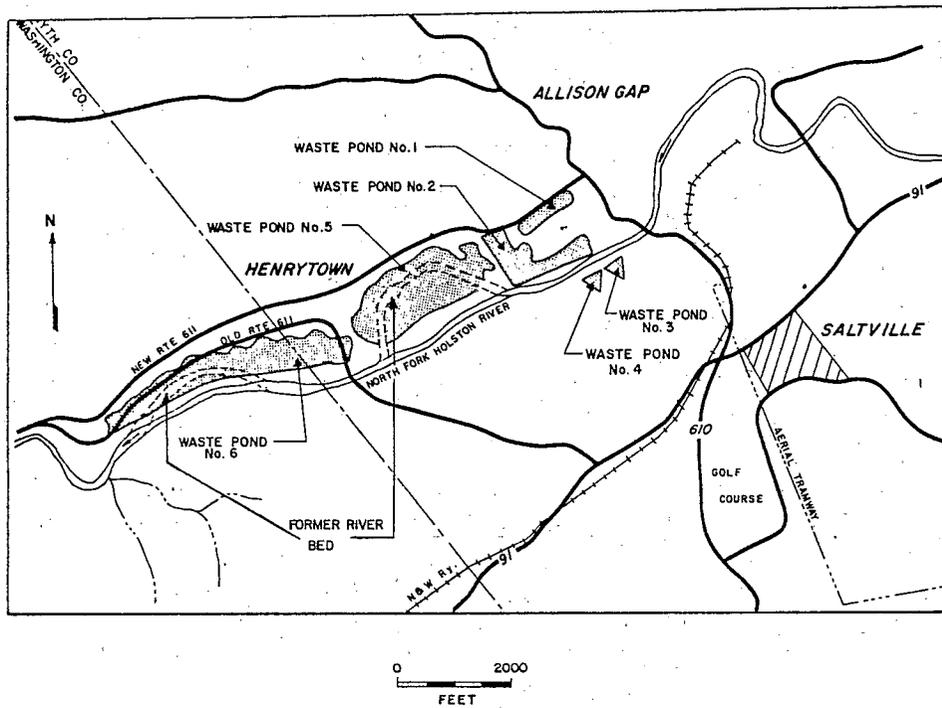
Figure 2-5. Location of former river bed through Waste Ponds 5 and 6. [2-3]

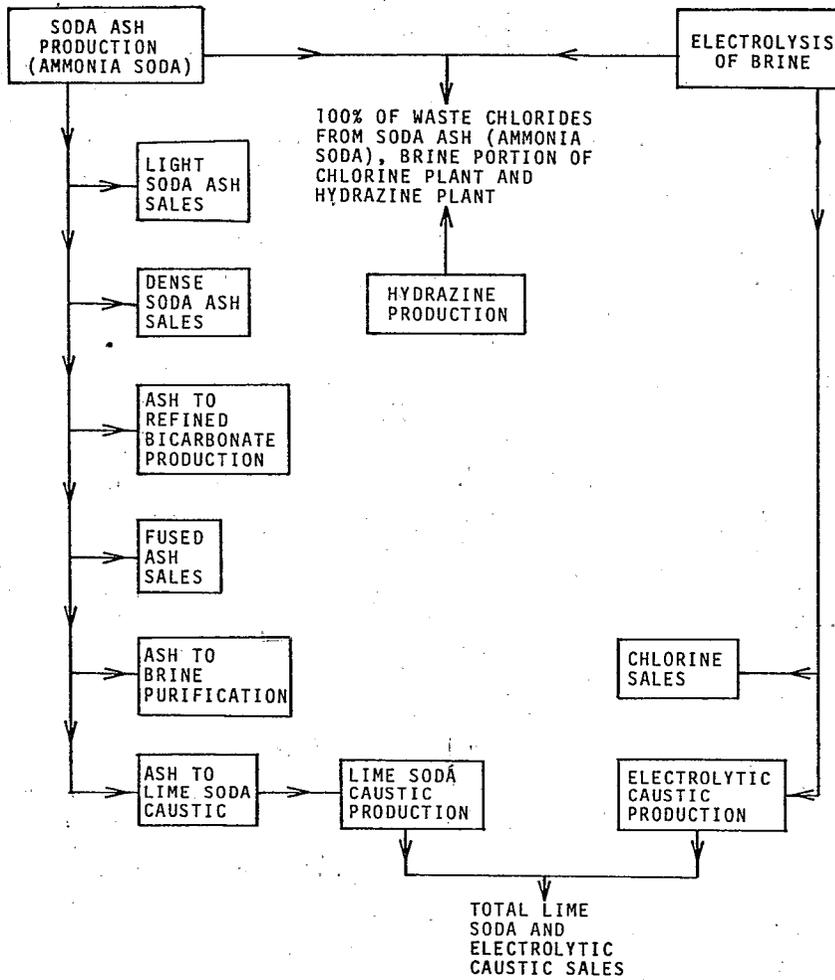
Figure 2-6. Process flow diagram for Olin alkali plant. [2-2]

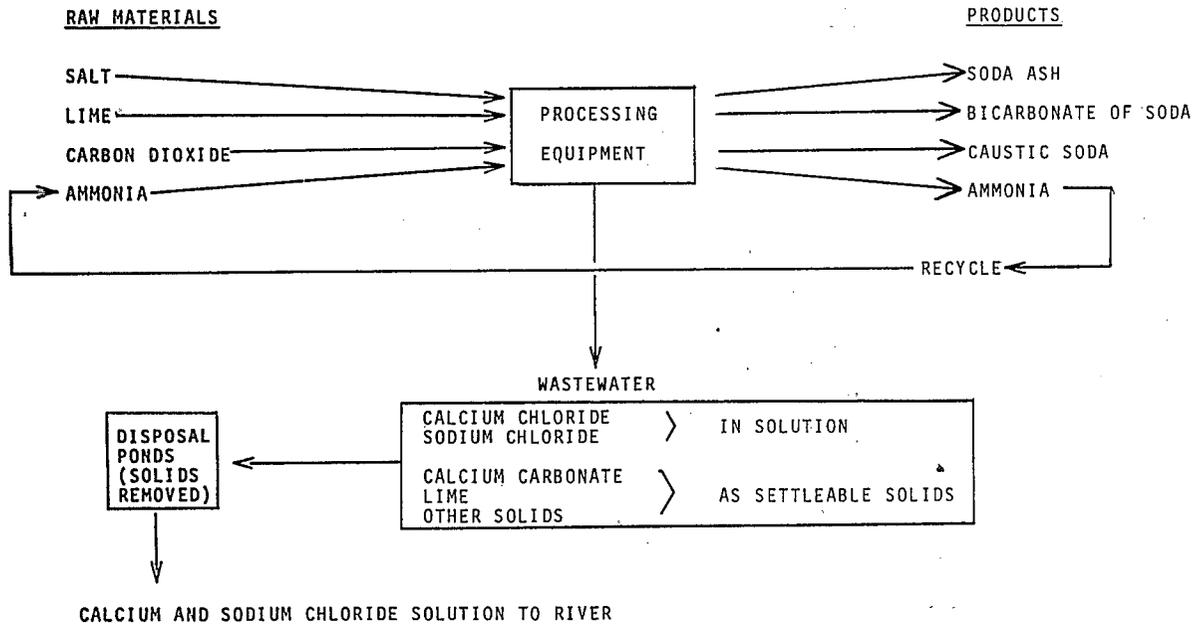
Figure 2-7. Soda-alkali production at Olin Saltville plant. [2-2]

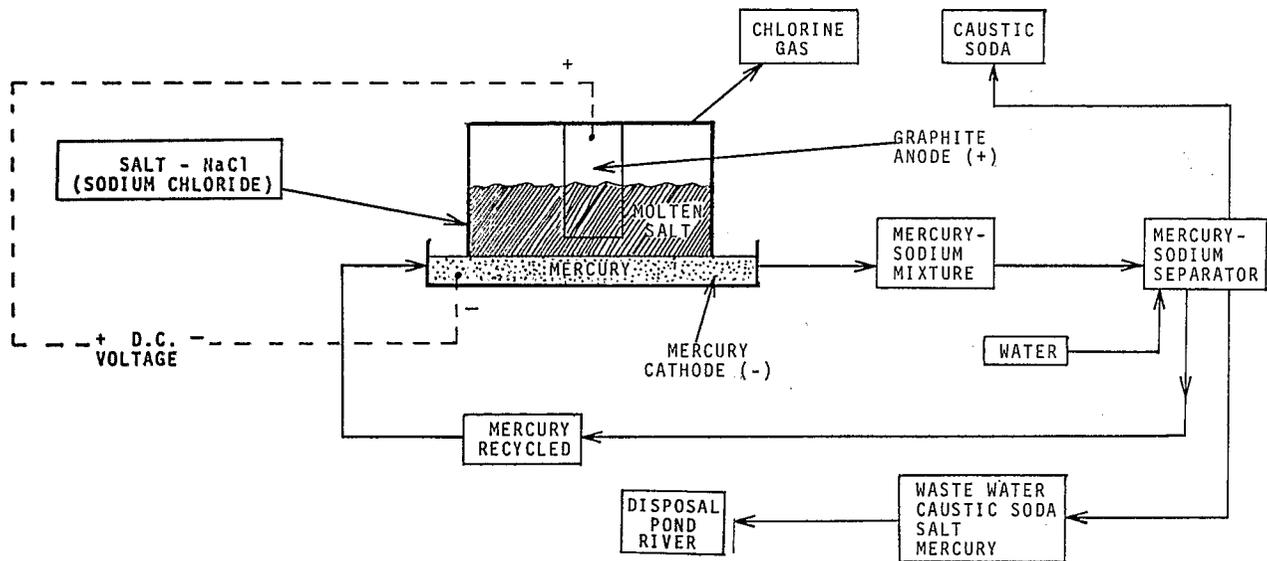
Figure 2-8. Chlorine-caustic production at Olin Saltville plant. [2-2]

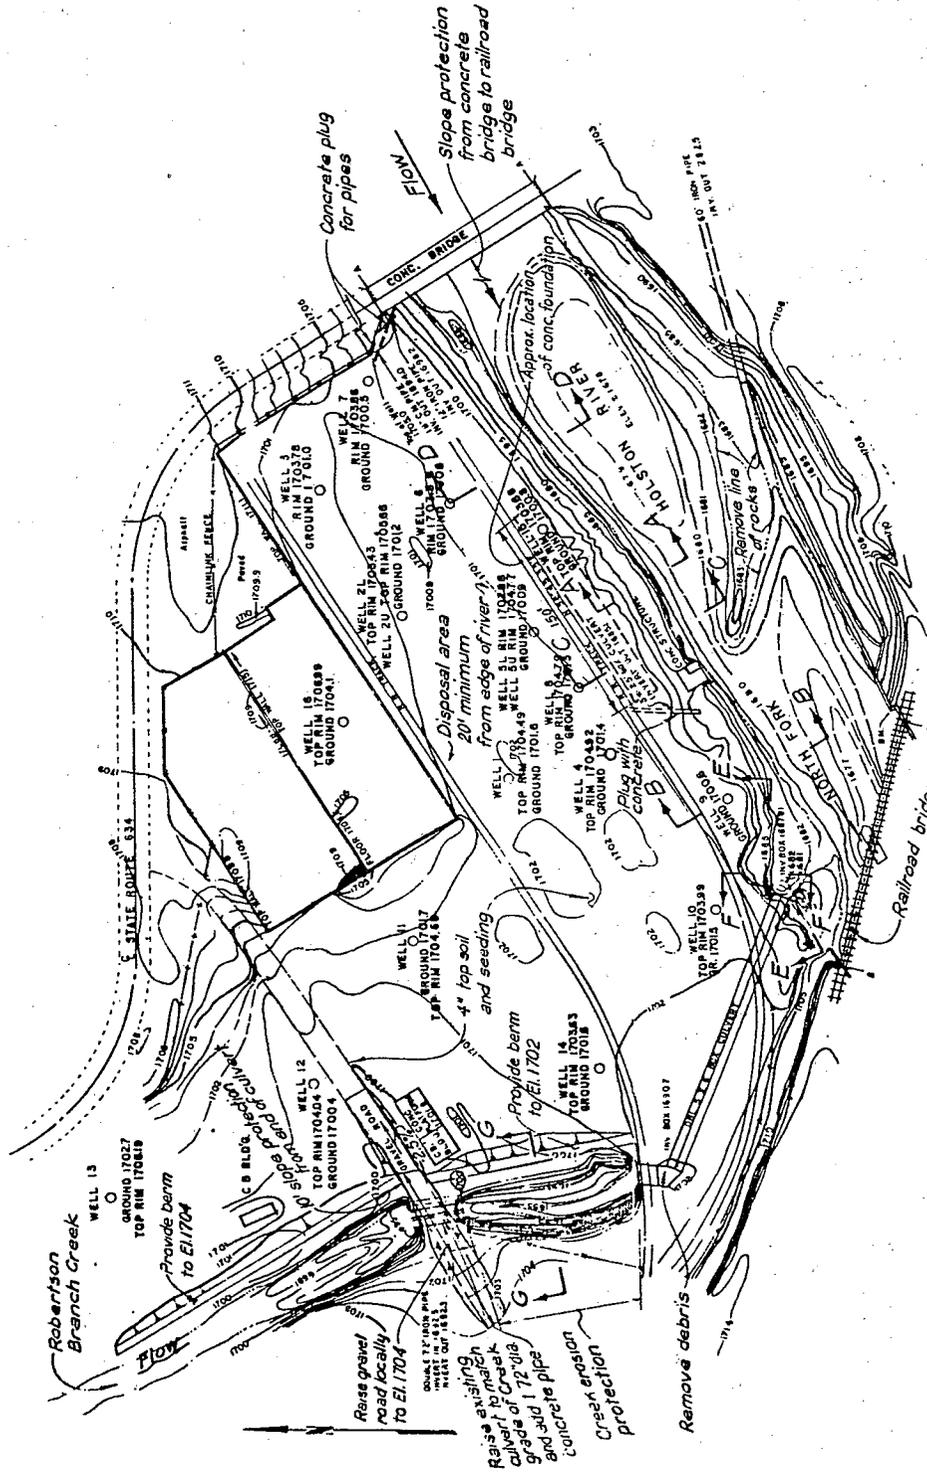
Figure 2-9. Erosion control measures at chlorine plant site. [2-6]

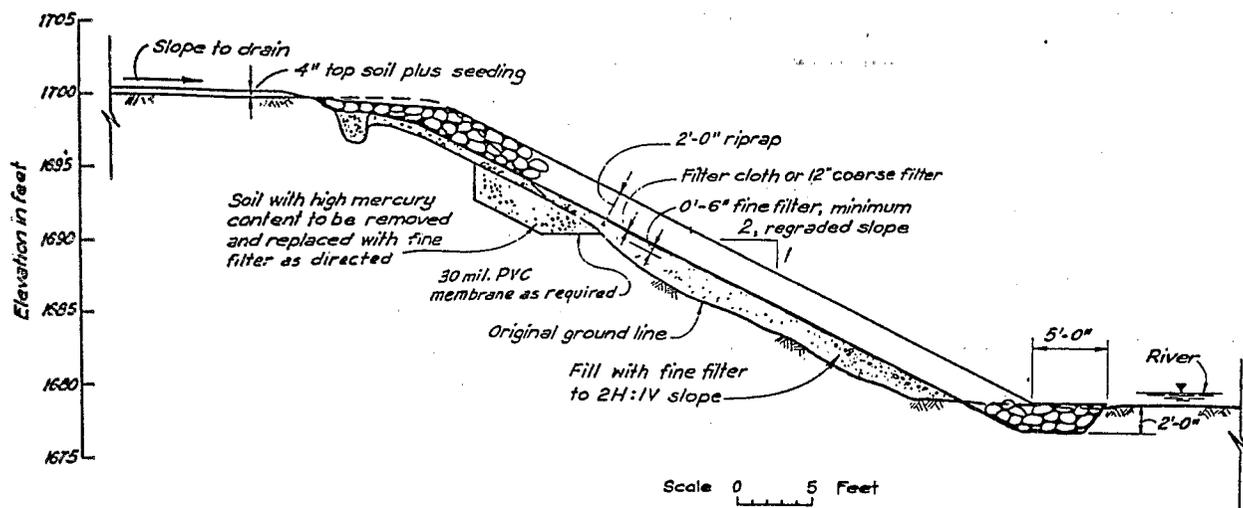
Figure 2-10. Construction details for sealing North Fork riverbank. [2-6]

2. Sealing off the plant site from the North Fork (see Figure 2-10). The slope of the chlorine plant site facing the river was regraded to a 2:1 incline. Soil and debris which noticeably contained mercury deposits were removed from the slope and placed back away from the North Fork on the former chlorine plant site. Sand

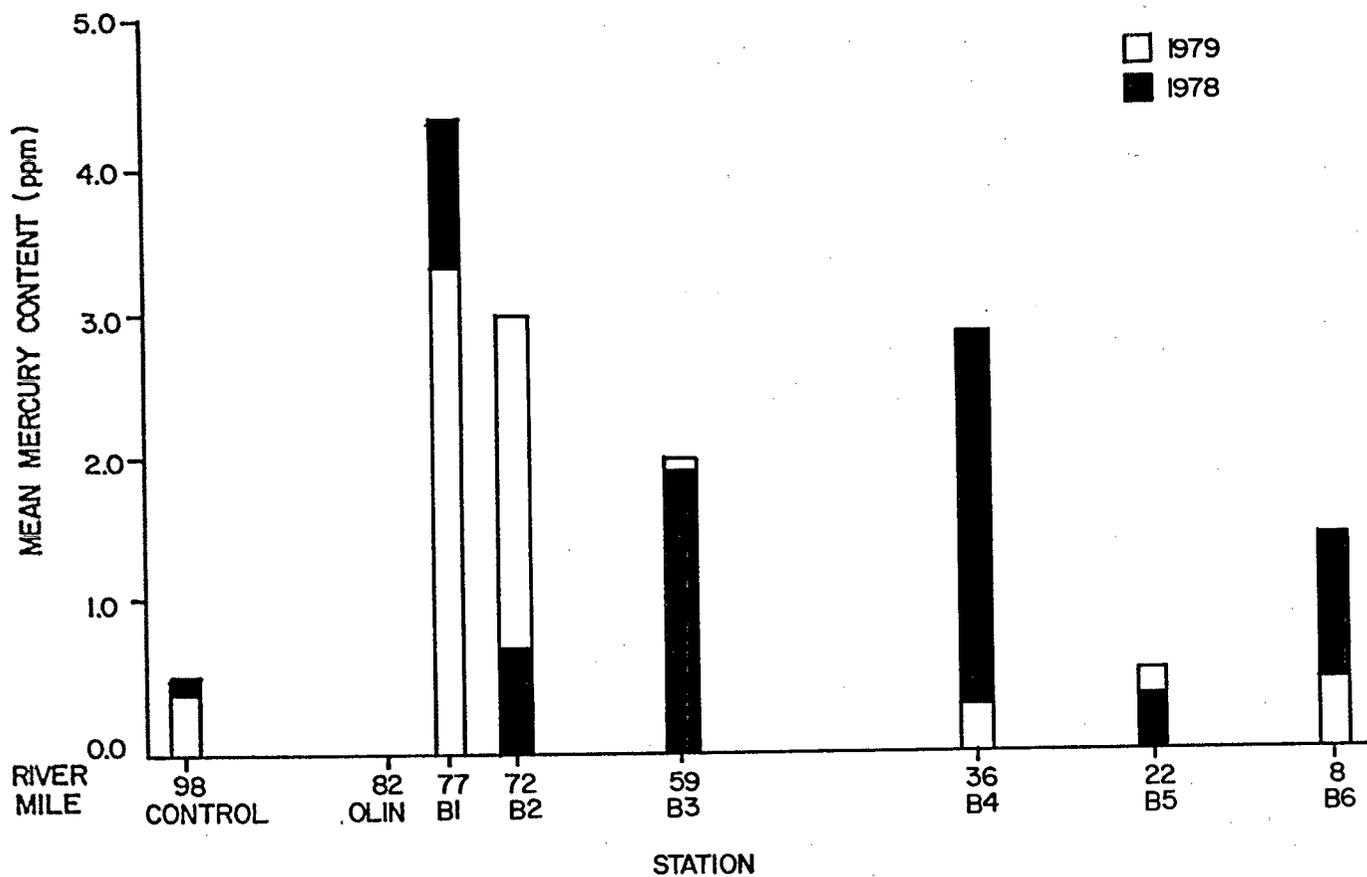
Figure 2-11. Mean mercury content of the sediment at the control and affected stations on the Holston River, July 1978 and July 1979. [2-7]

Figures 2-11 and 2-12 present mercury concentrations of fish and sediment before and after the erosion control activity was implemented at the chlorine plant site. The sampling station identification number increases with distance downstream from the site. Sampling Station B1 is located 8 km (5 mi) downstream from the former Olin plant site. Sampling Station B6 is 119 km (74 mi) downstream of the Olin site. Figure 2-11 illustrates the mean mercury content of fish in July 1978 (prior to remedial action) and July 1979 (after remedial action). Likewise, Figure 2-12 indicates the mean mercury content of the sediment in the North Fork in July 1978 and July 1979. From viewing Figures 2-11 and 2-12, it is difficult to determine if further discharge of mercury has been prevented. Because of the behavior of mercury, lodgement of mercury on the river floor may be creating a random data appearance. Time will permit the collection of a larger data base for mercury concentrations in fish and sediment. Perhaps then, a site-specific accurate assessment of mercury mobility and transport mechanisms can be made, as well as a determination of whether further mercury discharges from the chlorine plant site are continuing.

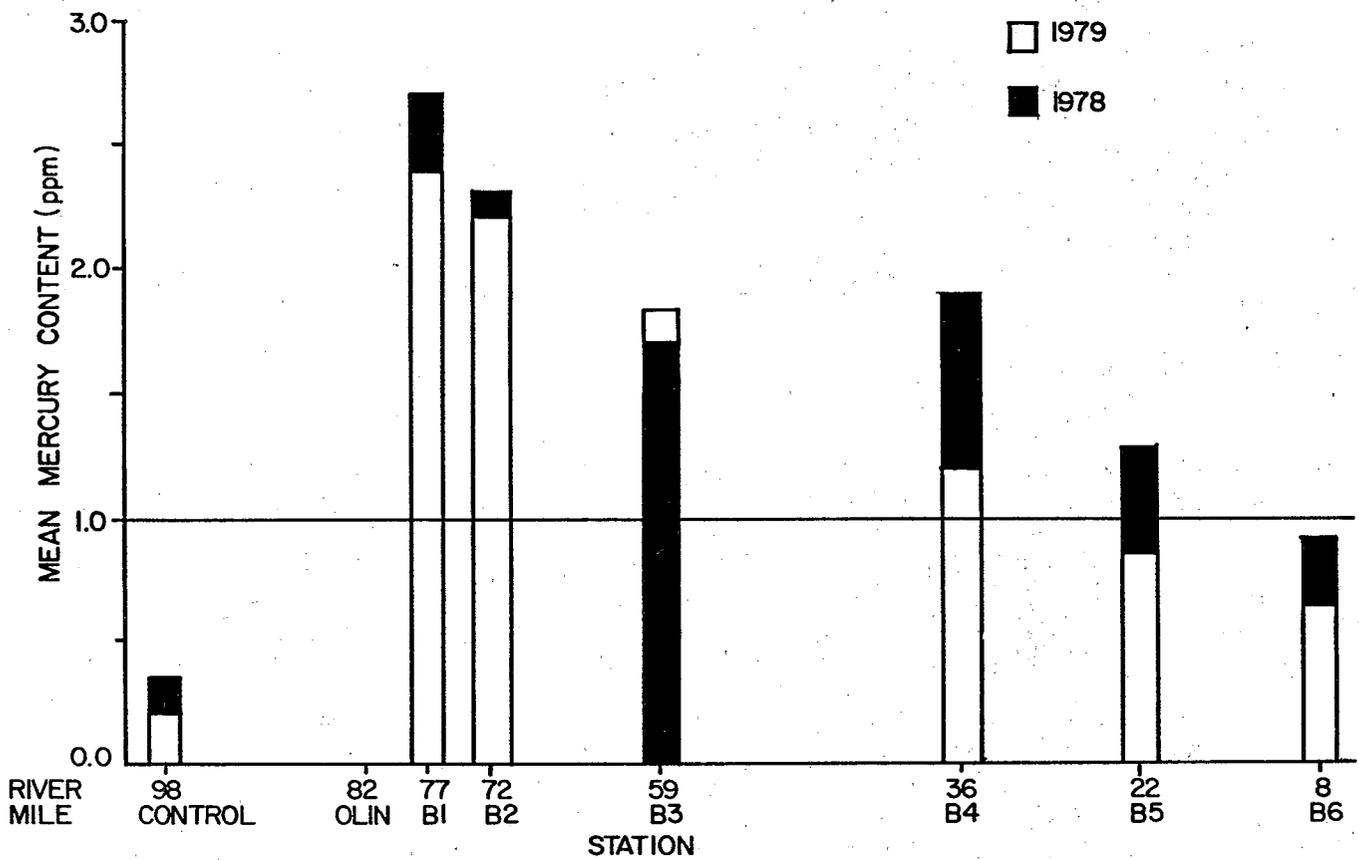
Figure 2-12. Mean mercury content of the fish at the control and affected stations on the Holston River July 1978 and July 1979. [2-7]

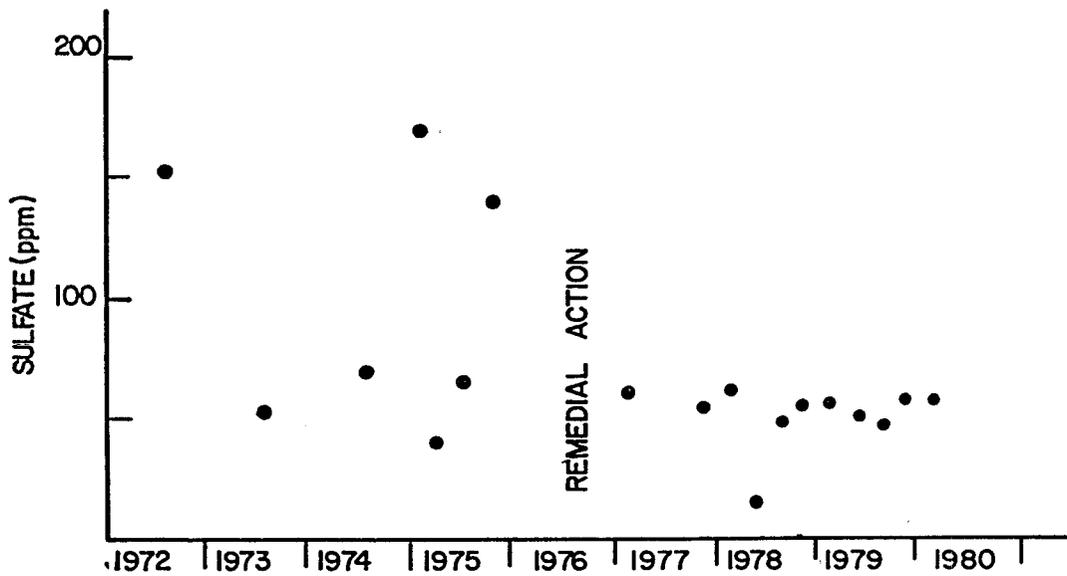
Figure 3-5. Sulfate concentrations in the ground water before and after the use of the recovery wells.

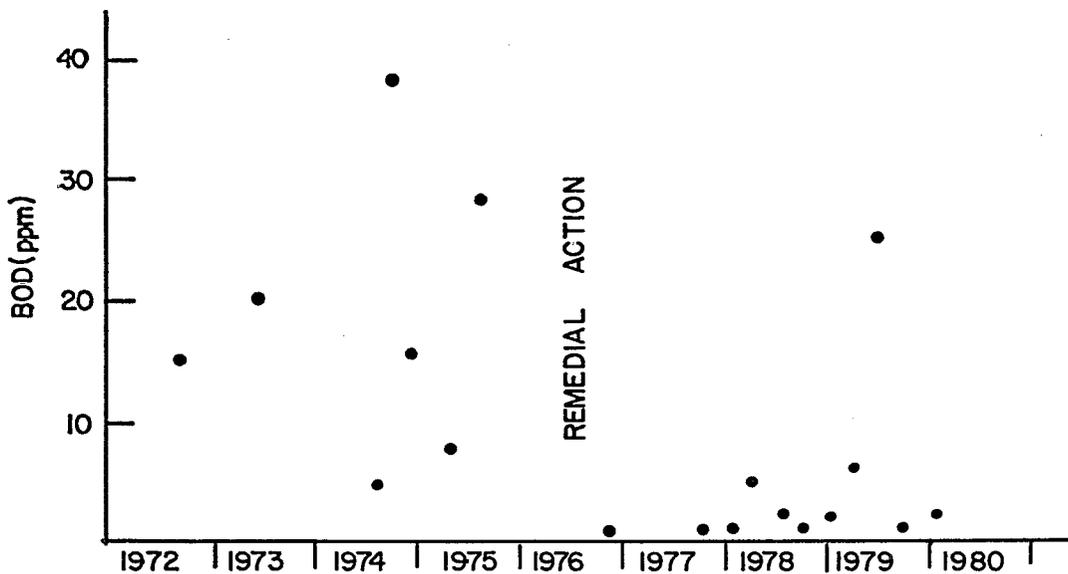
Figure 3-6. Five day BOD in the ground water before and after the use of recovery wells.

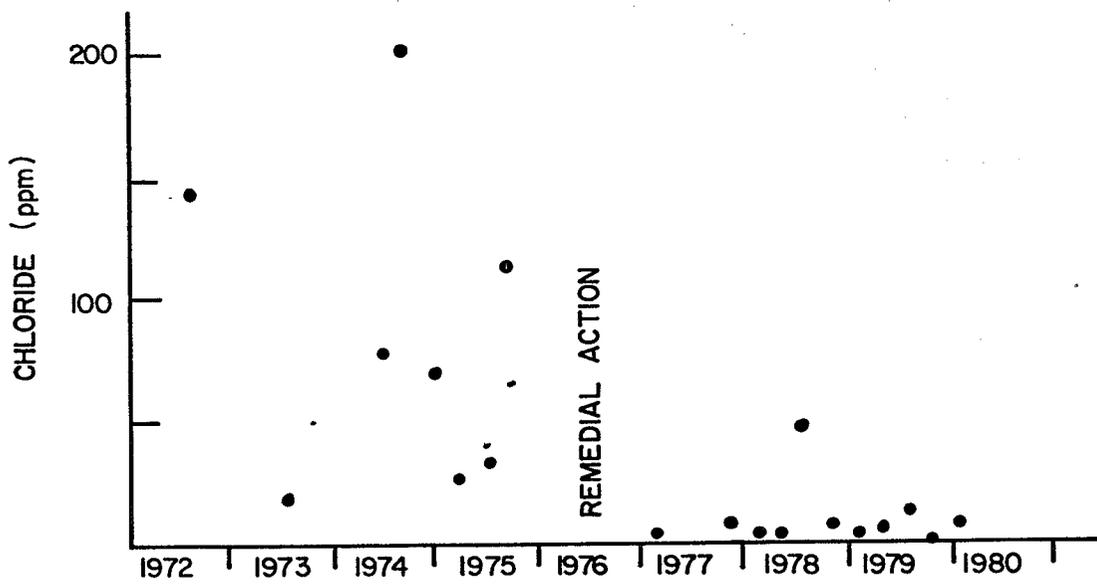
Figure 3-7. Chloride concentrations in the ground water before and after the use of recovery wells.

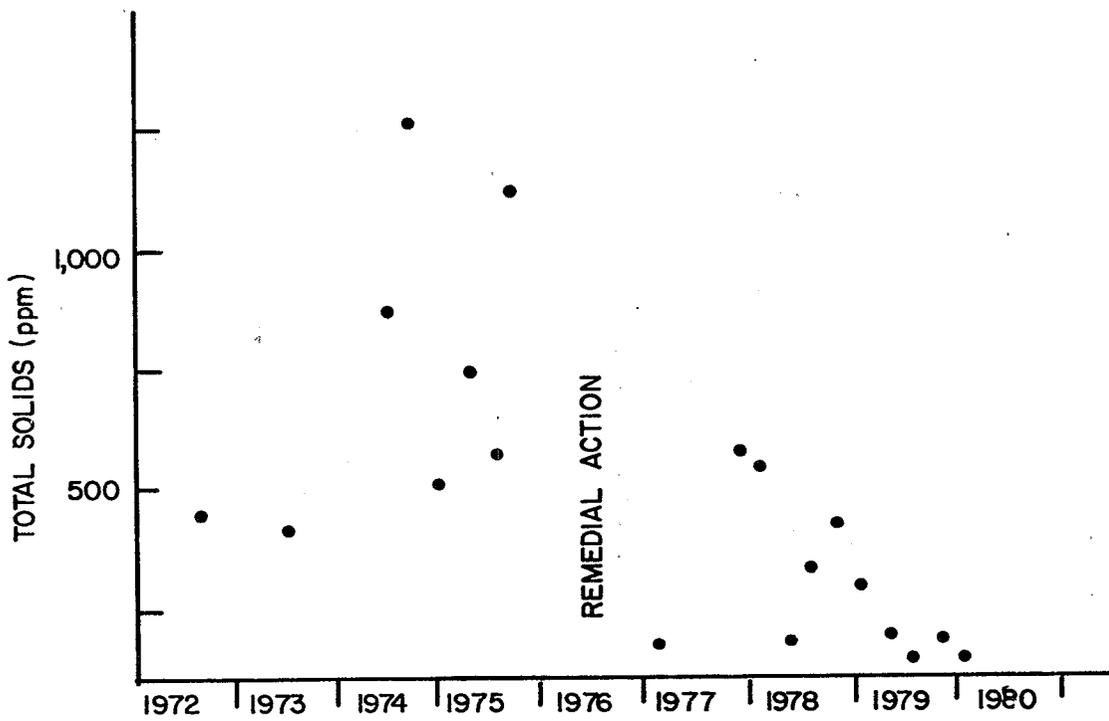
Figure 3-8. Concentration of total solids in the ground water before and after the use of the recovery wells.

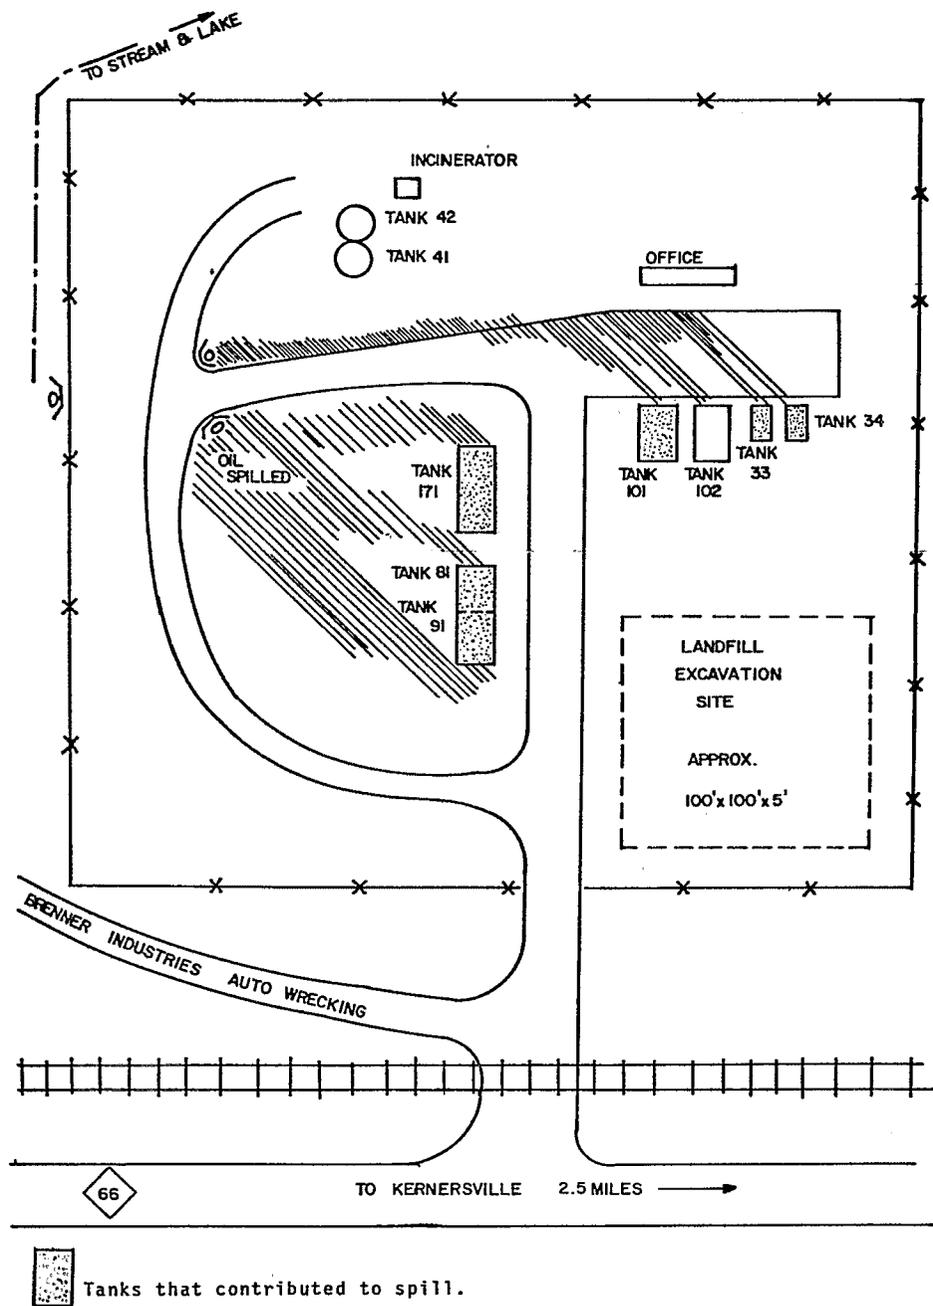
Figure 5-3. Tank location and flow direction of 1977 spill at Destructo Chemway. [5-5]

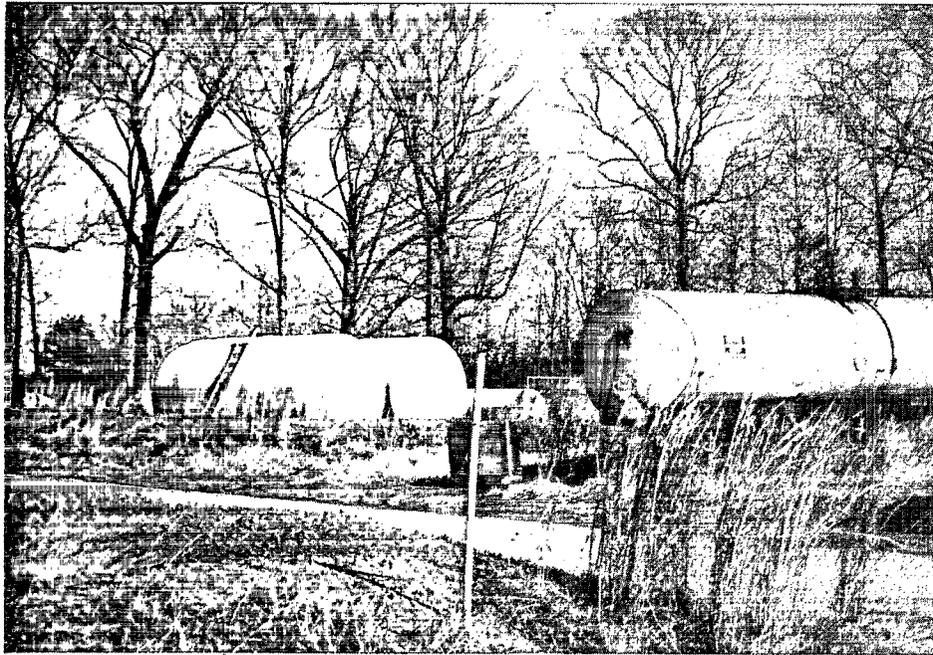
Berms (top photo) were placed around the tanks following the 1977 spill. By March 1980 pools of water had collected in the bermed area around the tanks (bottom photo).

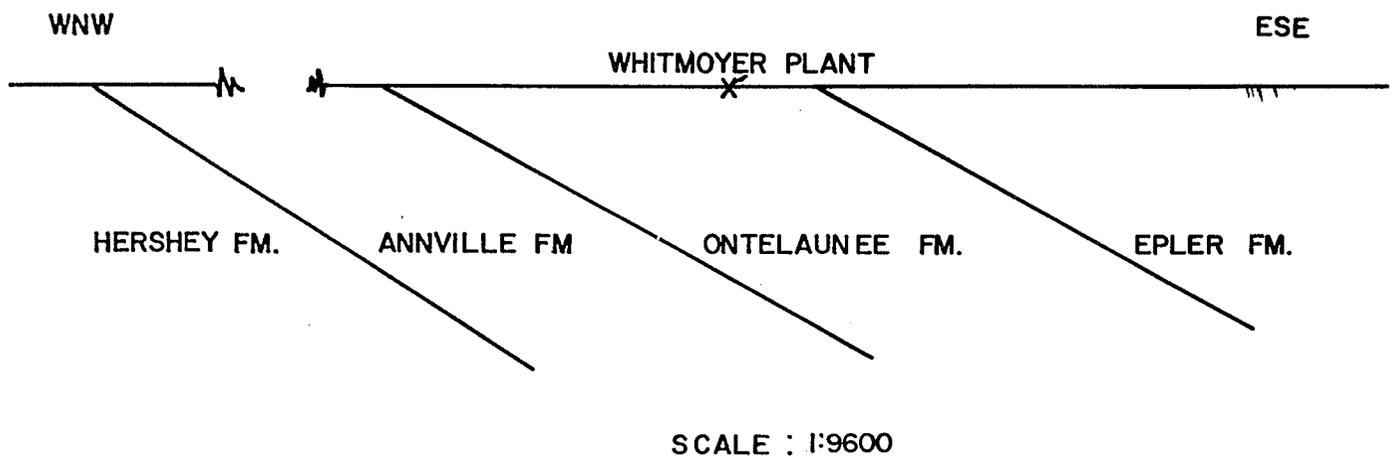
Figure 6-4. Generalized geologic cross section drawn perpendicular to the strike direction.

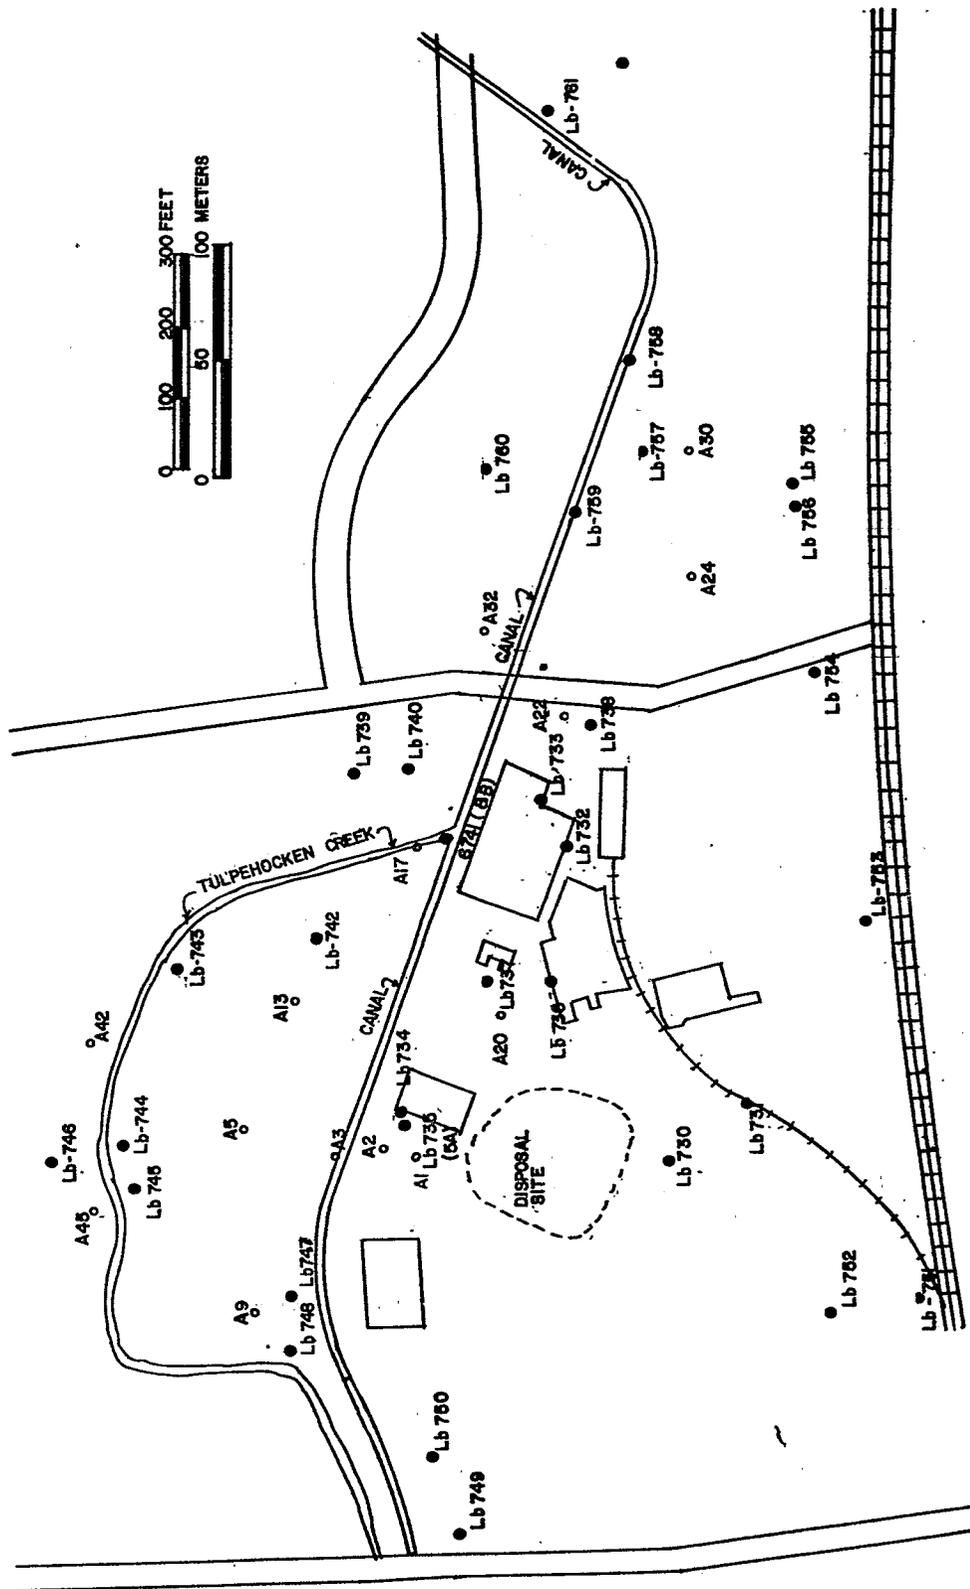
Figure 6-5. Location of wells on Whitmoyer Labs property. [6-2]

Whitmoyer Lab's production rate was partially dependent on its purging rate and the development of the cones of depression. Nearly all of the liquid extracted from the ground was returned. Natural precipitation also contributed to the recharge adding to the aquifer's volume. The cones of depression were developed to stop the migration of the ground water. Therefore, as the volume of the aquifer contained by the cones of depression grew, it became more and more difficult to maintain the existing cones of depression. With the addition of the seven new purging wells, the cones of depression were initially increased and Whitmoyer Labs could increase their production rates.

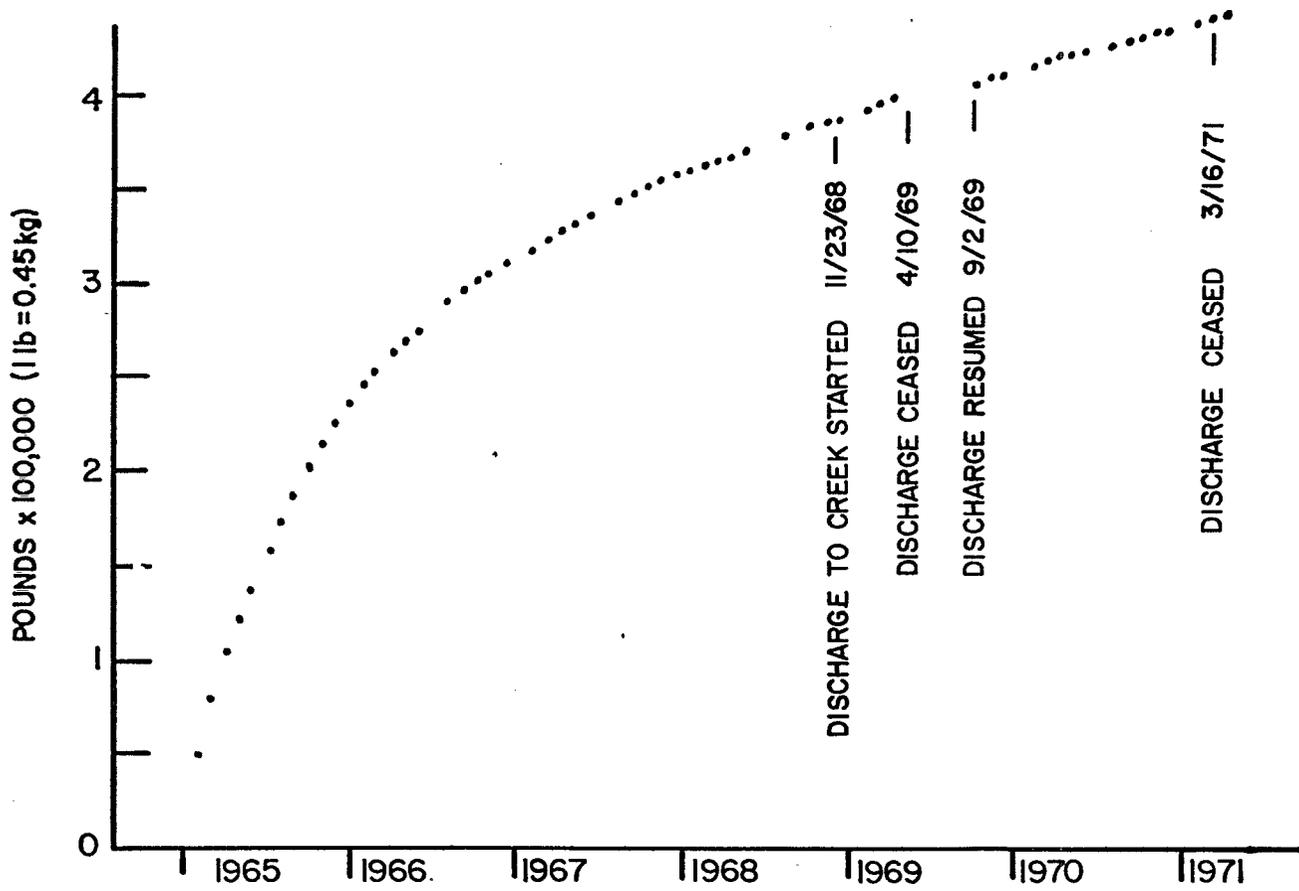
Figure 6-8. Cumulative graph of arsenic removed from the groundwater at the plant site. [6-2]

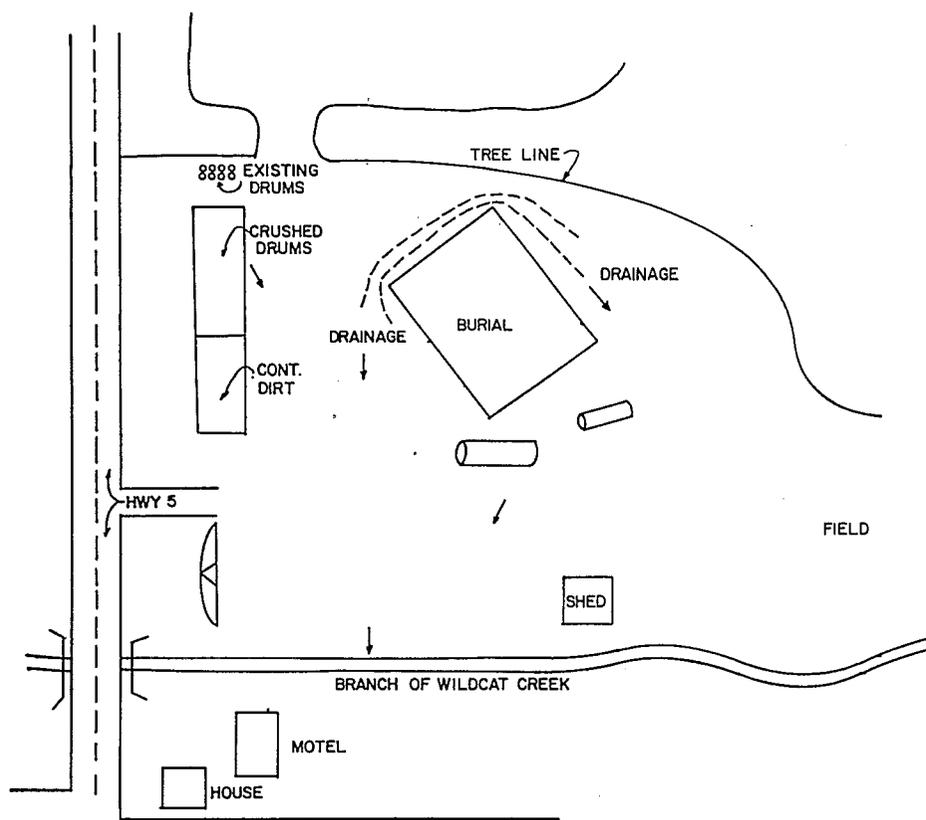
Figure 8-3. Site layout after remedial action at the Ferguson property. [8-1]

Figure 8-3 displays the pit, barrels, and tank locations at the site after completion of the second set of remedial activities. Approximately two weeks were required for the second temporary remedial activity. The second set of remedial actions cost \$88,000 bringing the total temporary remedial cost to \$143,000. Table 8-2 further defines the cost of the two temporary containment efforts. As was stated before, this action was carried out to minimize potential fire hazards and the possibility of a chemical spill reaching the nearby stream. The permanent/long term remedial action will be forthcoming when a legal determination has been made as to the responsible party.

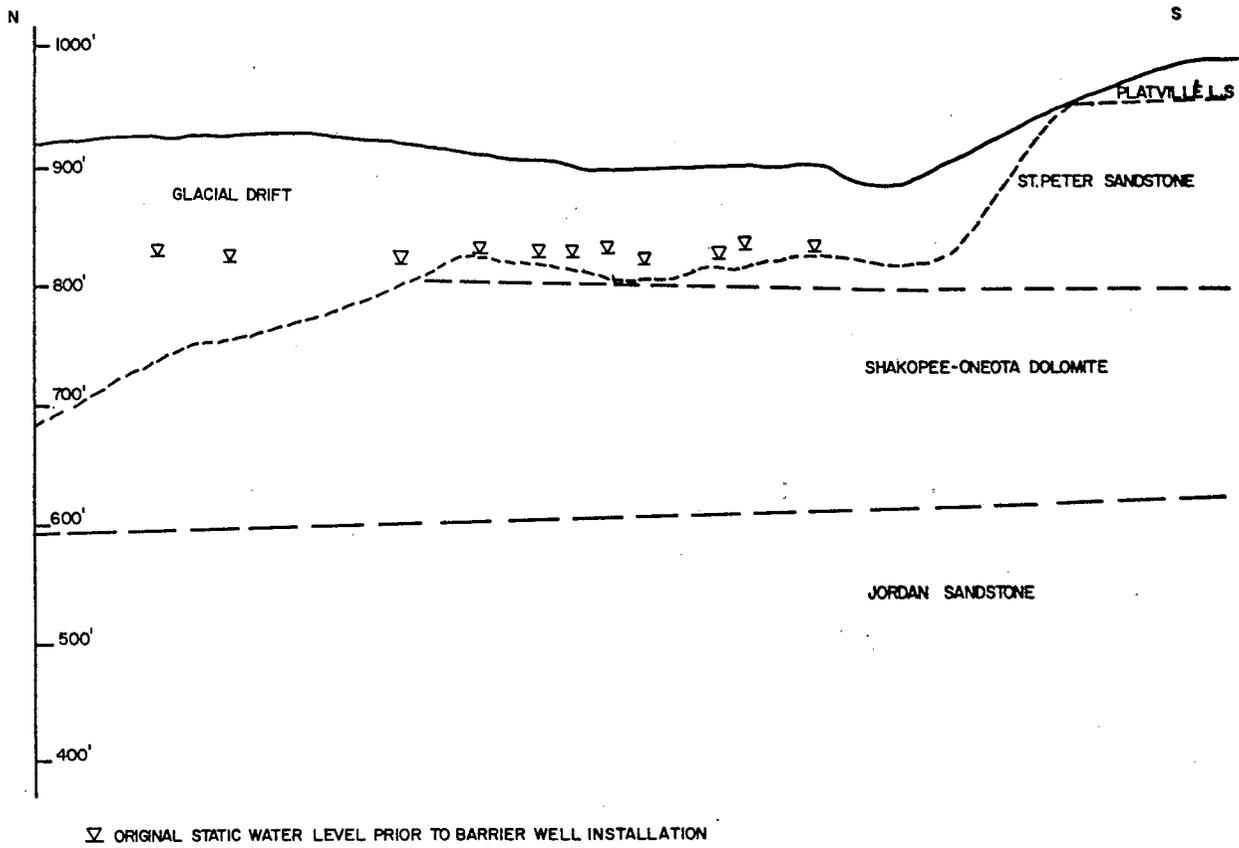
Figure 9-2. Geological cross section of area beneath Woodbury disposal site. [9-1]

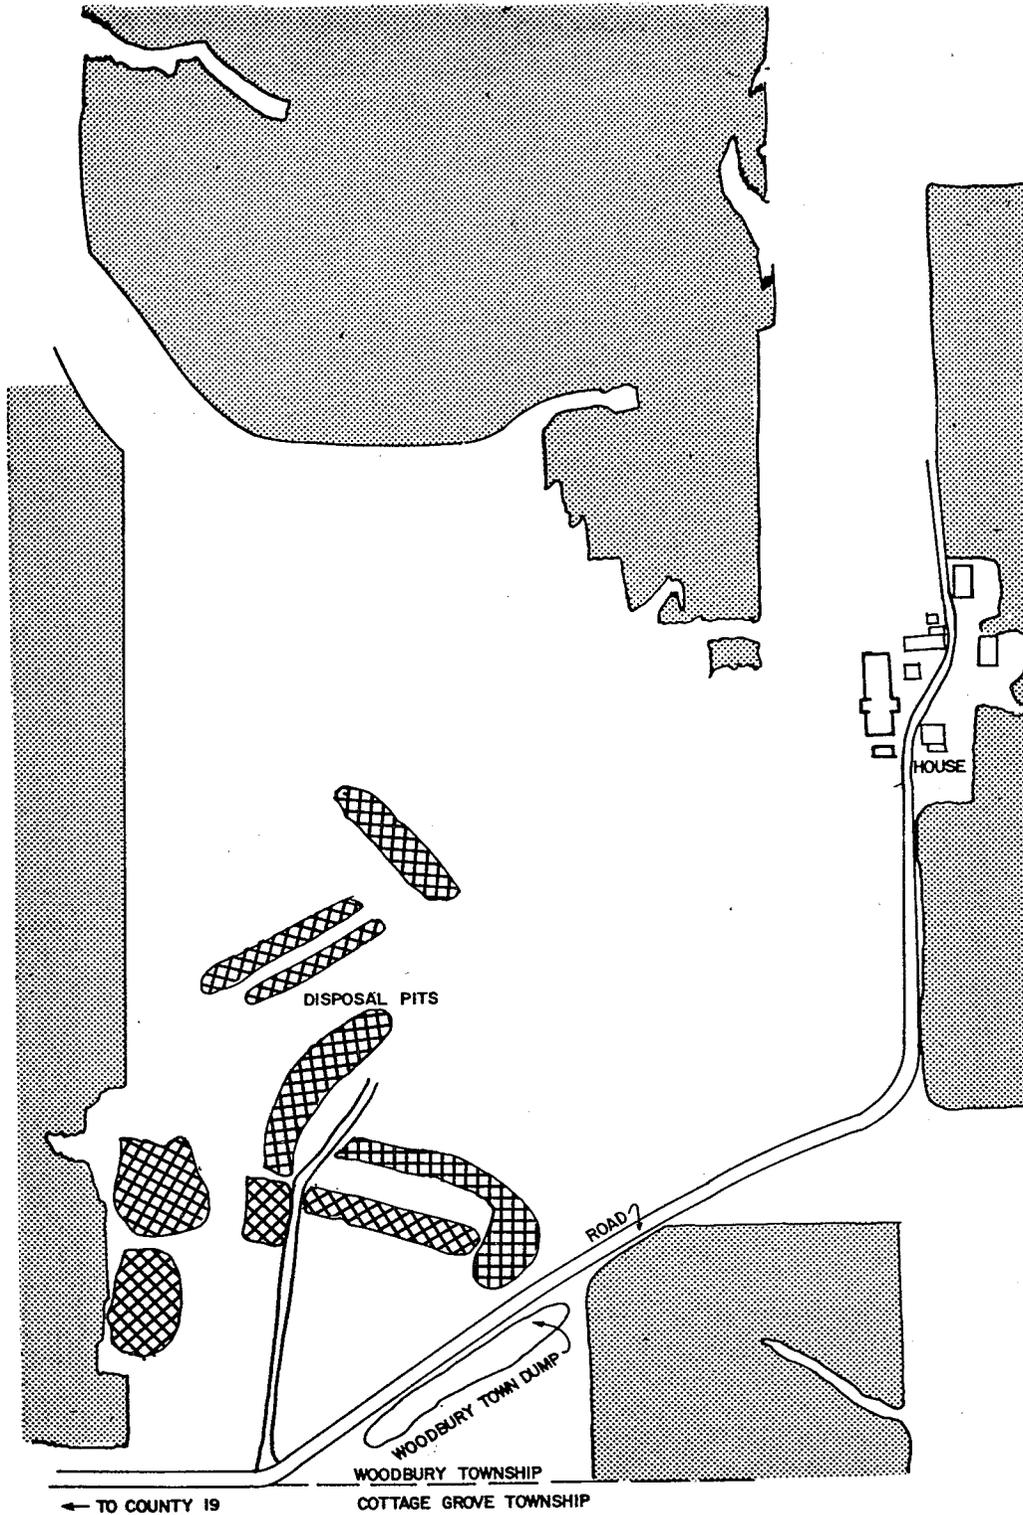
Figure 9-3. Configuration of waste disposal pits at 3M Woodbury site. [9-2]

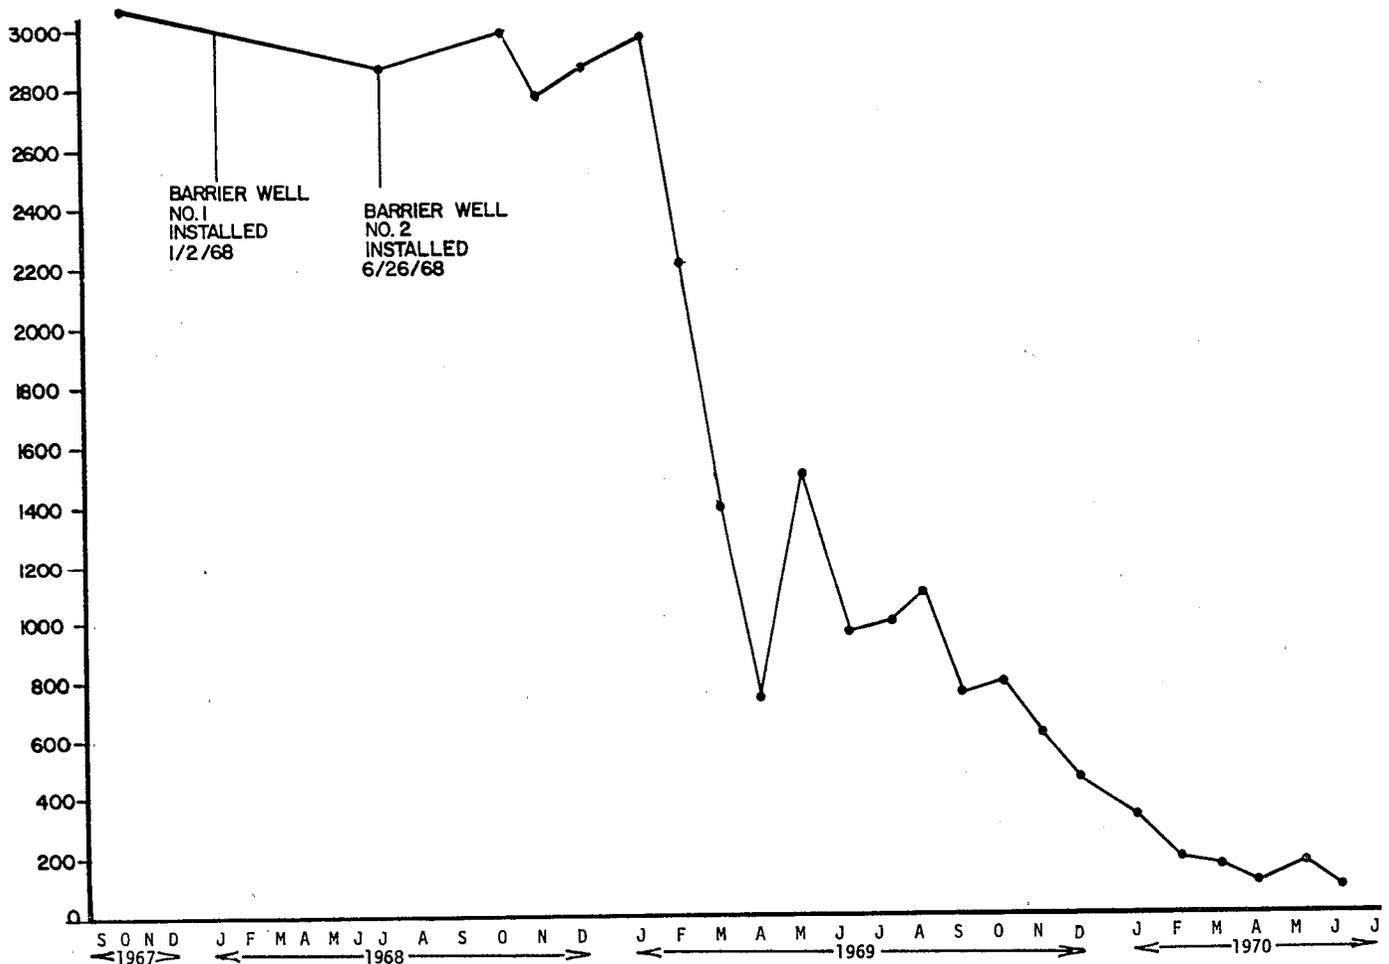
Figure 9-5. Sum of the concentration of isopropyl ether, isopropanol, and dichloromethane for shallow well at Schussler residence.

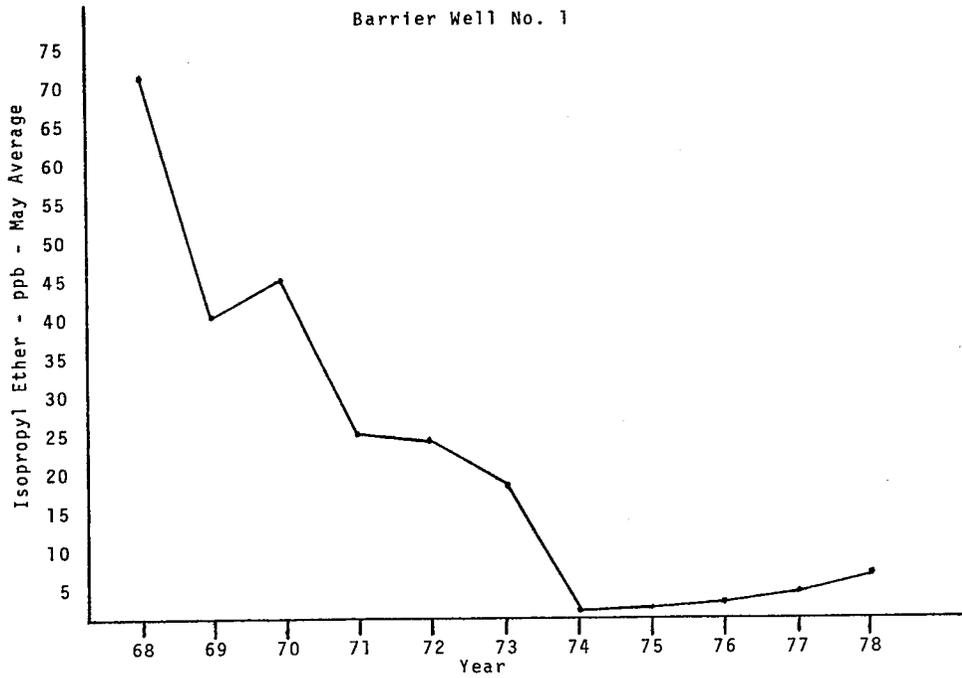
Figure 9-6. Graphs of isopropyl ether measurements for Barrier Wells Nos. 1 to 4.
