REMEDIAL ACTIONS AT HAZARDOUS WASTE SITES

Survey and Case Studies

N. Neely, D. Gillespie, F. Schauf, J. Walsh
SCS Engineers
Covington, Kentucky

This final report EPA-430-9-81-005 describes work performed for the Municipal Environmental Research Division of the U.S. EPA Office of Research and Development under Contract No. 68-01-4885 and is reproduced as received from the contractor

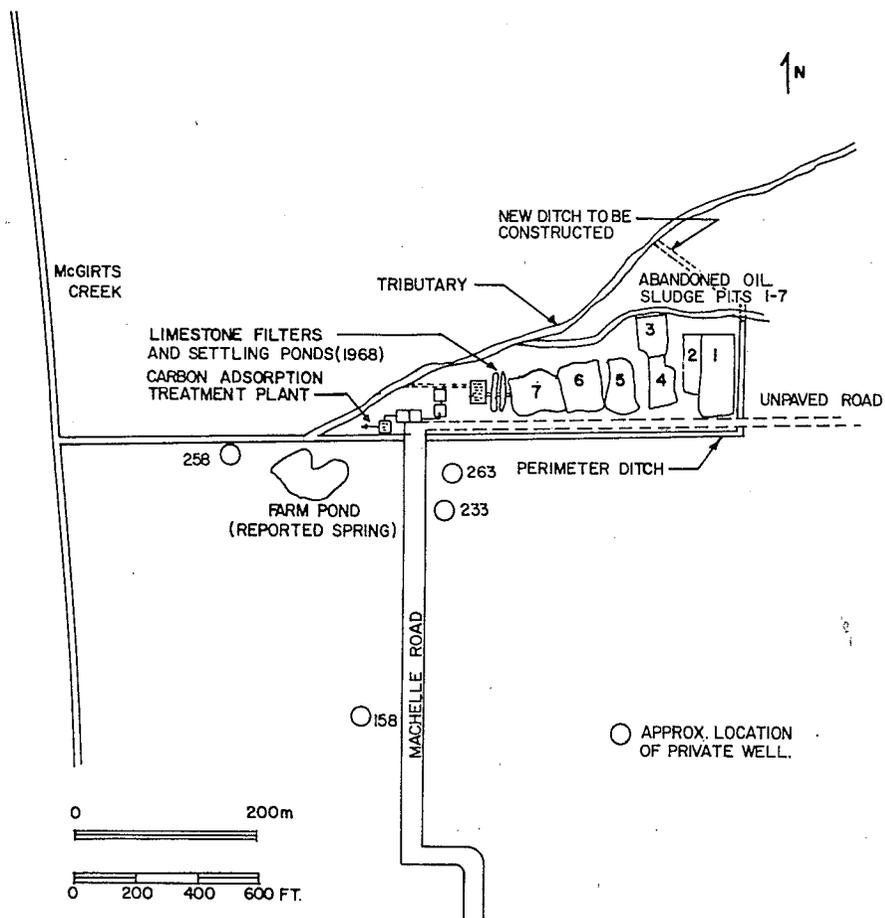
Figure 10-2. Layout of Whitehouse oil pits (1976).

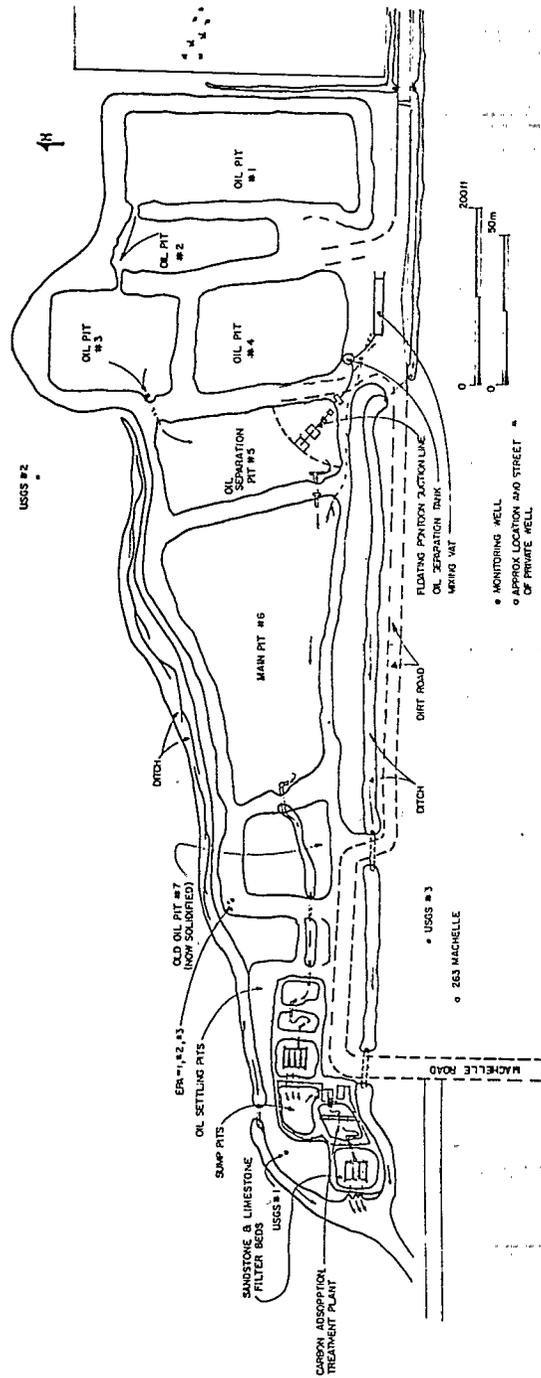
Figure 10-3. Layout of Whitehouse oil pits and diversion ditches (1976).
