**FACILITY COMPLIANCE INSPECTION REPORT**  
**Division of Waste Management**  
**Solid Waste Section**

| Lined MSWLF | | LCID | <b>X</b> | YW | | Transfer | | Compost | | SLAS | | COUNTY: FRANKLIN<br>PERMIT NO.: 35-03TP<br>FILE TYPE: COMPLIANCE |

**Date of Site Inspection:** August 17, 2012    **Date of Last Inspection:** January 7, 2008

ORGANICS RECYCLING  
 2095 US 1 Hwy South,  
 Franklinton, NC 27525

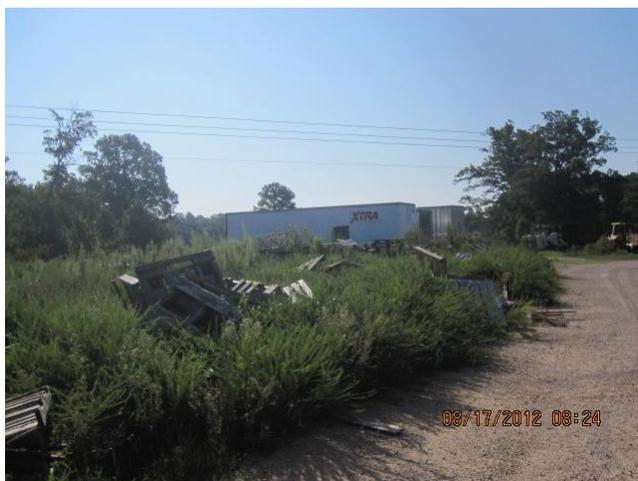
Pallets piled along one of the access roads.

- b. There are other operations taking place on the property that are not included on the site plan for the facility. **All operations are to be included on the site plan and approved by the Solid Waste Permitting Branch.** There is screening for soil taking place that appears to be from one of the piles of old LCID. There is an area that appears to be over one acre in size where concrete block, brick, etc. is being stockpiled. There is another area where the stockpiling of pallets is occurring and another area has piles of gravel and soil.

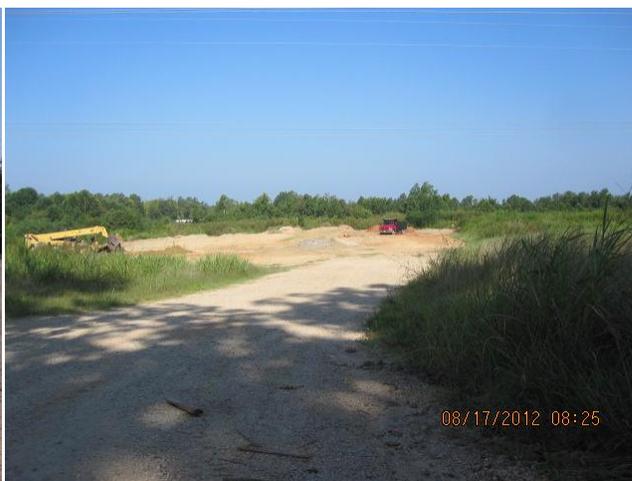
Soil and gravel area.

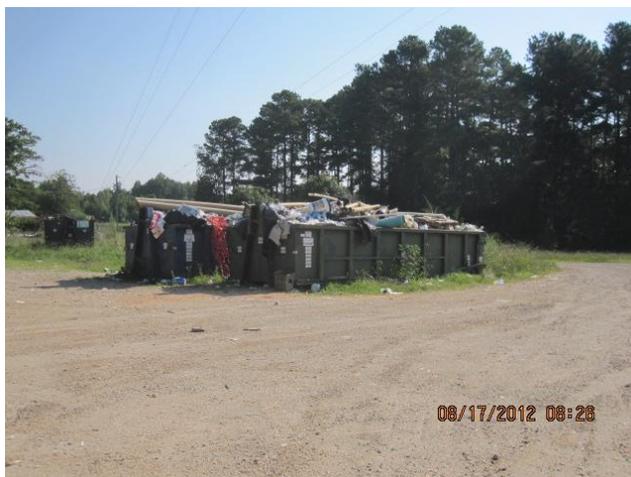
Several open top containers filled with waste.

2. There are several containers with waste stored on the property, including two, approximately 30 yard open top containers filled with what appears to be household waste, being stored to the left side of the office (looking to the back of the property). **The waste in the containers must be disposed of at a permitted facility within 7 days of receipt of this Inspection Report.** 15A NCAC 13B .0105(a) states “The solid waste collector shall be responsible for the satisfactory collection and transportation of all solid waste to a permitted disposal site or facility.”

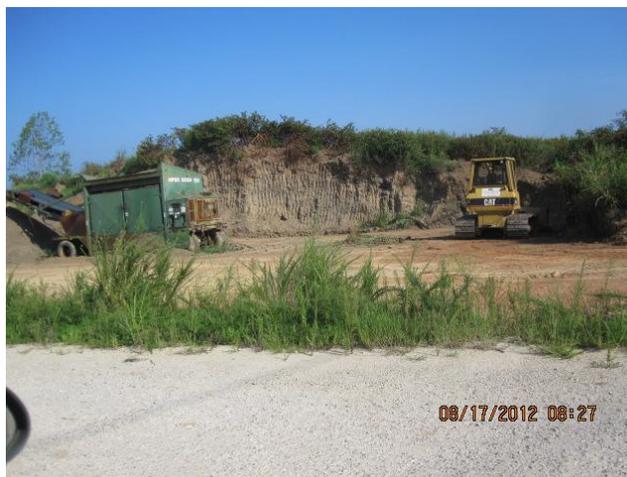
Mining of soil from old LCID pile?

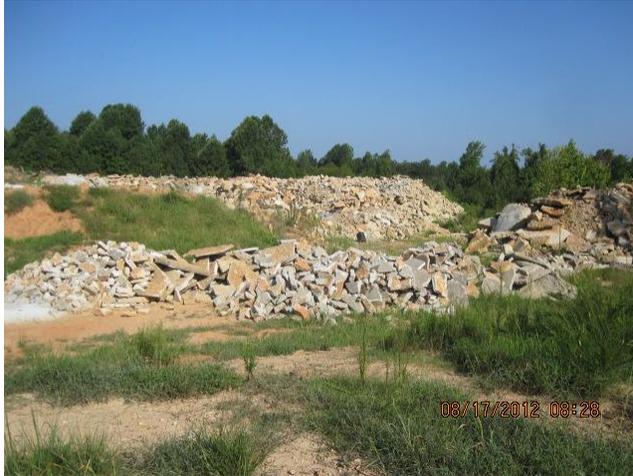
Stockpiling of concrete, brick and asphalt.

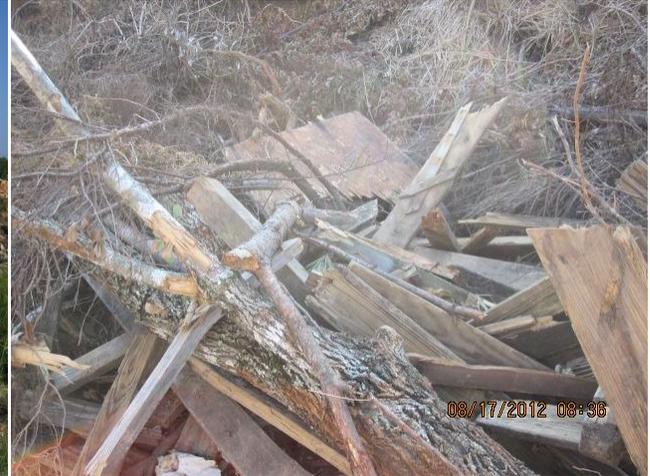
Unacceptable wastes in pile of land clearing debris.

2. **15A NCAC 13B .0302 states that** “A facility shall only accept wastes which it is permitted to receive; ”Only the materials listed in the permit and Operations Plan are to be accepted. There is to be no landscaping debris brought to the site. Landscaping debris must be composted or used as boiler fuel. Several truckloads of grass were observed mixed in with the land clearing debris. There is to be no manufactured, treated or painted wood, only untreated and unpainted boards are acceptable. Plywood, OSB and some painted boards were observed. There are miscellaneous plastics and other non-acceptable materials in the waste. **The unacceptable waste needs to be removed daily, as a minimum, or as it is noticed.**

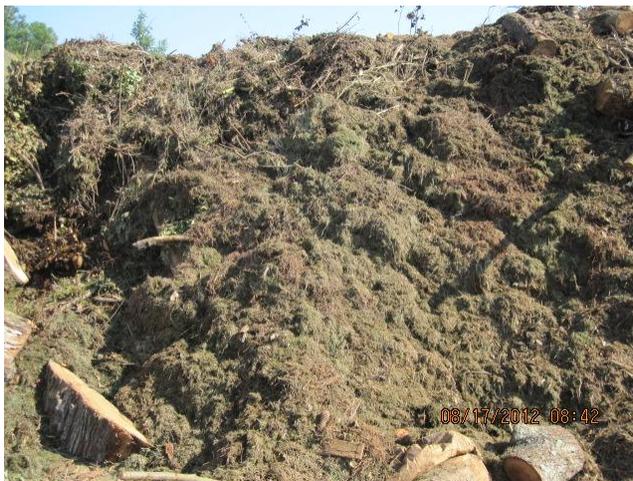
Grass clippings and landscaping debris mixed in with land clearing debris.

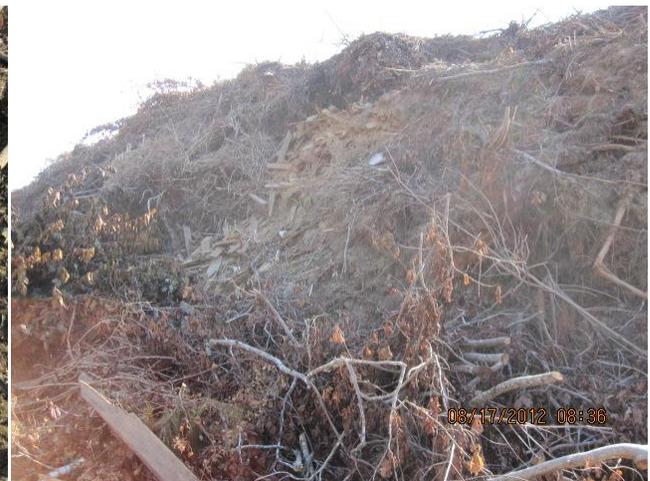
Mounds- twenty feet + high

- a. The size and location of the land clearing debris piles must be according to your Operations Plan. Access lanes need to be made around the perimeter of the piles, as well as between the piles, in accordance with your Operations Plan. There is no emergency access around the debris or between each windrow. If there were to be a fire, there would be no possible way to put it out. **The perimeter access as well as access in between**

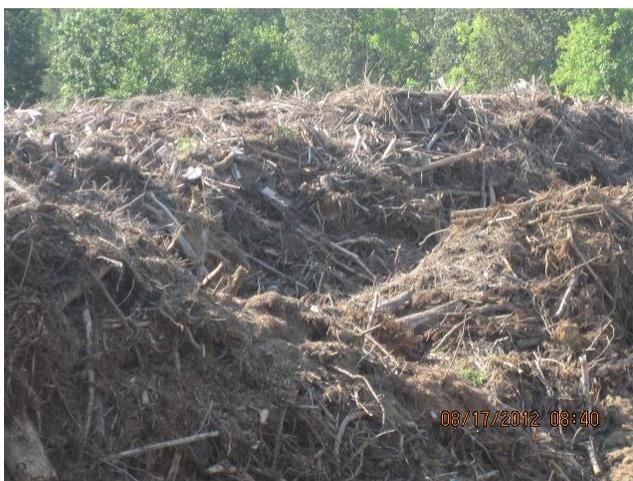
No access around or between windrows.

**windrows and location of the windrows must be aggressively worked on and completed within one month of receipt of this audit.**
