FACILITY COMPLIANCE INSPECTION REPORT
Division of Waste Management
Solid Waste Section

Haywood County Municipal Solid Waste Processing Facility
 278 Recycle Road
 Clyde, NC 28721

Comprehensive Site Inspection

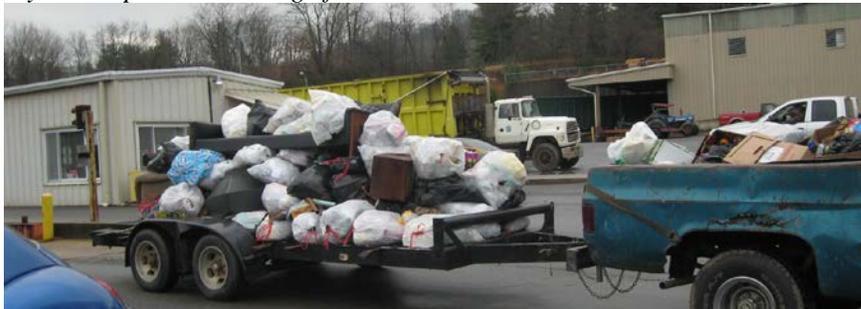
1. On site on January 30, 2012 to conduct a partial site inspection. During the visit a vehicle was observed transporting solid waste with no tie-downs or tarps to prevent littering and/or spillage. The Solid Waste Rules state, under 15A NCAC 13B .0105 COLLECTION AND TRANSPORTATION OF SOLID WASTE (d) in part, that *vehicles or containers used for the collection and transportation of any solid waste shall be loaded and moved in such a manner that the contents will not fall, leak, or spill and shall be covered when necessary to keep contents dry and to prevent blowing of material.* Please continue to work toward community compliance on this issue.

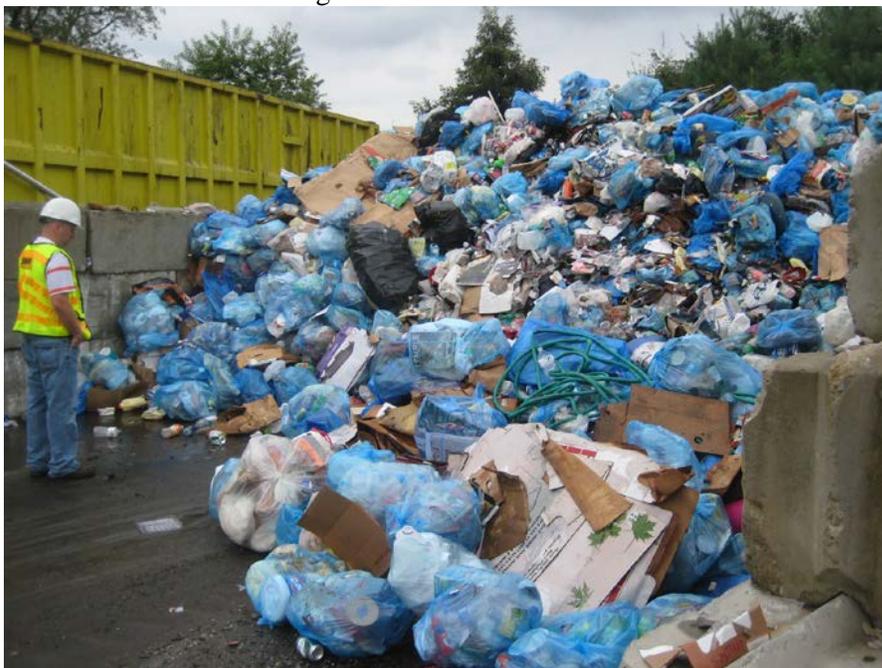
3. On site July 31, 2012 to conduct a partial site inspection. During the repair phase of the Material Recovery Facility structure (fire damage), the segregated blue bag recycled material was being managed in area typically used for containing segregated glass materials and/or drywall area. This area is uncovered and contains the material through the use of concrete blocks.

Please note that this material storage must contain recyclable materials only. Mixed wastes (recyclables co-mingled with refuse or garbage) must be treated as solid waste and must be managed in accordance with storage rules (15A NCAC 13B .0104). Additionally, it was noted that there was material overflow on the

back side of the concrete barriers. This area should be maintained in accordance with the permit and the operations plan similar to how windblown material is managed (collected and contained by the end of each working day).
