# Environmental Monitoring Reporting Form

**RE: METHANE MONITORING RESULTS – SECOND QUARTERLY EVENT OF 2013  
CLOSED HENDERSON COUNTY LANDFILL, PERMIT NO. 45-01  
HENDERSON COUNTY, NORTH CAROLINA**

PROJECT  
**HENDERSON COUNTY CLOSED MSW AND C&D LANDFILL  
PERMIT # 45-01**

TITLE  
**METHANE MONITORING LOCATION MAP**

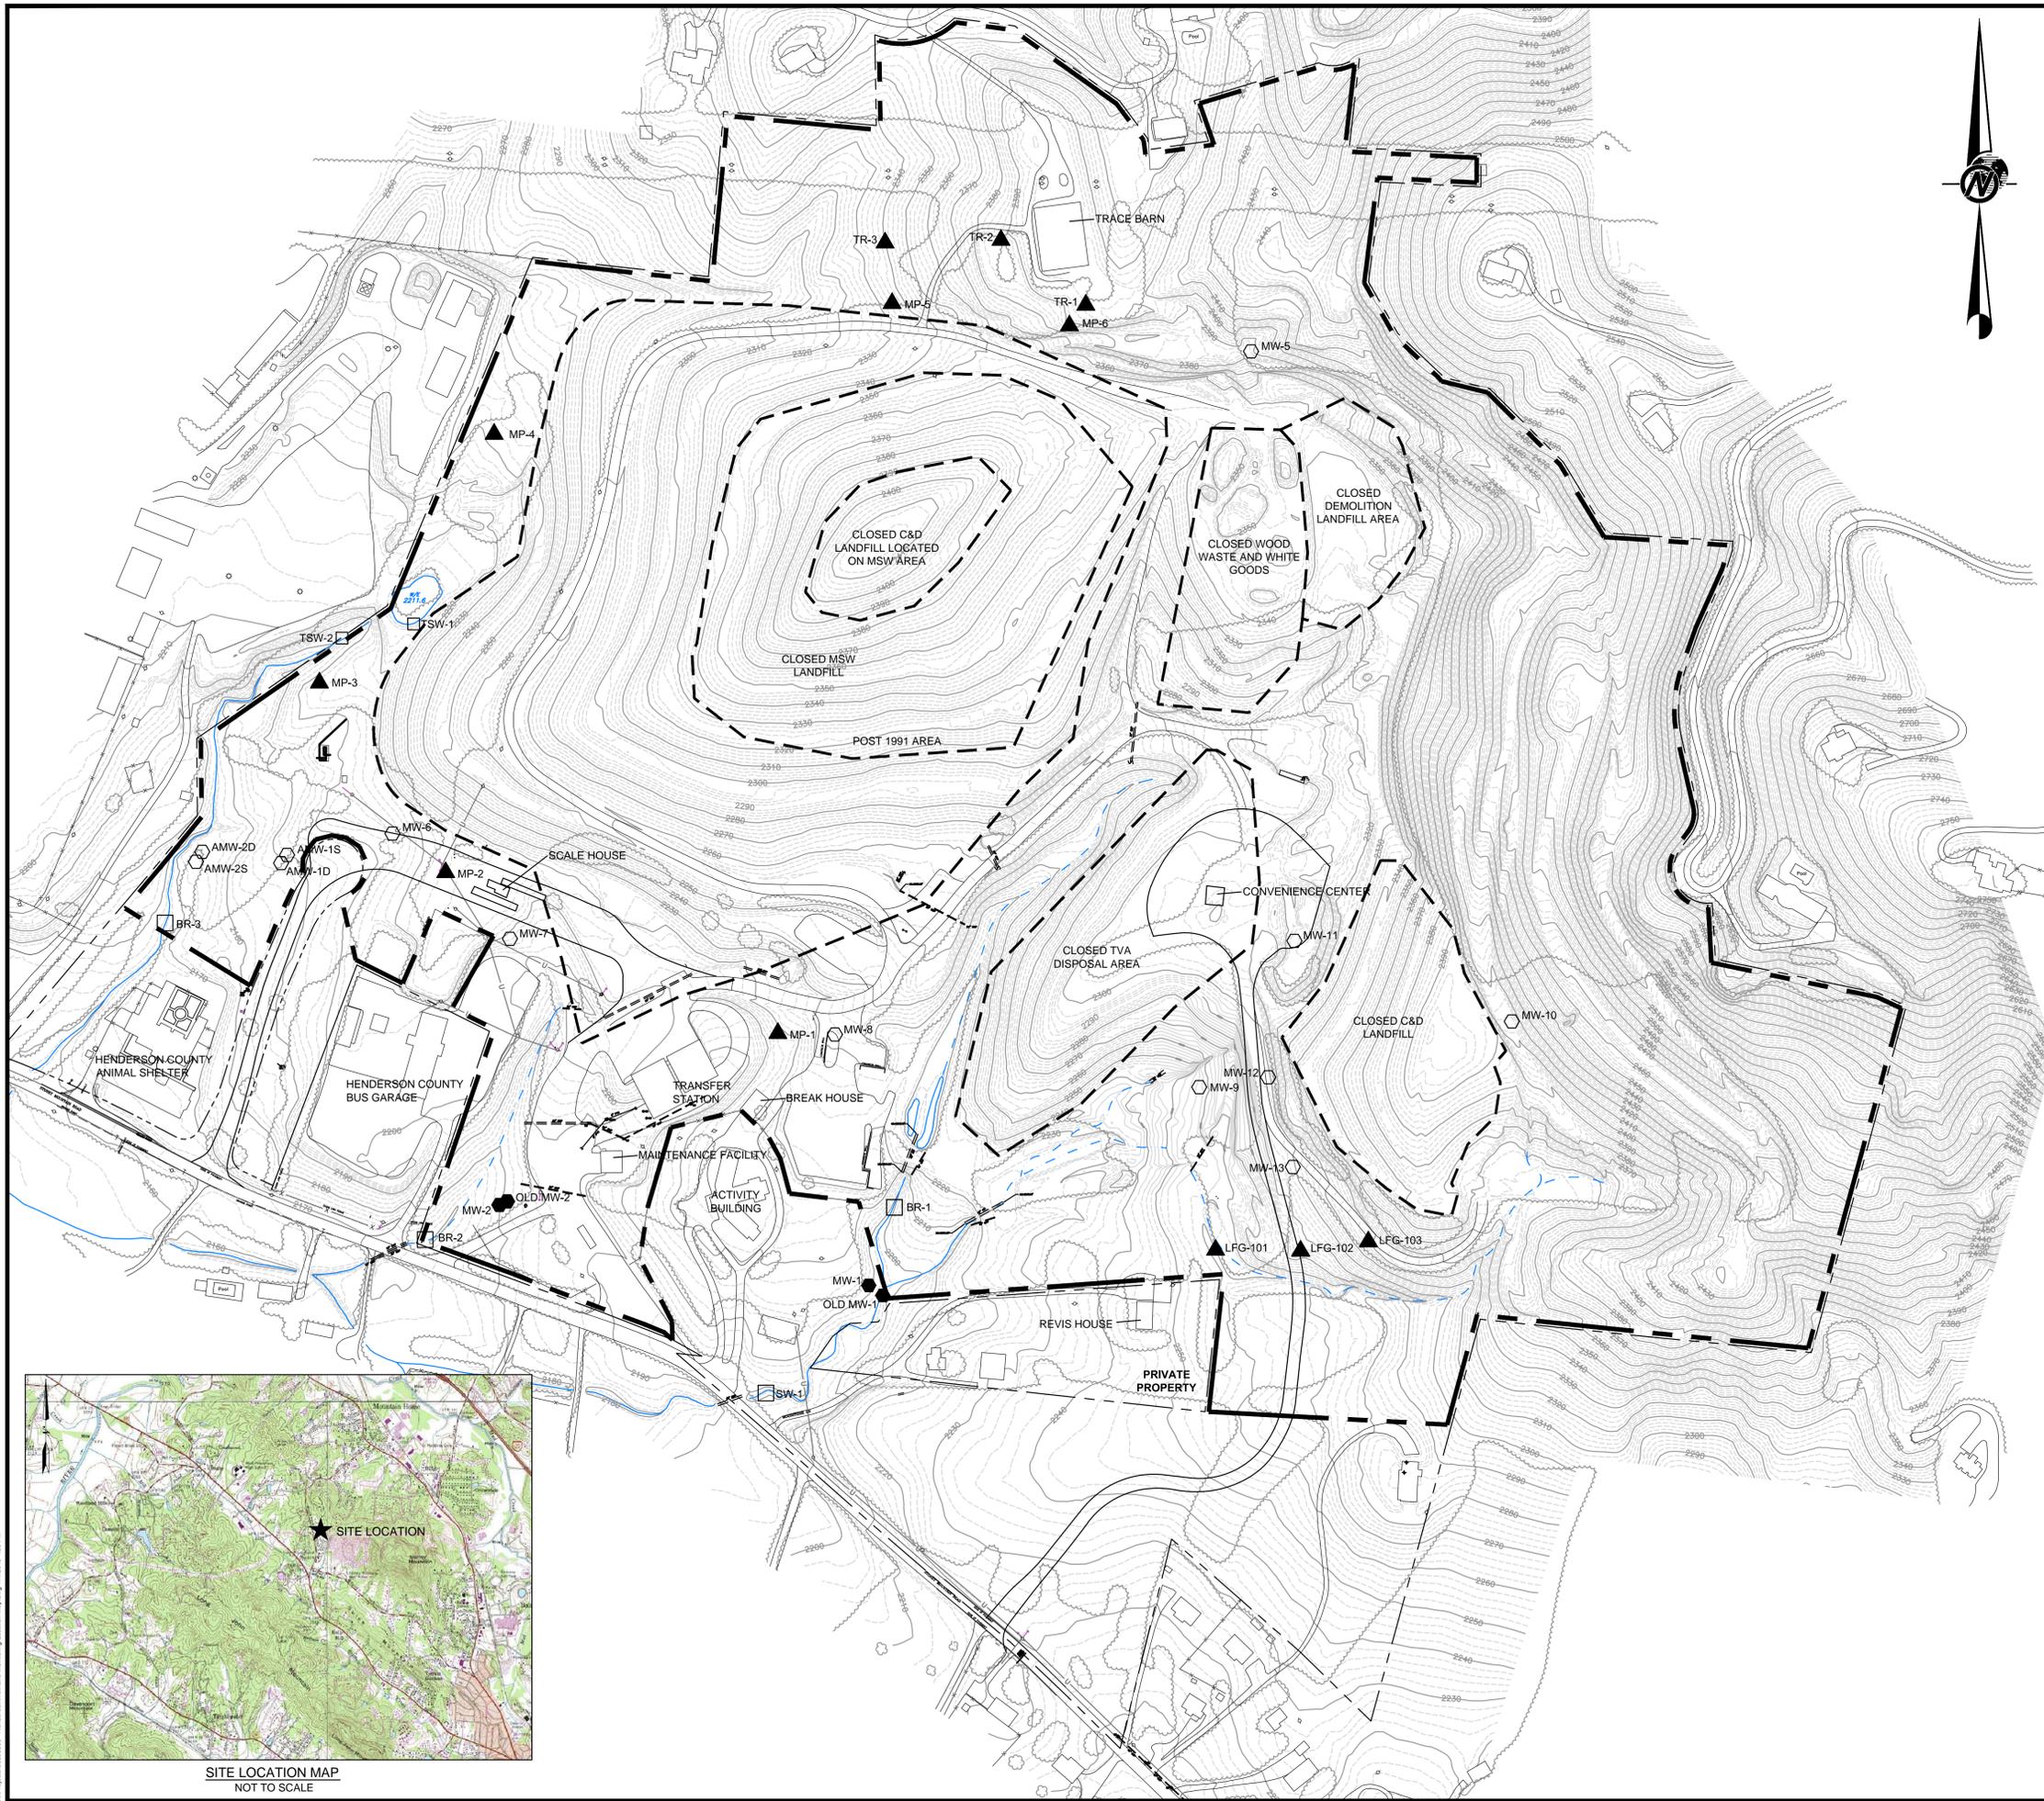
**DWG. 1**

EXISTING 10 FT. CONTOUR
	EXISTING 2 FT. CONTOUR
	PROPERTY LINE
	LIMITS OF WASTE
	STREAM
	BUFFER
	TREELINE
	EXISTING ROAD
	FENCE
	MW-8 2210.79 COMPLIANCE MONITORING WELL AND IDENTIFICATION
	MW-1 NON COMPLIANCE MONITORING WELL AND IDENTIFICATION
	MP-6 METHANE MONITORING PROBE AND IDENTIFICATION
	BR-1 SURFACE WATER MONITORING POINT AND IDENTIFICATION
