FACILITY COMPLIANCE INSPECTION REPORT
Division of Waste Management
Solid Waste Section

Date of Site Inspection: October 4, 2012 **Date of Last Inspection:** January 31, 2011

Hertford County Transfer Station
 227 Mount Moriah Road
 Winton, NC 27986

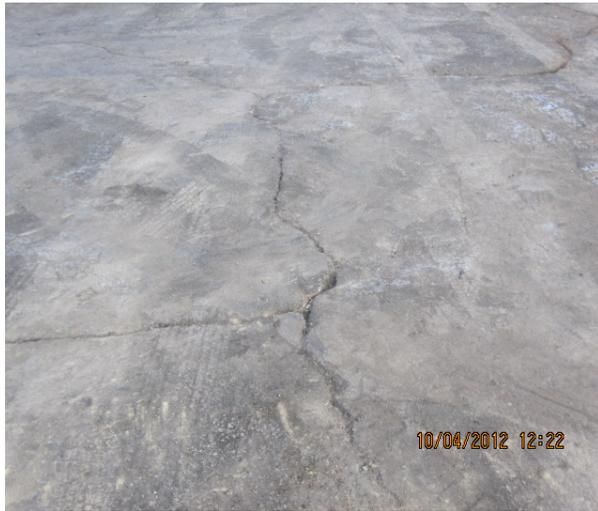
10. The tipping floor does have cracks. The cracks appear to be deep enough to allow the seepage of leachate to the soil underneath. **The tipping floor must be repaired or verification from a licensed engineer must be submitted to Mary Whaley within two weeks of receipt of this report showing that there is not a possibility of leachate penetrating to the sub soil of the tipping floor.**

Cracks in tipping floor

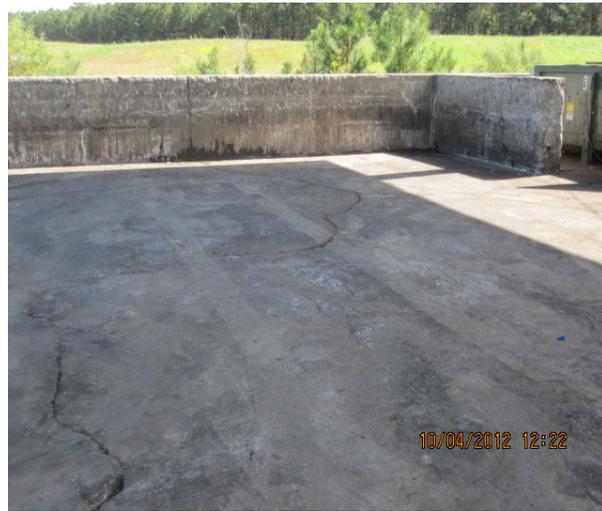
Tipping floor with cracks

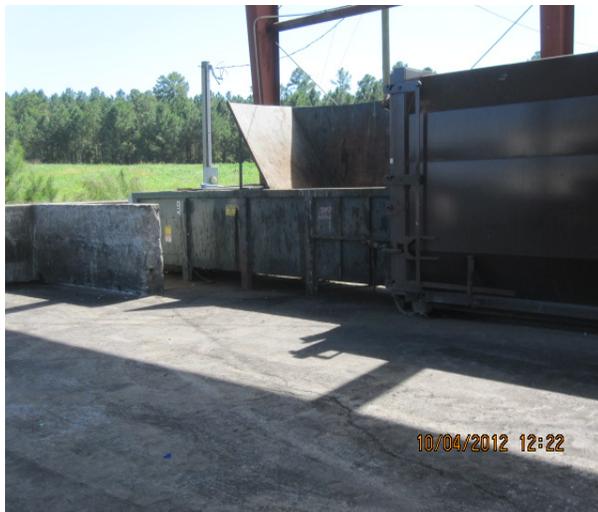
Tipping floor crack

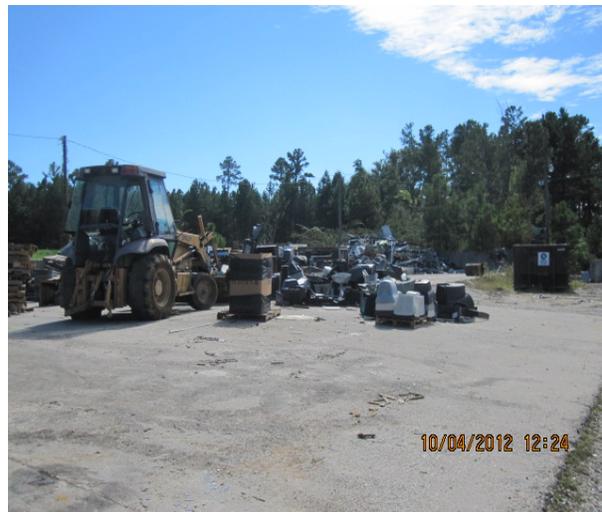
Looking toward recycling area from tipping floor

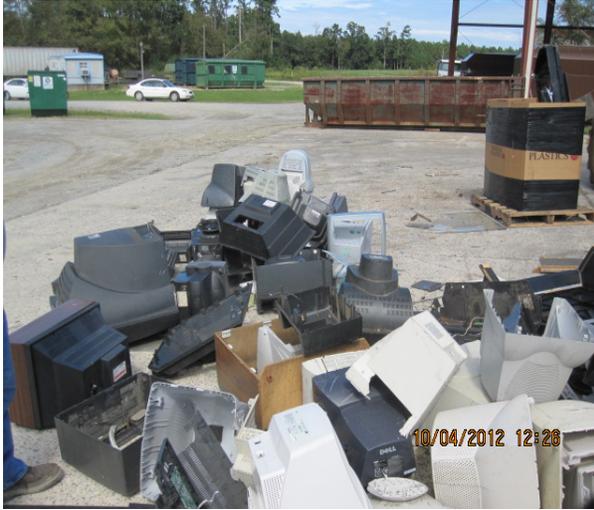
11. The windblown litter is being managed. There was some debris around the electronics, white goods and shingles recycling areas. **Windblown must be picked up on a daily basis.**

Electronics recycling

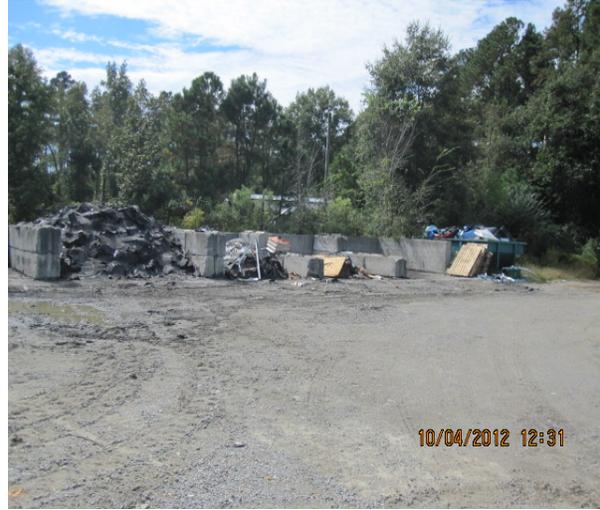
13. **There is a 20 or 30 yard open top container filled with waste, at the end of the shingle recycling area that should be removed.** It appears to have been on site, uncovered for a period of time.

Shingle recycling

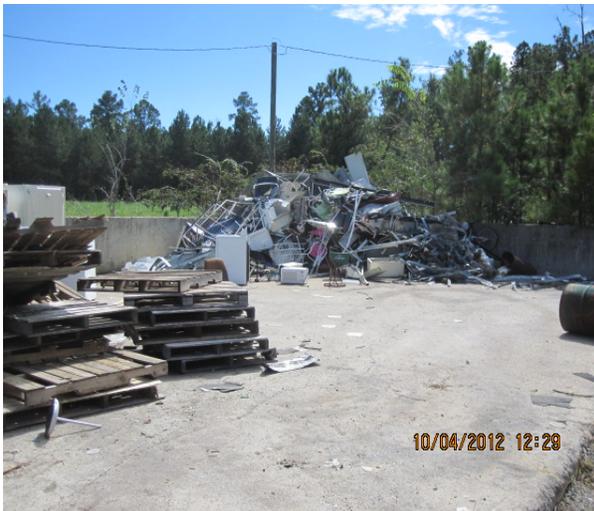
16. The white goods appear to be handled properly. The CFC's are removed by Liverman's Metal Recycling in Bertie County. The records of units and volume of CFCs removed is given to the County. **It is recommended that the volume and number of units with broken lines be included in the record keeping.**

Pallet collection and white goods area
