**FACILITY COMPLIANCE INSPECTION REPORT**  
**Division of Waste Management**  
**Solid Waste Section**

**Date of Site Inspection:** June 21, 2012

Martin County C&DLF  
 1445 Landfill Rd.  
 Williamston, North Carolina 27892

Comprehensive Audit

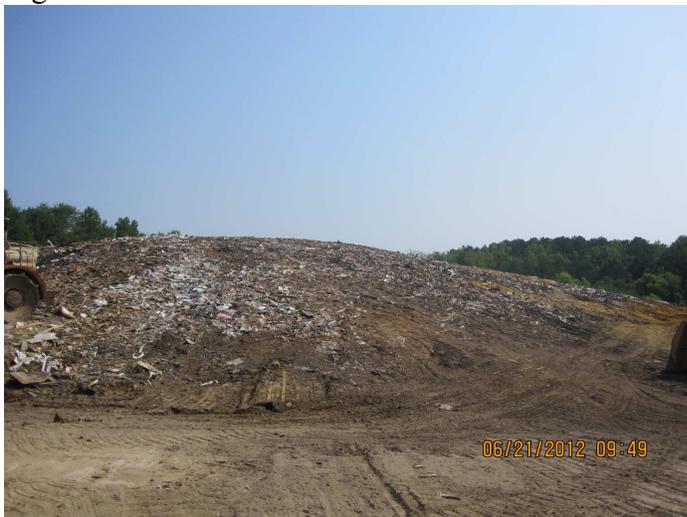
Uncovered waste on top of the landfill

- 16) **Cover of the working face needs to be improved. There were several areas on the top of the landfill that needed more cover.**
- 17) **A Methane Monitoring Plan is included in the new permit. The plan needs to be implemented as required.**

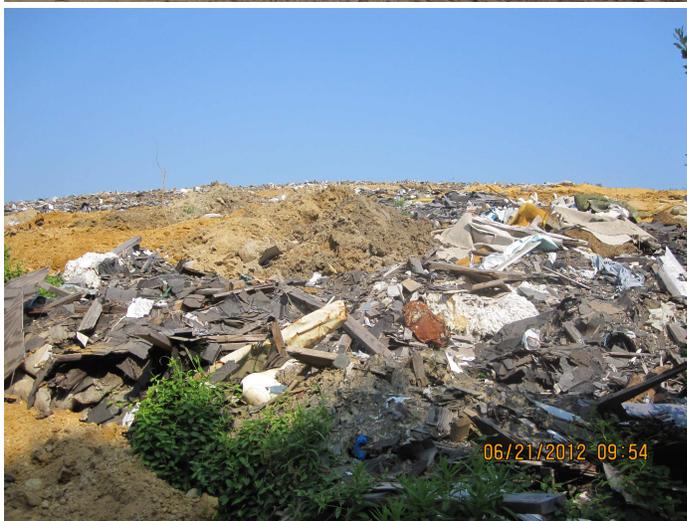
Uncovered waste on top of the landfill
