FACILITY COMPLIANCE AUDIT REPORT
Division of Waste Management
Solid Waste Section

Date of Audit: March 4, 2010.Date of Last Audit: January 11, 2008**FACILITY NAME AND ADDRESS:**

Martin County C&DLF
 1445 Landfill Rd
 Williamston, North Carolina 27892

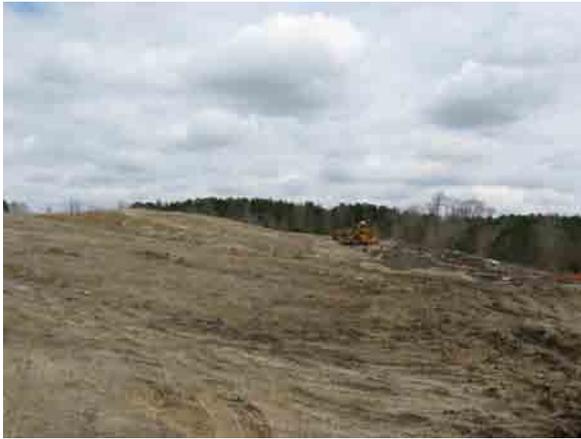
View of C&D area facing northeast

- 7) The facility needs to do a better job covering the waste.
- 8) The CFC containing white goods (refrigerators, air conditioners etc) are being separated from the non CFC containing white goods and stacked neatly. United Salvage of Roanoke Rapids is collecting the white goods and is providing records of CFC removal.

- 17) A log indicating the days for covering of the waste in the C&D area needs to be kept.
- 18) Methane monitoring needs to be required in the new permit

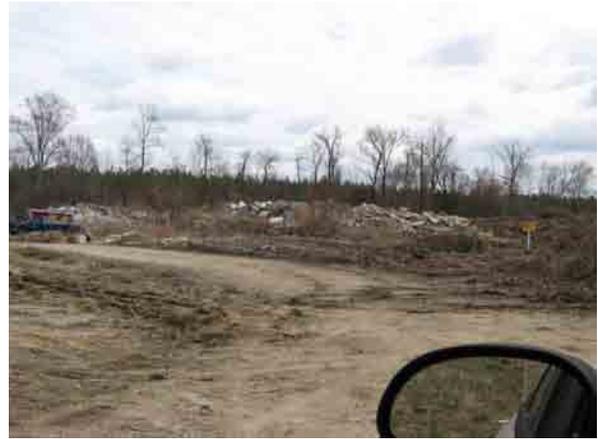
View of concrete pile facing south east

- 14) Concrete piled up in front of the yard waste area needs to be ground and the aggregate removed for reuse. Any concrete accepted at the facility should be ground within one year of receipt.

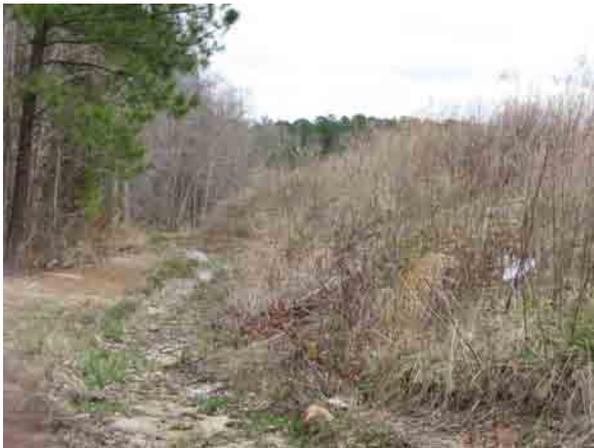
View of back side of closed area facing north east

- 12) The side slopes of the closed area adjacent to the C&D area need mowing.
- 13) Edge of waste markers for the closed MSWLF and C&DLF need to be installed.

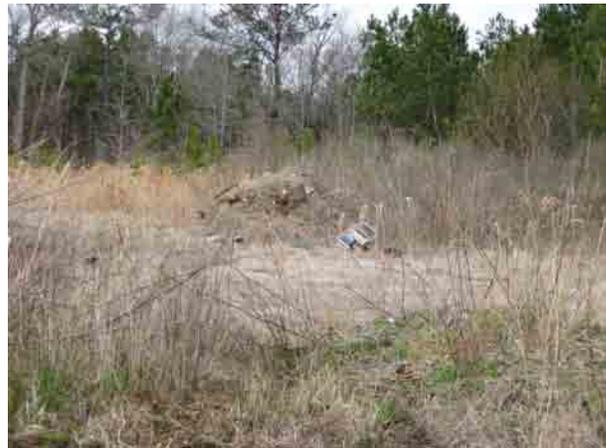
View of the dirt/waste piles behind the white goods pad facing north west

- 15) Make sure that only waste generated by the construction and demolition of structures is accepted at the landfill.
- 16) Dirt piles behind the white goods pad need to be removed and any waste mixed with the dirt disposed of properly.

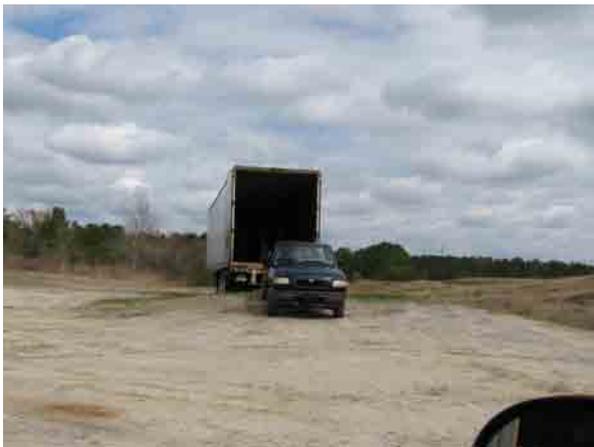
- 5) Make sure all ground water monitoring wells are locked and numbered.
- 6) Scrap tires are being stored in closed trailers and are being managed well.

View of scrap tire collection area facing north east

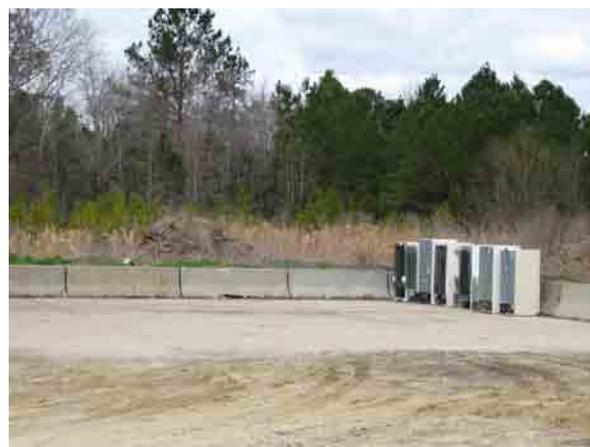
View of white goods pad and dirt/waste mixture facing north west
