PART 1 – SITE SUITABILITY APPLICATION

HYDROGEOLOGY AND FACILITY PLAN REPORT

Rutherford County Central MSW Landfill
Rutherfordton, North Carolina

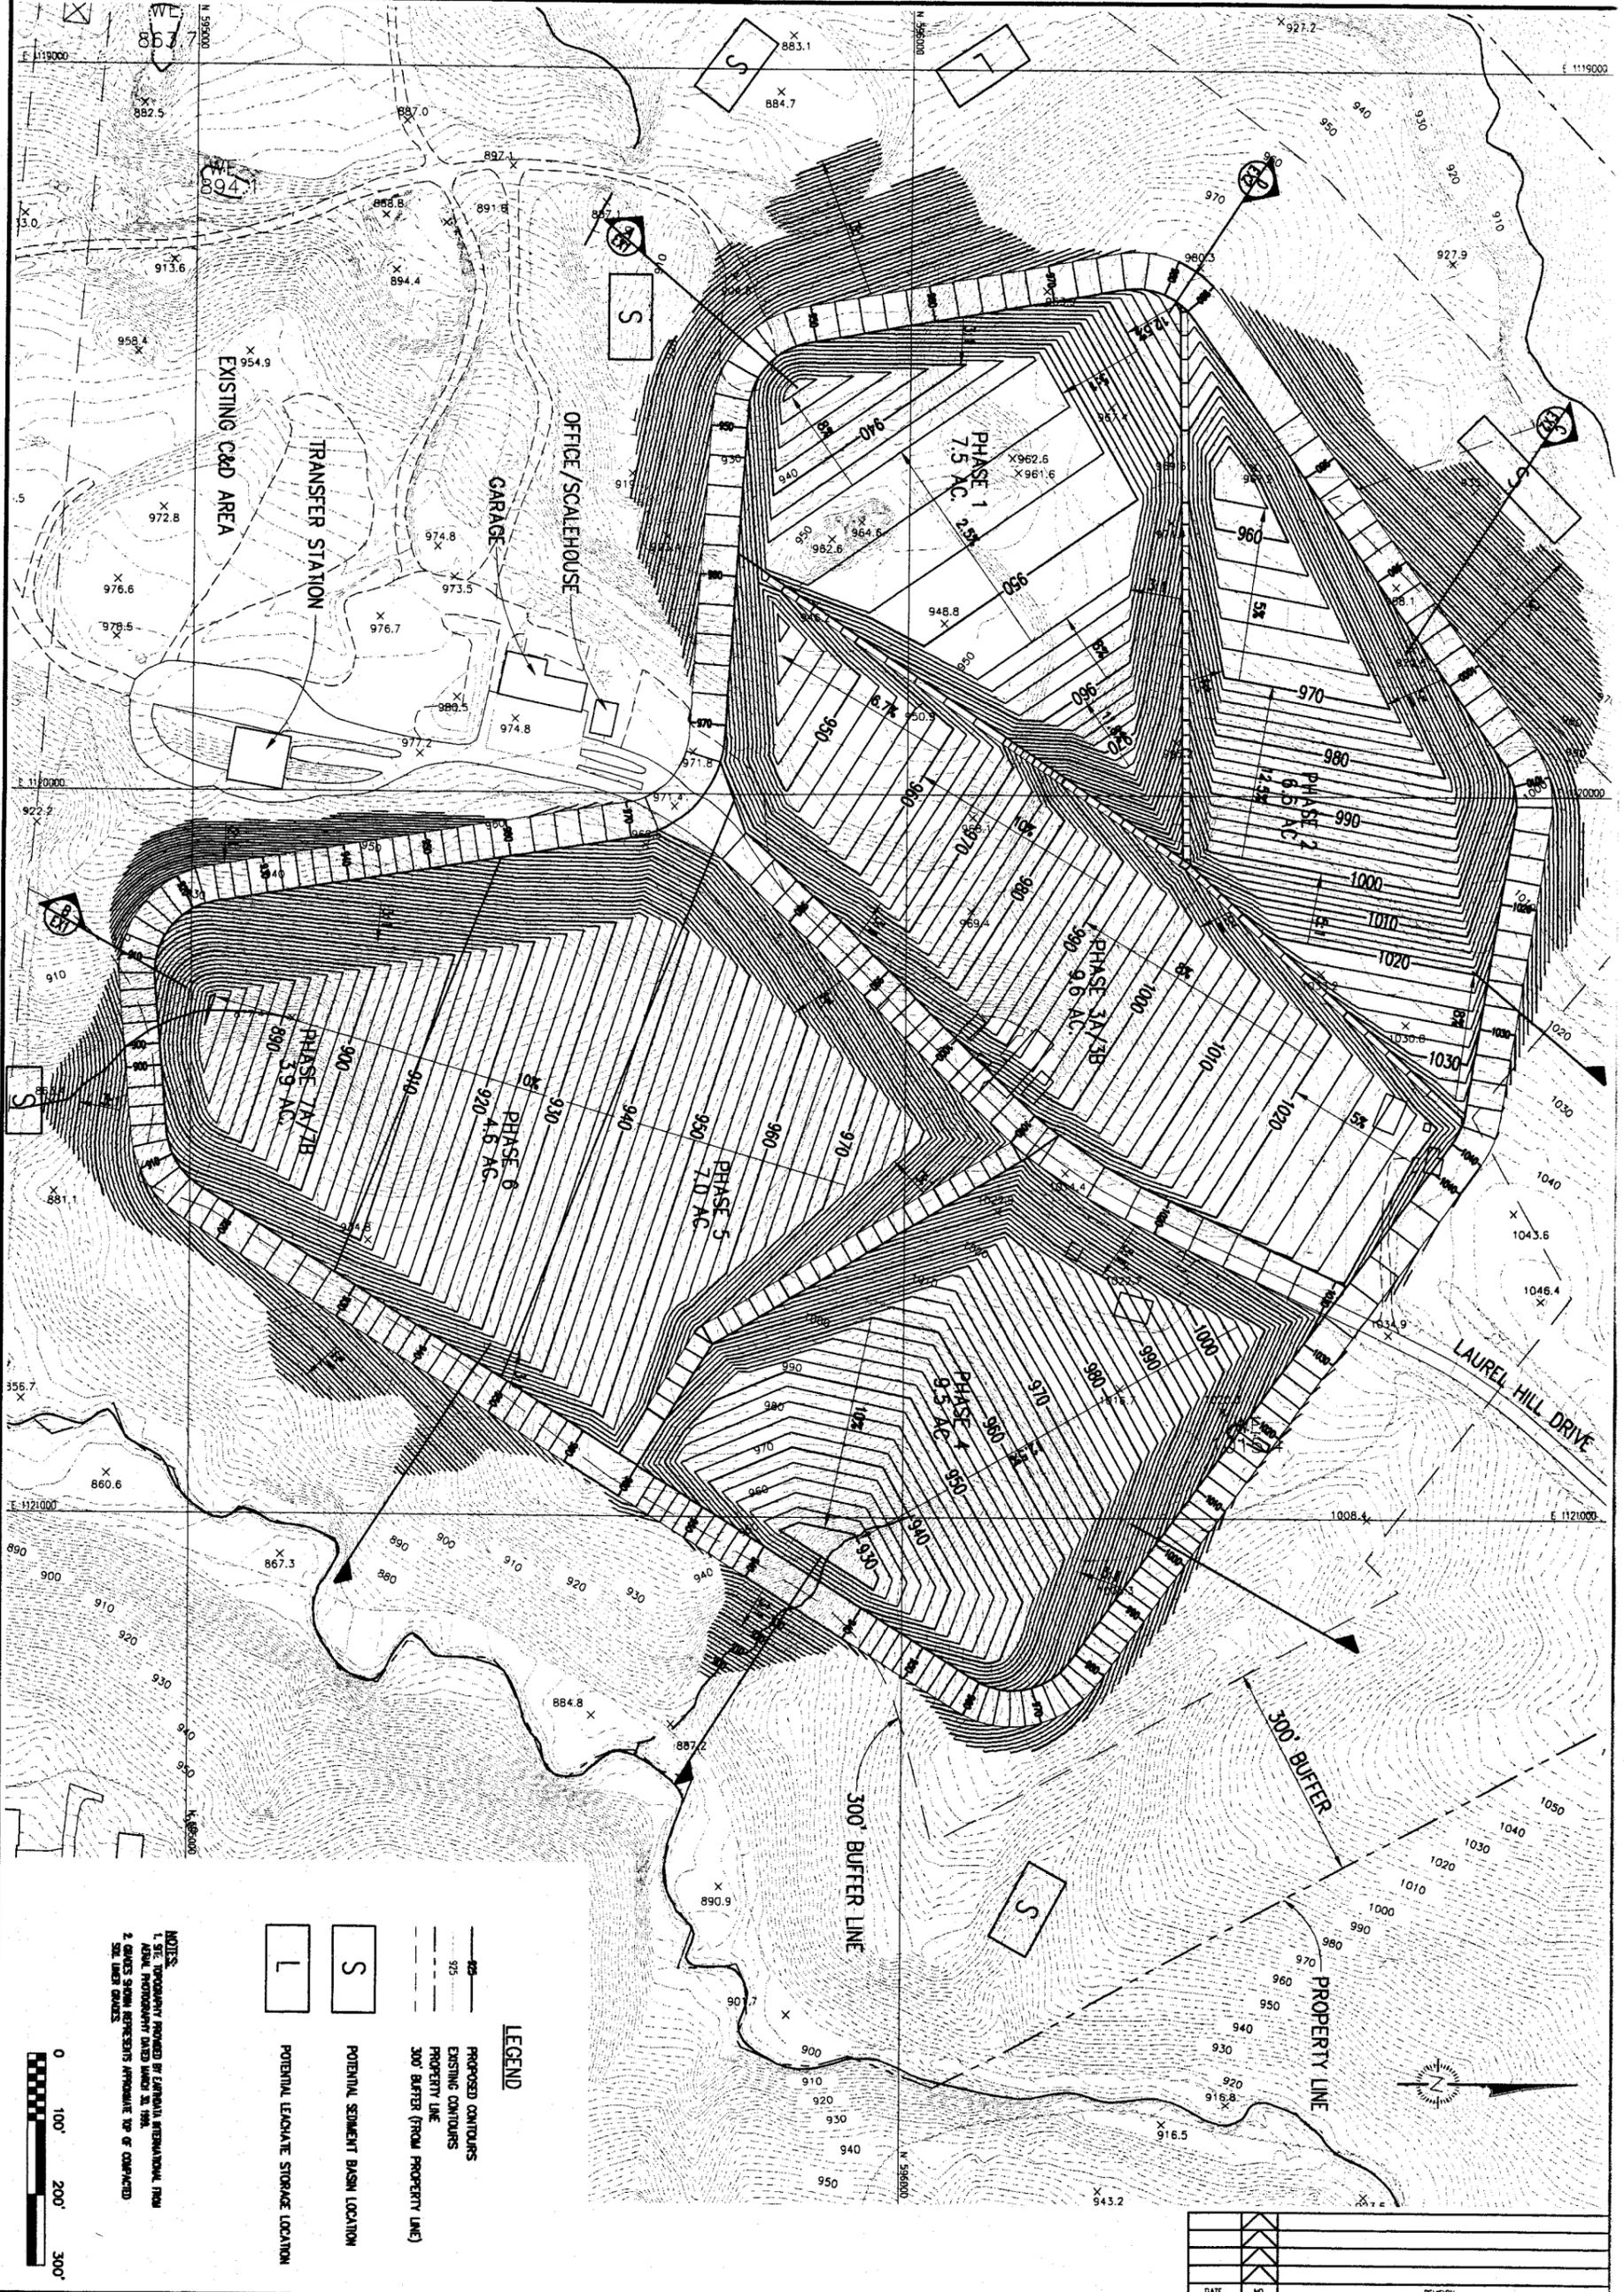
DRAWING NO.	RU14-00039
SHEET NO.	S2
DATE	JAN. 2001
SCALE	AS SHOWN
DESIGNED BY	C.T.L.
CHECKED BY	P.K.S.
DATE	JAN. 2001
BY	AS SHOWN
FILE NAME	RU14-00039

The project site is located on a portion of the existing Rutherford County Landfill facility on Laurel Hill Drive off of the Highway 74 Bypass in Rutherfordton. Existing conditions are shown on **Drawing S2** of the Project Drawings.

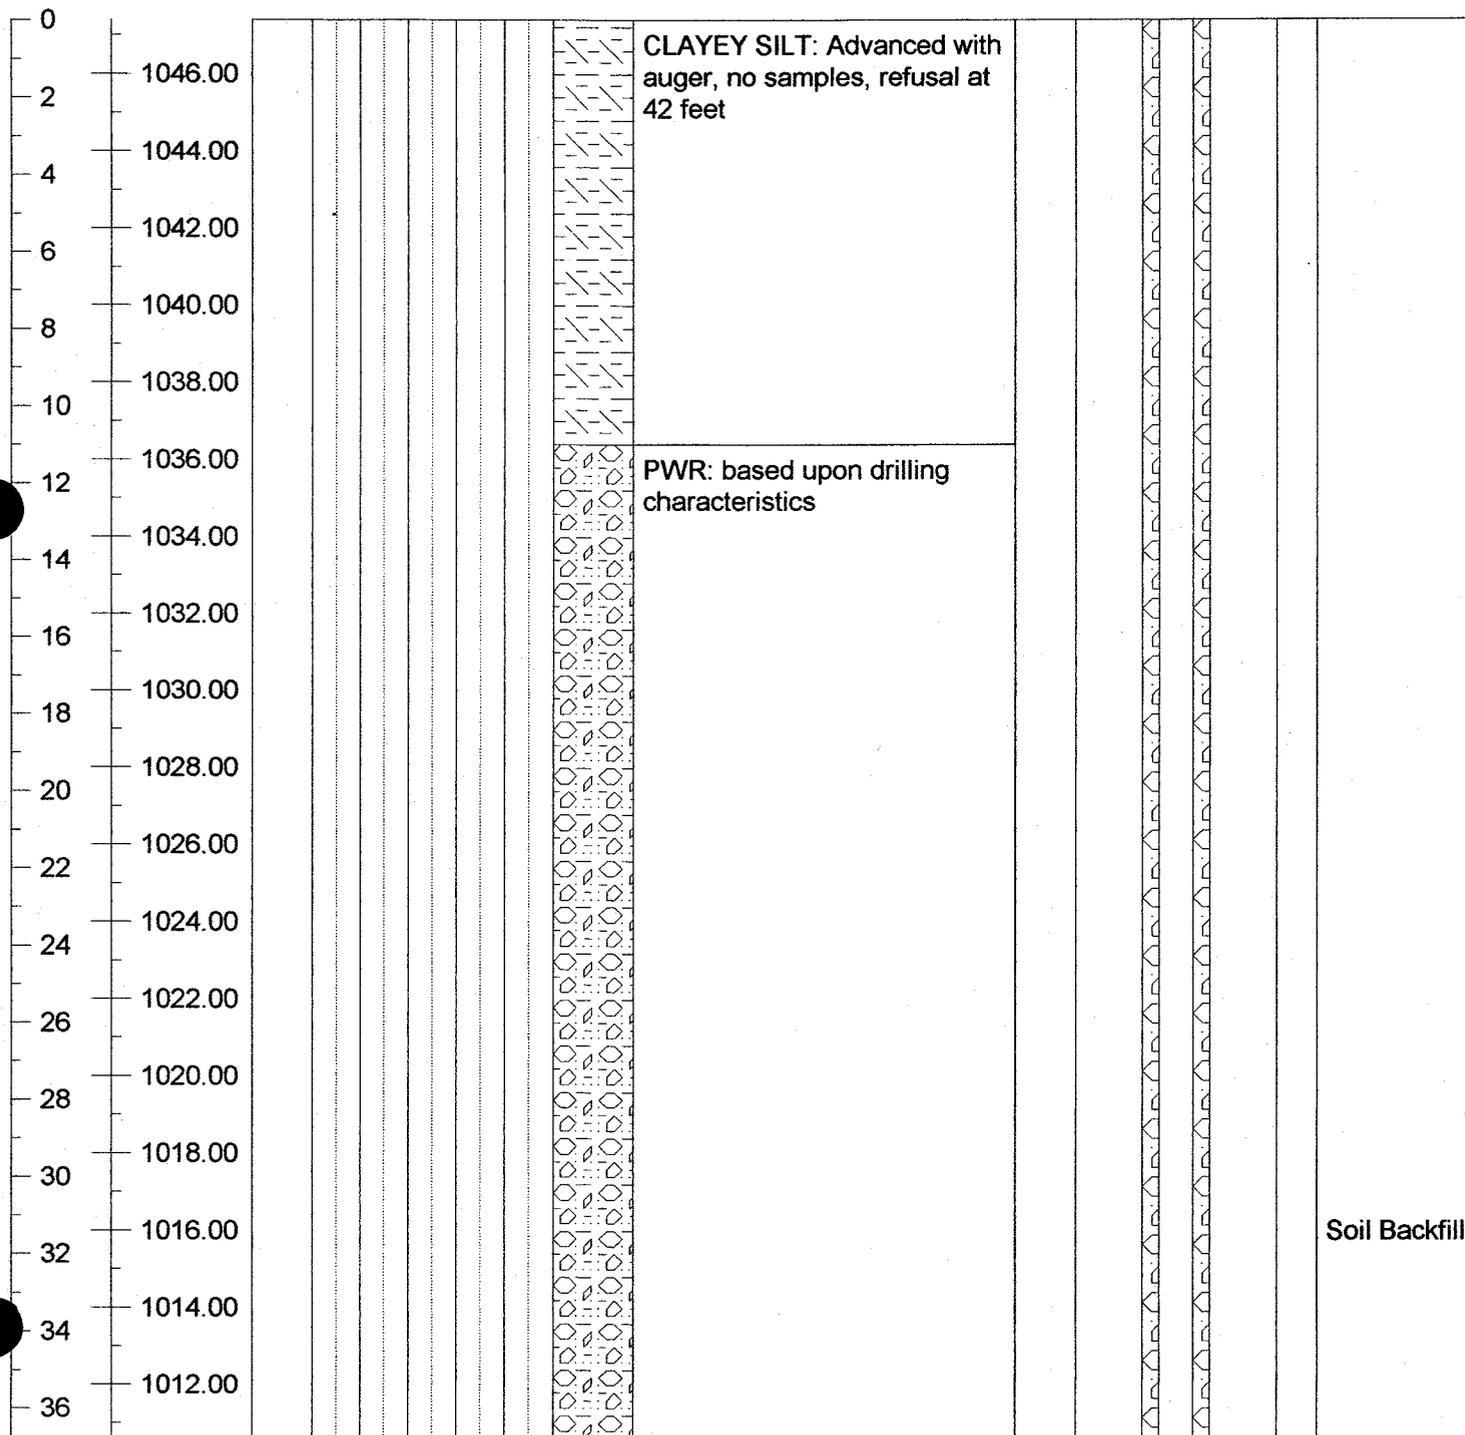
Client and Project	Rutherford County Central MSW Landfill	Collar Elevation	1047.38
Equipment	Mobile B-53 ATV	Drilling Method	HSA/ Air Rotary
Date Started	5/31/00	Date Ended	5/31/00
Drilling Firm	Bore & Core (Seiler)	Logged by	David Garrett
Comments	Cleared and stripped surface	Total Depth	78.0
		Water Level, TOB	63.2 ▾
		Water Level, 24 Hr.	64.8
		Stabilized Level	64.8 ▾
		Date of Observation	6/2/00

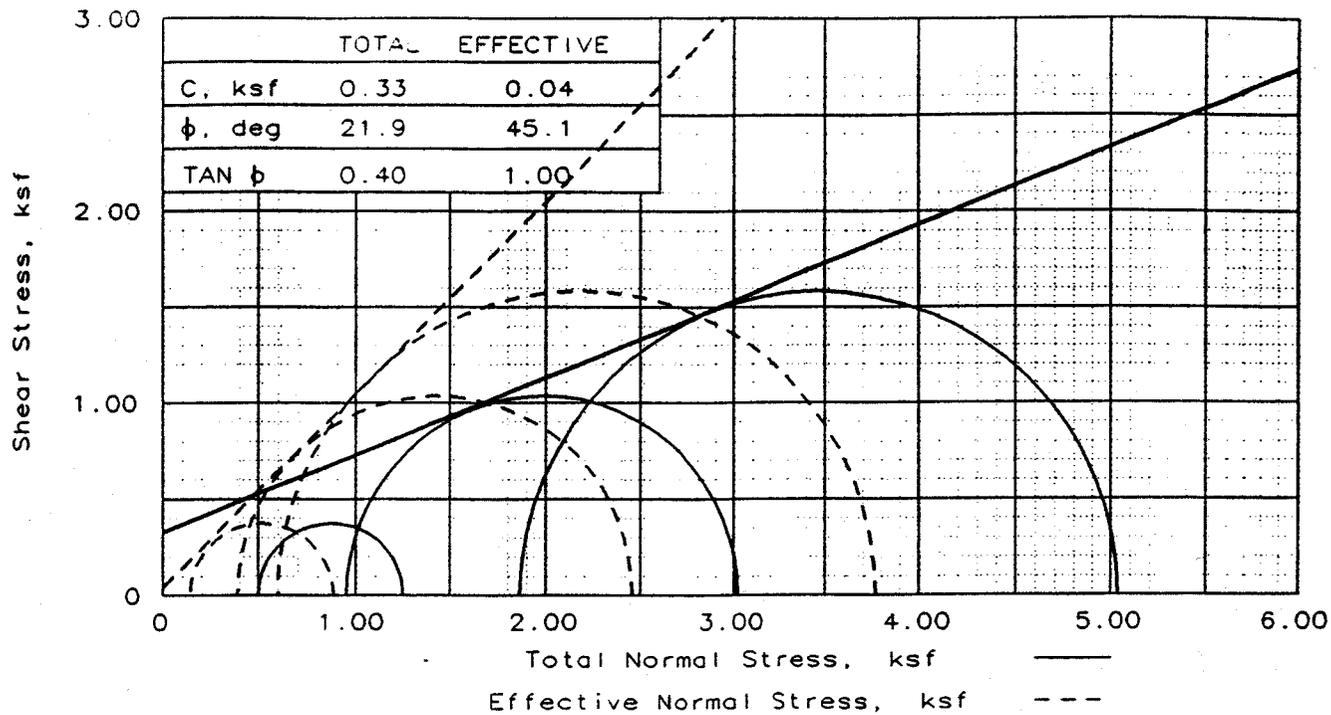
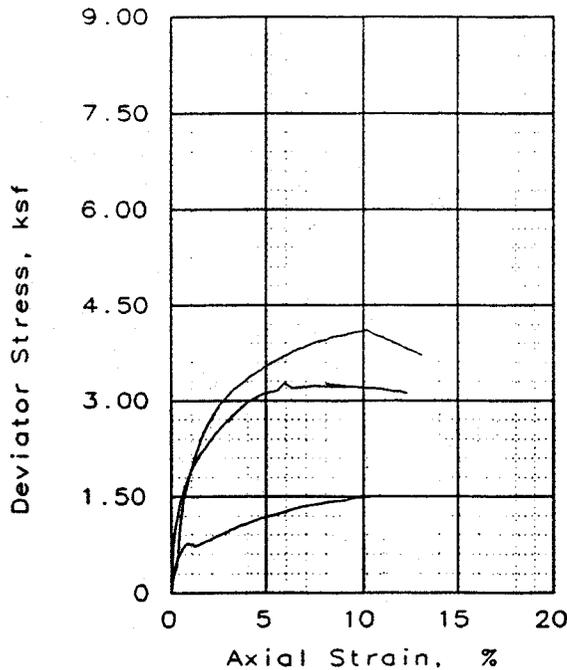
Average k = 4.37E-07 cm/sec

SAMPLE NO.		1	2	3
INITIAL	WATER CONTENT, %	29.9	30.1	26.4
	DRY DENSITY, pcf	92.9	95.3	94.4
	SATURATION, %	97.1	103.3	88.5
	VOID RATIO	0.848	0.801	0.819
	DIAMETER, in	2.89	2.89	2.86
	HEIGHT, in	5.61	5.82	5.60
AT TEST	WATER CONTENT, %	32.9	32.7	35.6
	DRY DENSITY, pcf	97.0	100.2	99.2
	SATURATION, %	117.5	125.9	134.1
	VOID RATIO	0.770	0.714	0.730
	DIAMETER, in	2.85	2.84	2.81
	HEIGHT, in	5.53	5.73	5.51
Strain rate, in/min		3.004	0.004	0.004
BACK PRESSURE, ksf		5.77	5.73	5.73
CELL PRESSURE, ksf		6.28	6.68	7.60
FAILURE STRESS, ksf		0.75	2.07	3.17
PORE PRESSURE, ksf		6.13	6.29	7.00
ULTIMATE STRESS, ksf		0.75	2.07	2.59
PORE PRESSURE, ksf		6.13	6.29	6.97
$\bar{\sigma}_1$ FAILURE, ksf		0.89	2.46	3.77
$\bar{\sigma}_3$ FAILURE, ksf		0.14	0.39	0.6

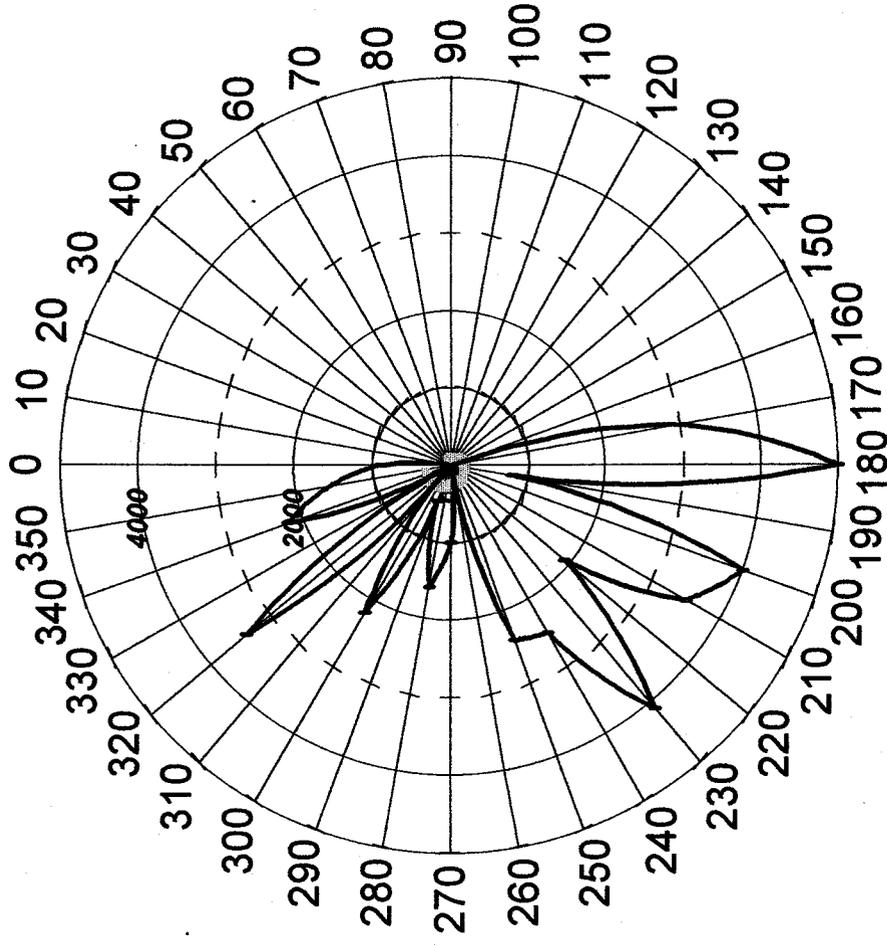
4.1.1 Fracture Trace Analysis – Generalized bedrock fracture trends are presented on the Cumulative Length Distribution diagrams for two-mile, one-mile, and half-mile study areas, as measured from the facility boundary (see Appendix G). Similar to rosette diagrams, these plots show the statistical trends for “blue-line” stream development as the summary length and orientation of major fracture systems. Topographic “blue-lines” were targeted since they represent the predominant fracture systems without the background “noise” or clutter introduced by counting all the drainage features. Some of the major fracture systems can be traced in the on-site bedrock through outcrop measurements (strike and dip of bedding and jointing), but bedrock exposures at the site are infrequent and highly weathered. The strata are cross-bedded, which complicates the correlation to topographic trends. Topographic orientations described below are given in azimuth rather than coordinates, and the orientations of the plotted data reflect the actual stream flow directions.

Data are plotted on even even 10-degree increments for preceding intervals.

Yet another poorly defined joint set (S2), oriented E-W and NW-SE (another conjugate set), corresponds to topographic lineations at N80°W (Az. 280°) and between N40° to 60°W (Az. 300° to 320°). Other joints and fractures exhibit strong overprinting (multiple tectonic events), secondary mineralization (remobilized quartz, aplite, and minor epidote), and a granite-like exfoliation.
