FACILITY COMPLIANCE INSPECTION REPORT
Division of Waste Management
Solid Waste Section

City of Raleigh/Wake County - Raleigh MSW Transfer Station
 820 Corporation Parkway
 Raleigh, NC 27610

Comprehensive Audit

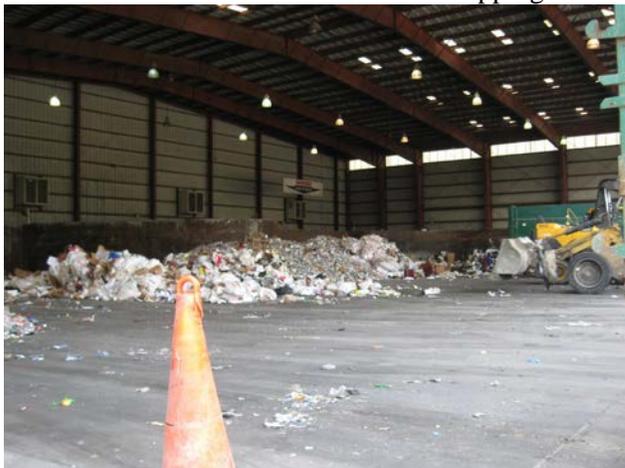
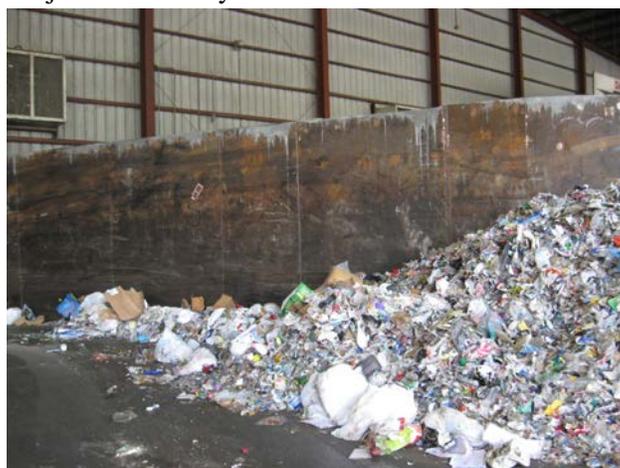
7. Waste screening reports were verified for February and March 2013. The facility conducts 1 percent of loads received, ~ 2 waste screenings per day.
8. Waste on the tipping floor was being well managed. A new tipping floor has been poured and angled so that leachate drains towards the loading bay and into the leachate collection drains in the bays. The push walls have also been reinforced. All cracks in the tipping floor and adjacent driveway have been caulked and sealed.

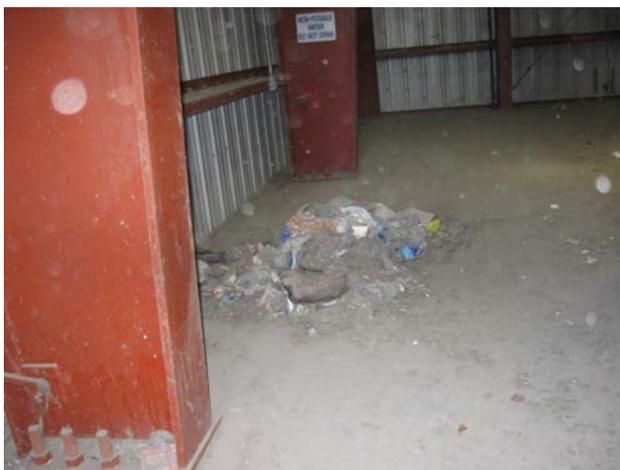
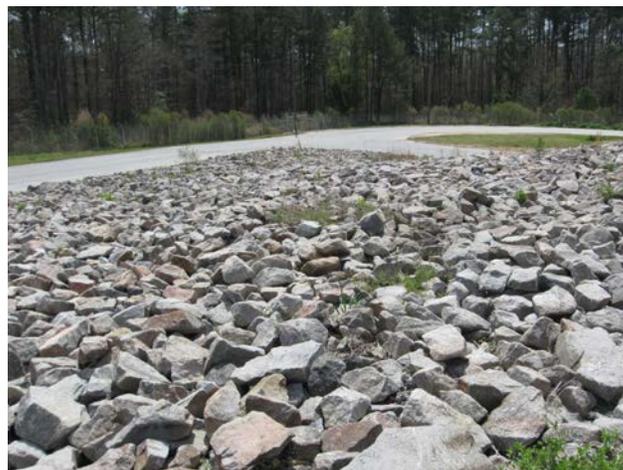
9. The perimeter walls of the transfer station need to be periodically cleaned of dirt and cobwebs. At the time of the inspection, it appeared that facility staff had begun sweeping behind perimeter walls but had not completed the maintenance.
10. Windblown material was being well managed. Windblown material resulting from the operation is collected and properly disposed of at the conclusion of each day of operation. Riprap adjacent to the front and back of the loading bay is scheduled to be removed and replaced with grass for improved ease of maintenance.

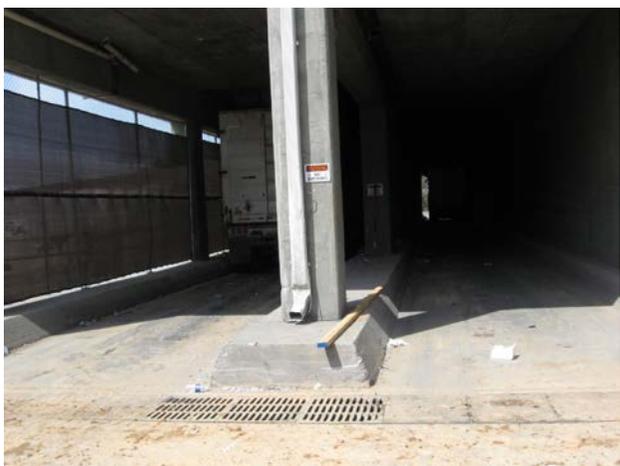
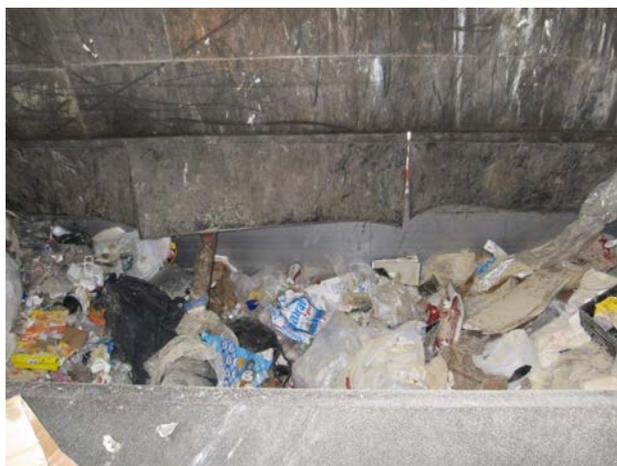
13. The hole in the wall at the rear of the transfer station (2nd load-out bay) has been repaired. A new chain-link fence with a mesh covering has replaced the metal siding.

14. MSW that accumulates in the load-out bay area is routinely removed as needed during the day, and is completely removed at the end of the day. Flaps have been installed in the loading shoot to direct waste into the transfer trailers. Waste is now being better directed into the trailers.

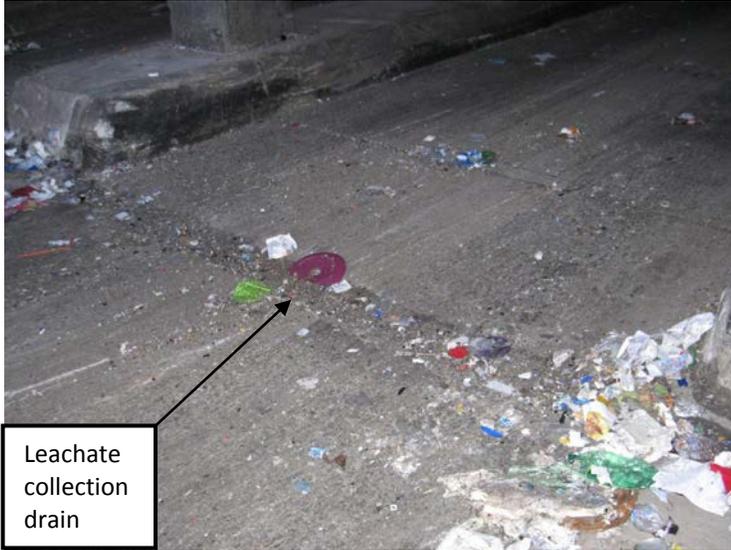
Photo taken January 20, 2012

15. Leachate generated by the facility is piped to the City of Raleigh Neuse River Wastewater Treatment Plant (WWTP). The leachate drains across both bay openings on the west and east side of the facility have been expanded and new grates have been installed. The system now has a grit separator and a flushing system to aid in preventing the system from becoming clogged.

Leachate collection drain
