FACILITY COMPLIANCE INSPECTION REPORT
Division of Waste Management
Solid Waste Section

Date of Site Inspection: December 7, 2012 Date of Last Inspection: February 25, 2011

Wilson County Westside Construction and Demolition Debris Landfill
 Hwy 42E Wilson,
 Wilson County, North Carolina

Comprehensive audit of a C&DLF

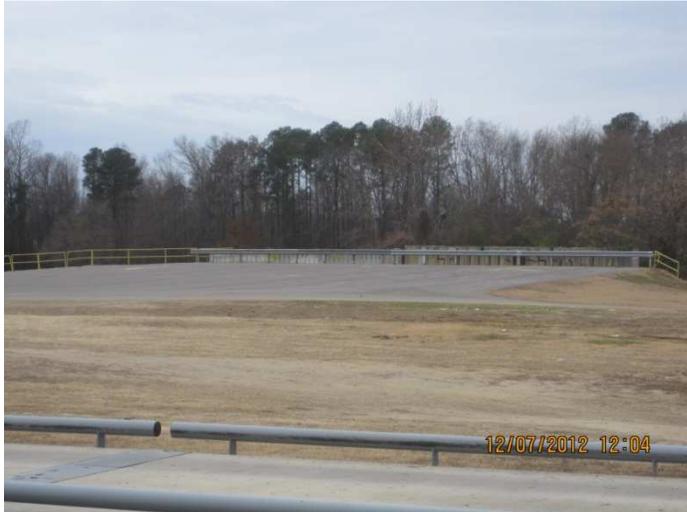
Scrap tire collection area. Tires are dumped by citizens on the concrete pad and transferred by Co. staff into trailers for transport to end user.

13. Scrap tires are being dumped on an elevated concrete platform and loaded into trailers. The tires are collected by Central Carolina Tire.
14. Davis has indicated that the county is exploring purchasing a horizontal grinder and transporting the chips to an end user rather than storing and managing on site for composting.

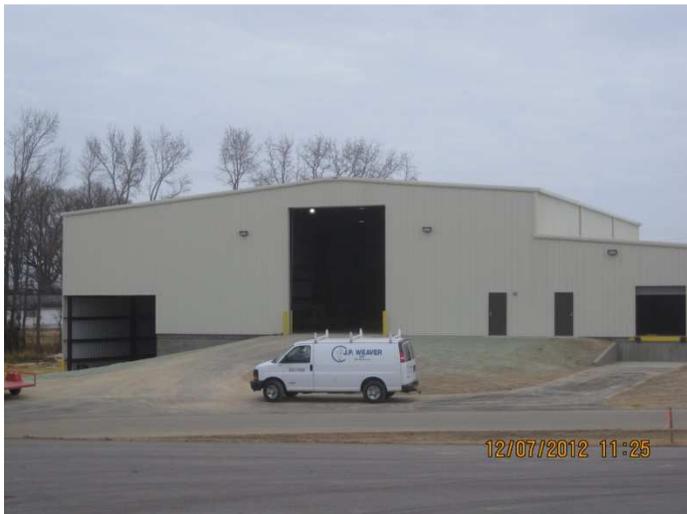
New electronics and single stream recycling building, electronics and single stream recyclables will be stored in the building for transport to the end user.

8. Landfill gas is being monitored and recorded as required in the Ops Plan. Three LF gas probes are being used to monitor LF gas.
9. The county has constructed a new storage building for electronic and single stream recyclables near the weigh station. Electronics will be transmitted to Creative Recycling in Morrisville NC. Single stream recyclables will be transported to Sunoco Recycling in Raleigh NC.

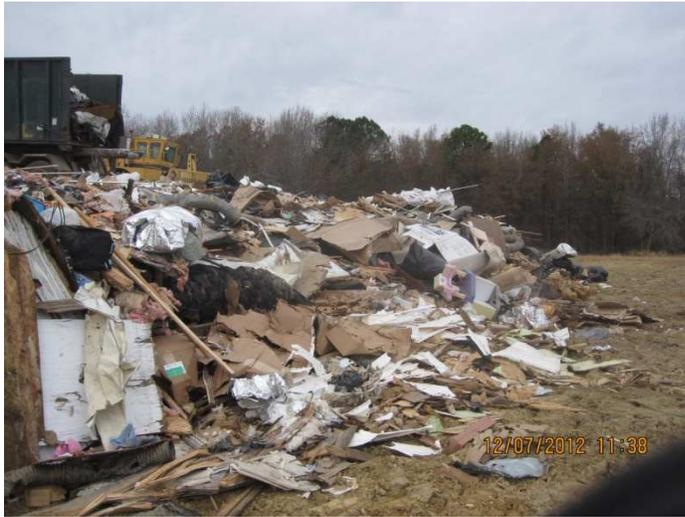
Working face, no unapproved materials were observed

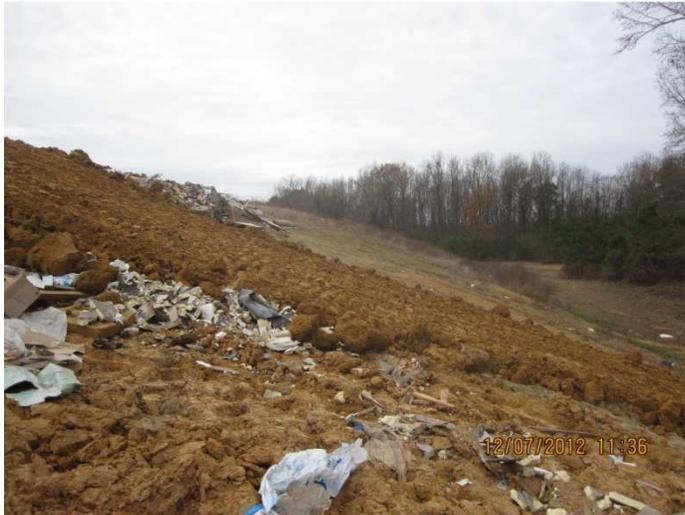
Eastern slope, cover was good but a few confined areas need extra cover

15. Cover is generally good but there are few scattered areas where waste is exposed. A cover log is being kept. **Make sure the scattered areas mentioned above are covered.**

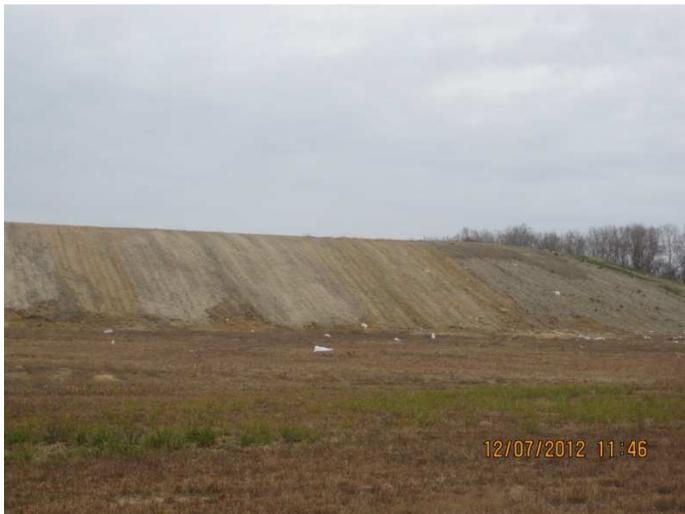
Southern slope showing good cover and stabilization

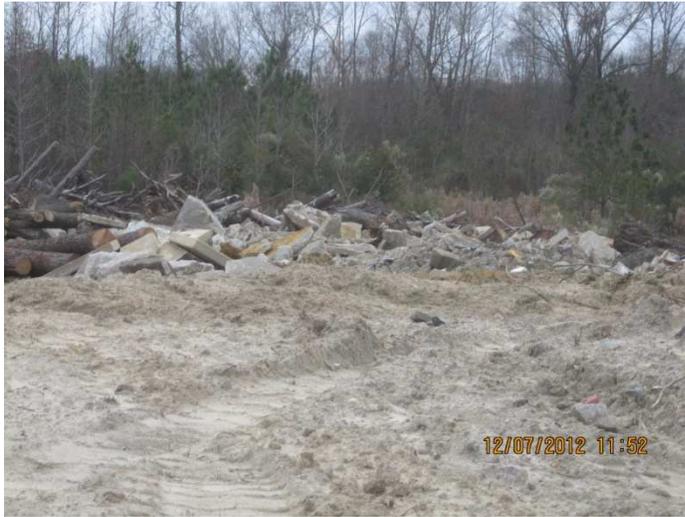
LCID area, some material needs cover

18. The operator is conducting routine weekly inspections for leachate breakouts as specified in the Ops Plan and keeping records.
19. **Make sure the LCID area is covered as required and the edge of LCID footprint area is marked.**

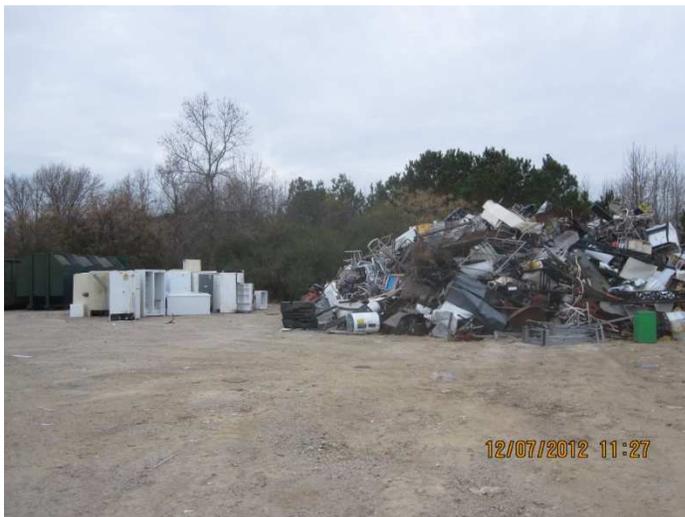
White goods area, CFC containing white goods are separated from non-CFC containing white goods, marked and stored neatly

12. The white goods area, scrap tire collection area, electronics collection area and YW area have been moved to the new location near the new scale house and are well maintained. CFC's are being removed by FOSS Recycling in Greenville who is also taking the scrap metal.
