**FACILITY COMPLIANCE INSPECTION REPORT**  
**Division of Waste Management**  
**Solid Waste Section**

**Date of Inspection:** 26 June 2013

Pungo River Lime Co Storage Facility  
 Smithwick Road  
 Ponzer, NC 27810

Comprehensive Facility Compliance Inspection

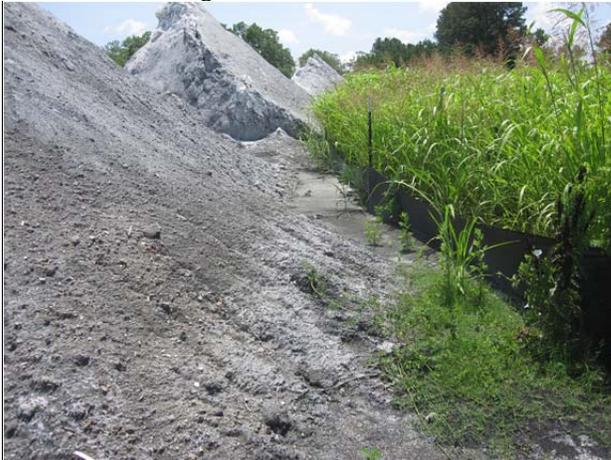
- 10) No off-site erosion or surface water run-off was observed during this Facility Compliance Inspection.  
 11) Please ensure that the height of the storage piles does not exceed fifteen feet.  
 12) Please continue to ensure that a 50' buffer is maintained from all property boundaries and surface water ditches.
