FACILITY COMPLIANCE INSPECTION REPORT
Division of Waste Management
Solid Waste Section

Date of Site Inspection: 10 January 2013 **Date of Last Site Inspection:** 4 October 2012

Smith Pit II LCID Landfill
Herring-Smith Road
Newport, NC 28570

N0707-20130110INSP

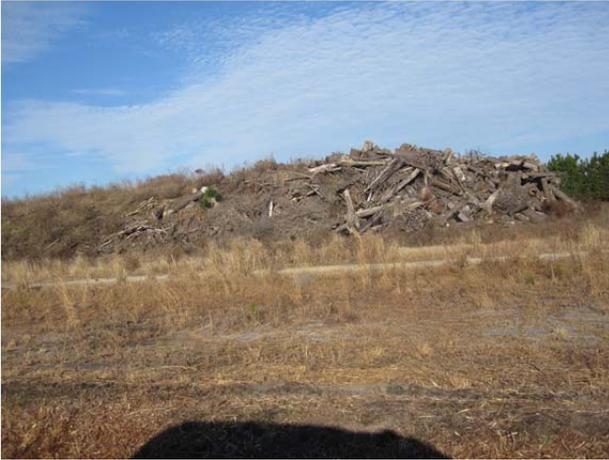
- 11) Overall, the landfill side slopes have been covered adequately and graded to promote positive drainage of surface waters; however, waste from the active working face has been disposed over the eastern side slope which needs to be covered and graded. * The landfill needs to be maintained in a series of vertical lifts. Please compact, cover, and grade the east side slope at a slope not greater than 3:1. This area should then be seeded and mulched to establish a groundcover suitable to prevent erosion of the landfill cap.

- 12) The landfill working face was less than one acre and is being maintained in a manageable size; however, waste from the working face has been pushed over the eastern side slope of the landfill. *Please ensure that the active working face is covered monthly or when it approaches one acre in size, whichever occurs first and that all newly disposed waste is maintained at the working face on the topmost lift.
