**FACILITY COMPLIANCE INSPECTION REPORT**  
**Division of Waste Management**  
**Solid Waste Section**

**Date of Site Inspection:** January 22, 2013    **Date of Last Inspection:** November 3, 2011

L&L Landfill  
 4468 London Church Rd.  
 Wilson, North Carolina

Follow up audit to determine compliance with NOV dated January 26, 2010

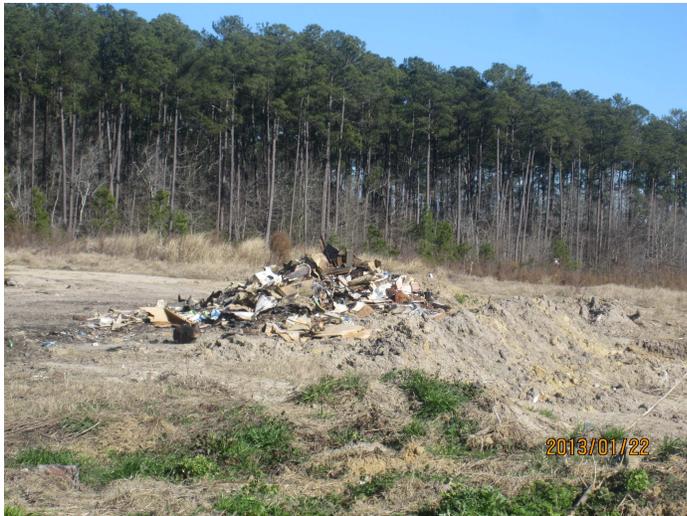
Nonconforming waste on the surface of the landfill

- 7) Only waste defined as land clearing and inert debris waste can be disposed in the landfill. **The nonconforming waste on the site needs to be removed and transported to a facility approved to receive this type of waste within 30 days of receiving this inspection form. Receipts from the approved facility must be provided to me at Ben Barnes, P.O. Box 8998 Rocky Mount, North Carolina 27804.**

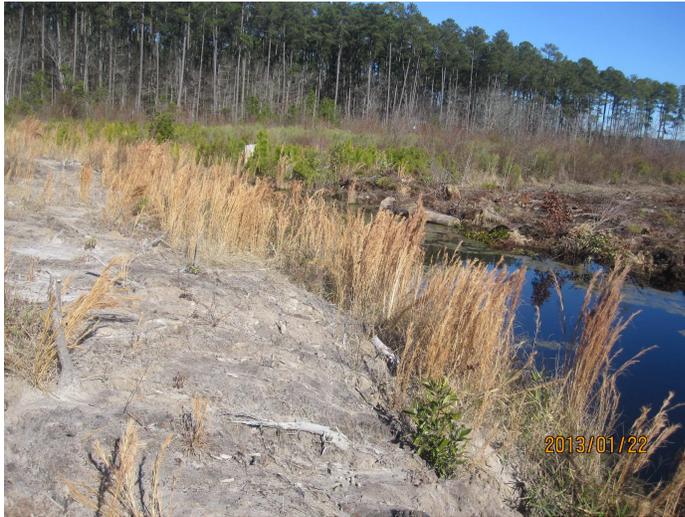
landfill

Impounded water on the eastern slope of the

- 5) There is a cable across the entrance that was open at the time of the audit. **The gate should be closed to prevent illegal dumping.**
- 6) The area of impounded water below the eastern slope should either be filled or drained.

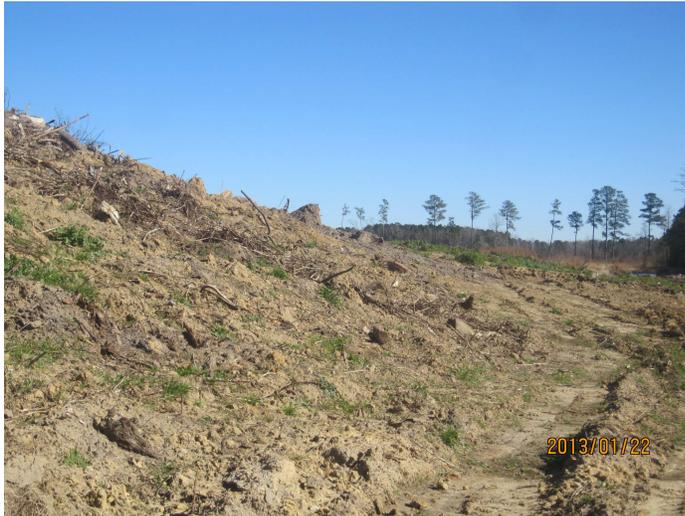
Southern slope of the landfill

- 2) The slopes need to be graded to 3:1 or no greater than 4:1 and stabilized with seed or mulch.
- 3) The cover is generally good.
- 4) The access road was well maintained.

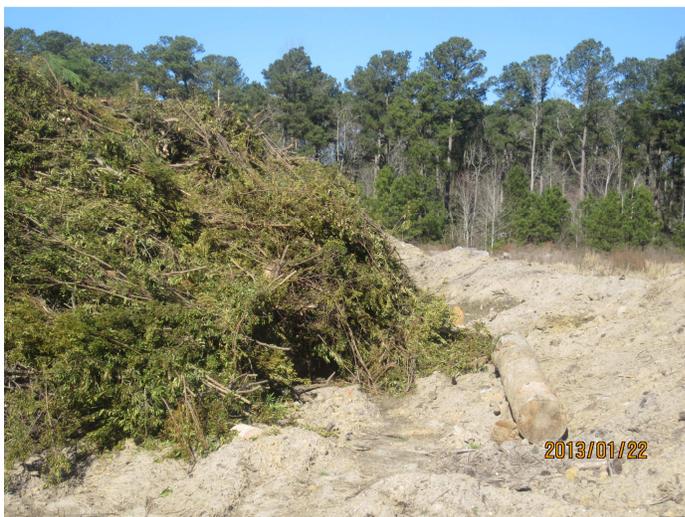
Fresh waste on the surface
