FACILITY COMPLIANCE INSPECTION REPORT
Division of Waste Management
Solid Waste Section

Coble's Sandrock, Inc. C&D Landfill
 5833 Foster Store Road
 Liberty, NC 27298

Comprehensive Inspection

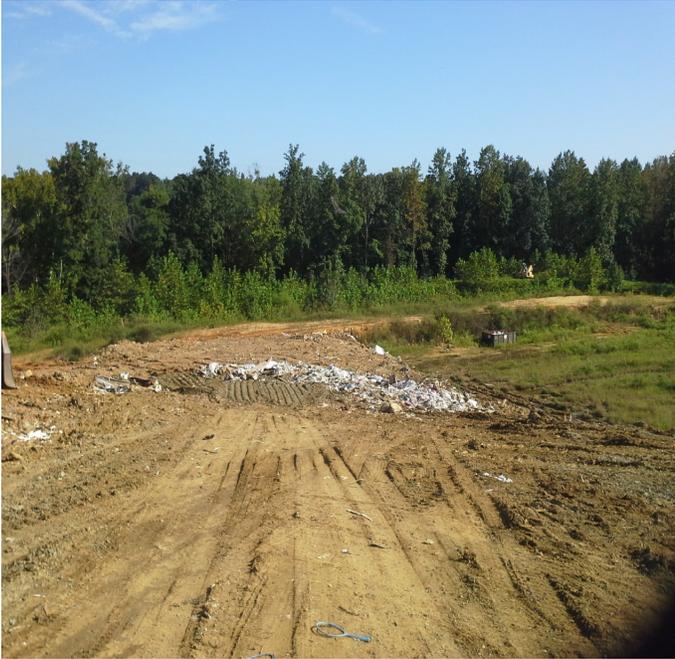
Working face, rear portion of Phase 3A

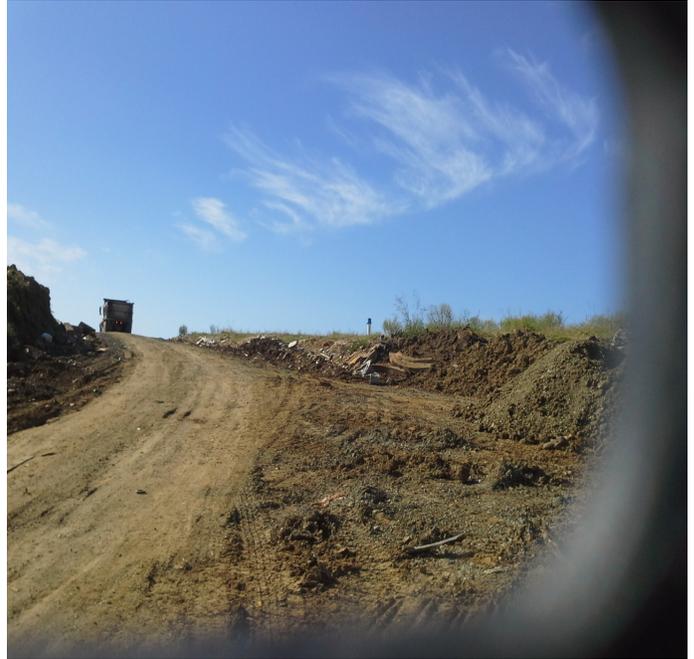
Debris at road bank – remove or cover with soil

21. Ensure C&D along the road bank leading up to the working face is removed or covered with soil.
22. The facility maintains a weekly soil cover log. The date and time (am or pm) is recorded on a wall calendar. Records were verified for January through August 2013. If the facility covers material Monday through Thursday it occurs ~ 4:30 pm, Friday at ~ 1 pm, and Saturday at ~ 9 am. The day of the week soil cover is applied generally depends on weather conditions.

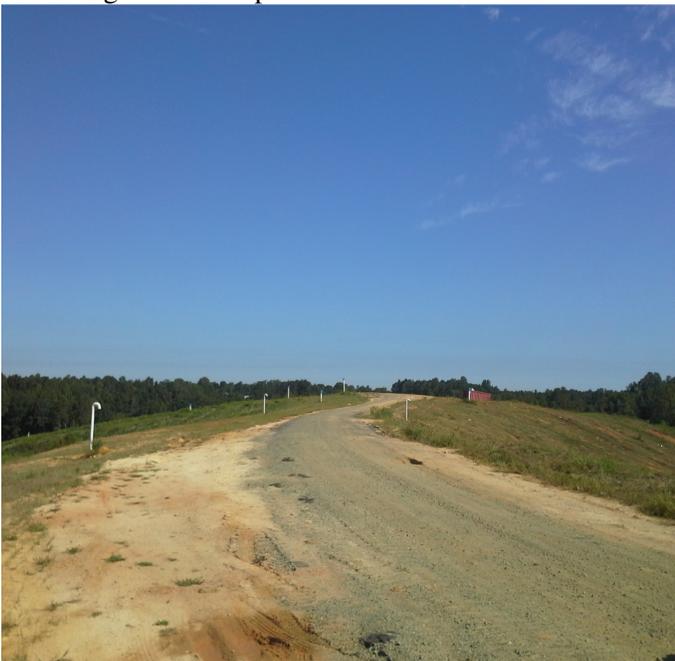
27. The facility has installed landfill gas (LFG) vents atop Phases 1A and 2B.
28. Ensure that groundwater wells and methane monitoring wells are readily accessible.

Landfill gas vents atop Phases 2B and 1A

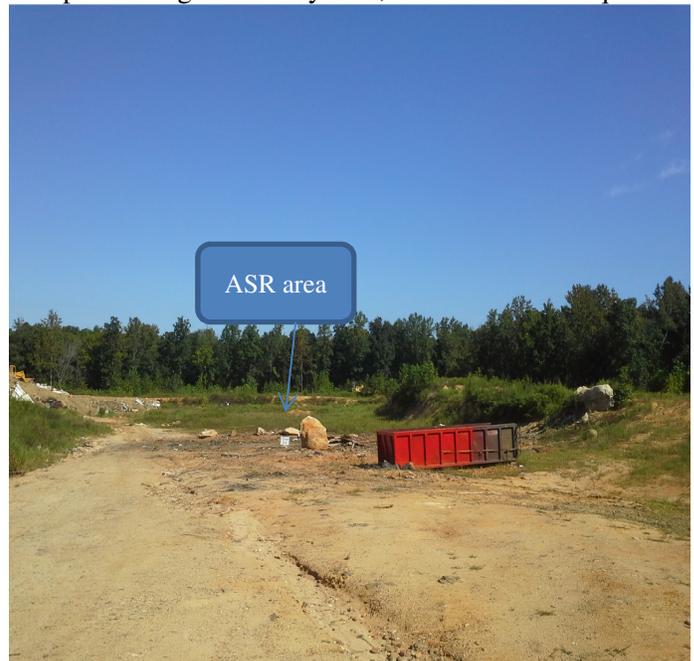
2. The T&P operation is located in Phase 3A. The asphalt shingle recovery (ASR) operation should be relocated as the facility is currently placing C&D in Phase 3A.

7. Asphalt shingles are picked-up every 2 or 3 months. Tonnage hauled-off for August 2013 is 314.90.
8. The facility stores asphalt shingles atop soil/on the ground. Appropriate barriers should be placed around the asphalt shingle recovery area. The operations plan states that Jersey barriers will be placed around three sides of the area.

Asphalt shingle recovery area, 3-sided barrier required

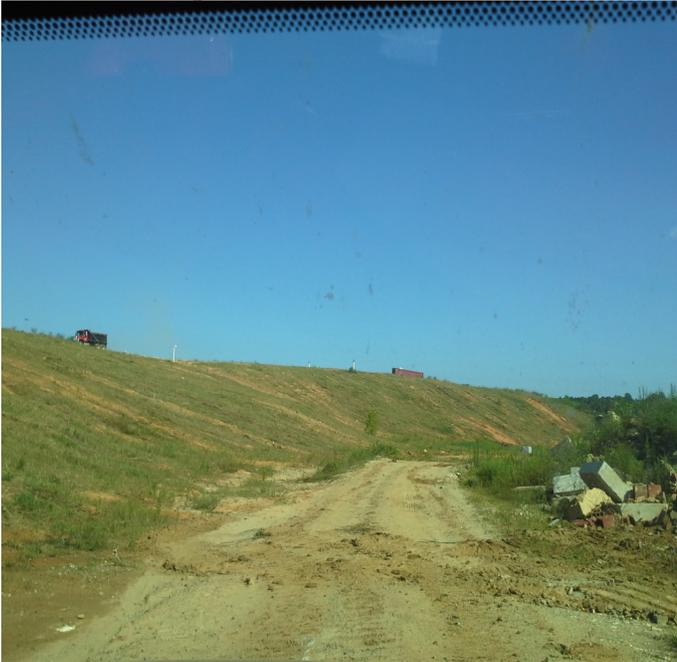
Exterior side slope – Phase 2B, east side

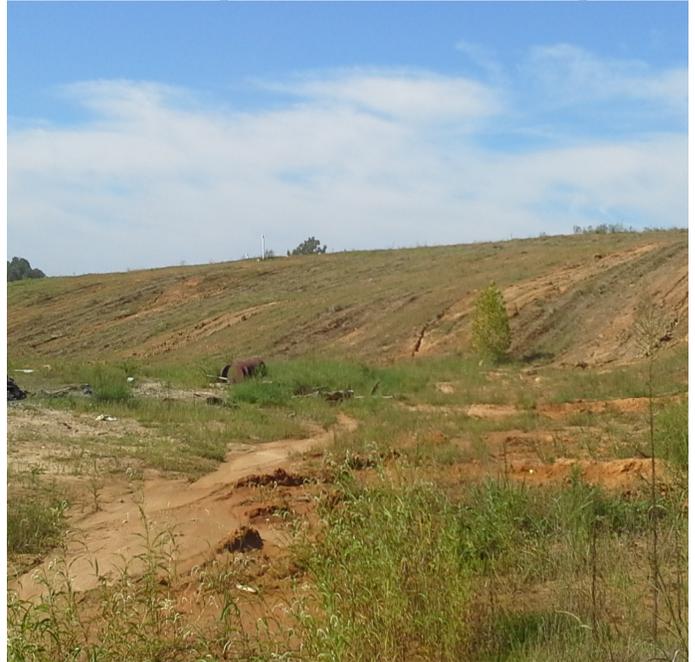
Exterior side slope – Phase 1A, east side - to repair rills

19. The landfill appeared to contain adequate soil cover. Mr. Coble was asked to repair erosion rills due to recent rains.
20. The facility shall cover solid waste with six-inches of soil weekly and when the disposal area exceeds one-half acre.

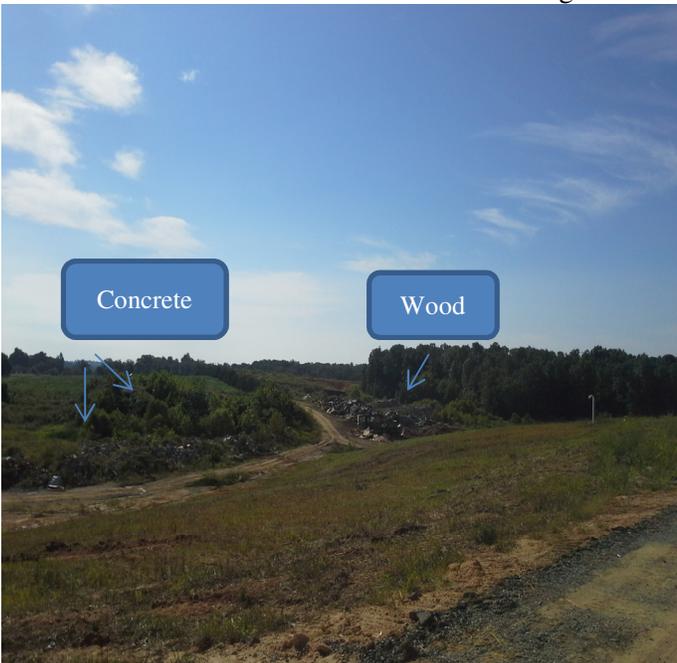
2. The facility has a stockpile of scrap metal.
3. The facility has a stockpile of clean wood. Mr. Coble stated that he plans to grind it by ~ November 2013.

4. The facility grinds engineered wood for boiler fuel. Ensure this activity is added to the permit/operations plan.
5. The facility has a large stockpile of concrete. Mr. Coble stated that he plans to crush the concrete by ~ January 2014.

Stored concrete and wood area – material to be ground

6. When the facility permit is renewed/modified the operations plan should include operating procedures for the grinding and crushing activities.
7. The facility operations plan states that mobile homes are deconstructed at the working face.

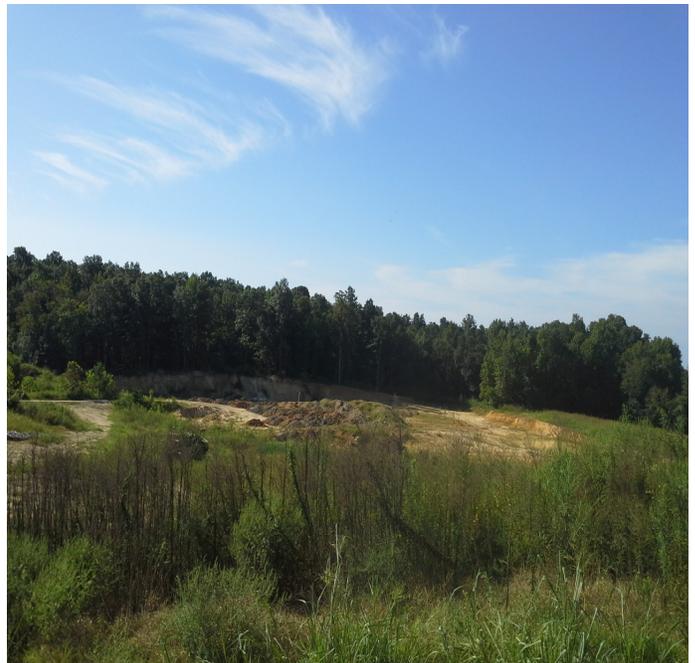
29. The facility obtains soil from a borrow area adjacent to proposed Phase 3B and when available from off site.
30. The Snow Camp and/or E.M. Holt Volunteer Fire Departments will address an emergency at the facility.

Soil borrow area
