FACILITY COMPLIANCE INSPECTION REPORT
Division of Waste Management
Solid Waste Section

Date of Site Inspection: February 10, 2014

Carolina Resource Recovery, Inc. Treatment and Processing Facility
 Jones Drive
 Mebane, NC 27302

Comprehensive Inspection

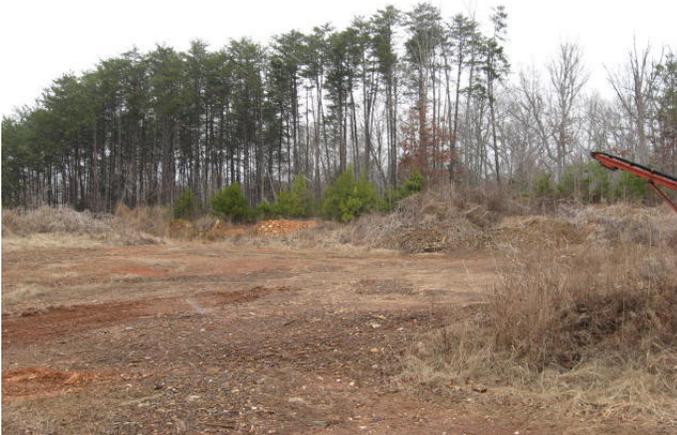
Soil screening area

10. Ensure overs from the screening process are reincorporated into the LCD process and storage area.
11. Land clearing debris is ground in the process and storage area. Mulch is generally sold soon after being obtained.

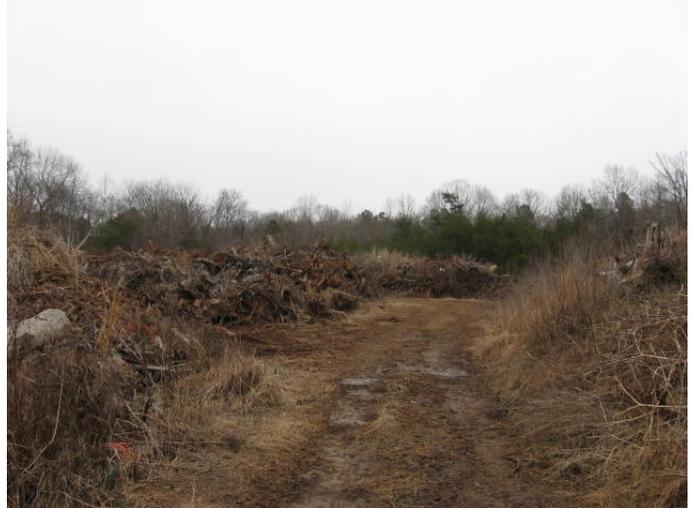
12. The LCD process and storage area piles appeared to be ≤ 33 feet wide and 16 feet high.
13. The LCD process and storage area shall maintain ≥ 20 feet row aisles. Ensure LCD that has encroached into the aisles is removed and the aisles are accessible year round.

LCD piles and access road

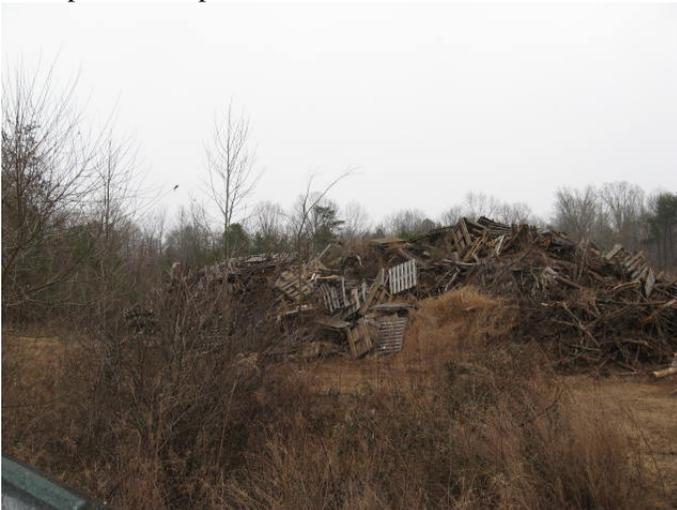
LCD pile – blue pallets to be removed

8. Blue pallets shall not be accepted. Ensure they are removed from the LCD process and storage area.
9. High carbon:nitrogen ratio material is formed into piles resembling windrows. The piles are left in-place, allowing vegetation to grow atop. Material is stored for ~ 18 months, turned ~ 3 times. Soil is collected from the piles during the turning operation and is stored until screened. Land clearing debris is ground twice a year or until enough is obtained to necessitate grinding.

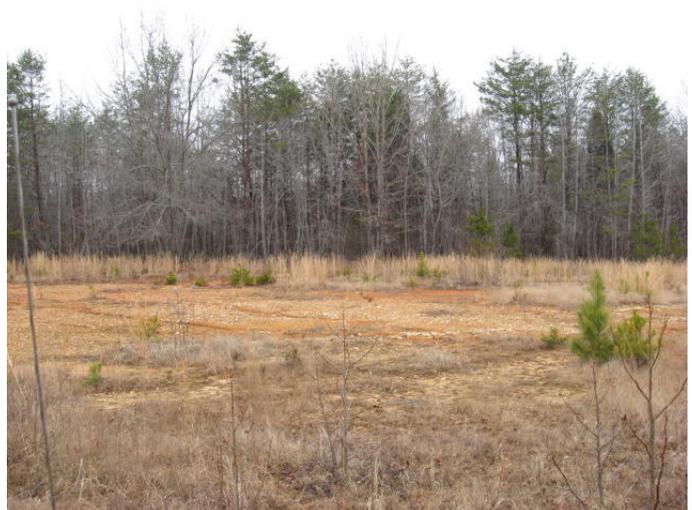
30. The TDDSS number is: DS01-001.
31. The area designated for the TDDSS consists of ~ 2.4 acres cleared of woody vegetation and ~ 2.4 acres containing trees.

TDDSS – cleared area

32. It is suggested that the remaining area available for the TDDSS be cleared of trees to increase the area available for debris storage during a disaster event.

33. It is suggested that the area available for the TDDSS be routinely mowed.
34. It is suggested that a site plan be maintained for the TDDSS, to include: a traffic pattern for ease of ingress and egress, material placement, equipment storage, waste screening activities, personnel facilities, etc.
