North Carolina Department of Environment and Natural Resources
Division of Waste Management

June 9, 2014

Re: Anson Cell 2B West Construction Project
Chambers Development MSW Management Facility,
Anson County, North Carolina
0403-MSWLF- 2010, DIN 21210

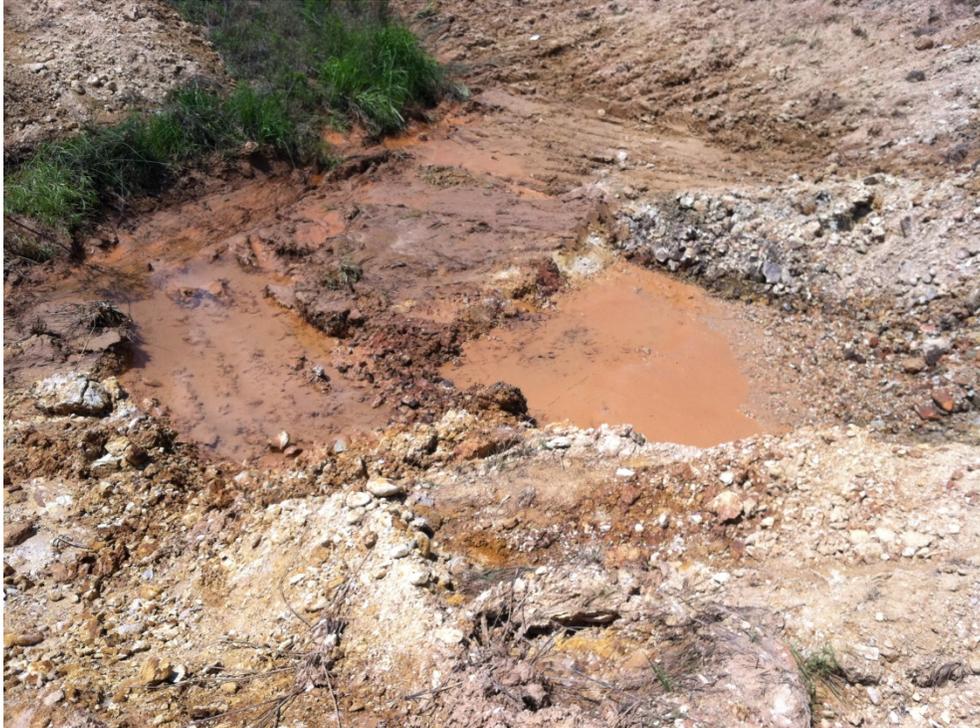
Photo 1 – Facing south – Wet area during initial excavation

Afterwards we inspected Cell 2B West in the field and discussed the need for the underdrain due to “perched water” conditions. This made the area unsuitable for liner construction. Therefore, to increase the stability of the liner the location and placement of the underdrain was approved by the Section.

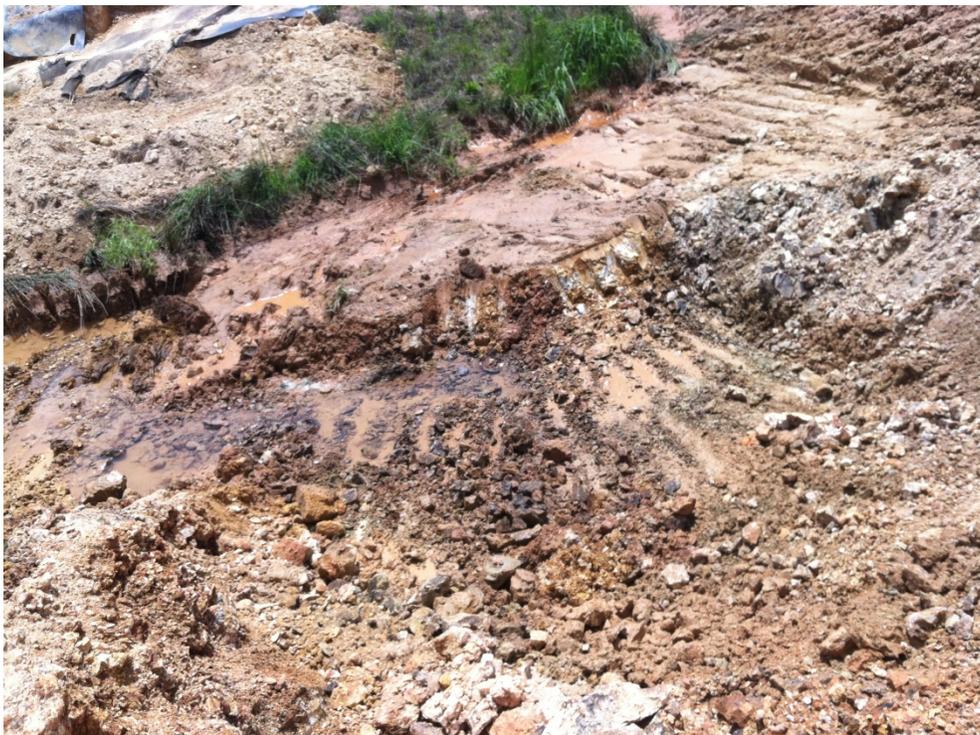
Photo 2 – Facing south – Wet area after final excavation, low area in center is elevation of perforated pipe and gravel column.

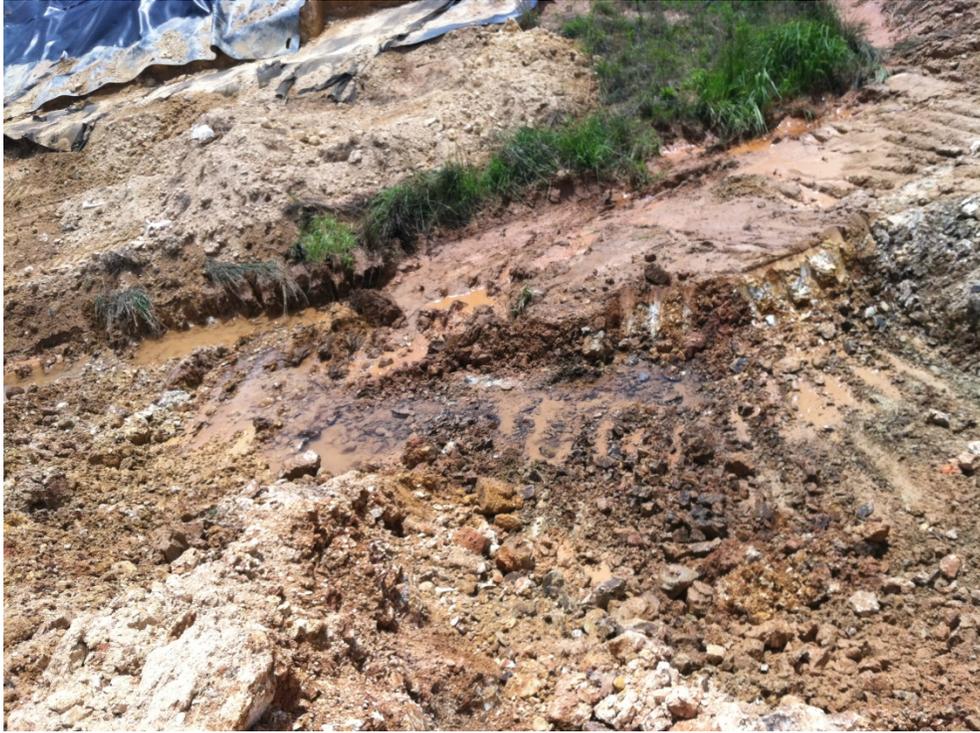
Photo 3 – Facing south – Wet area after final excavation, low area in right of photo is elevation of perforated pipe and gravel column.
