**FACILITY COMPLIANCE INSPECTION REPORT**  
**Division of Waste Management**  
**Solid Waste Section**

Buncombe County Solid Waste Management Facility  
 85 Panther Branch Road,  
 Alexander, NC 28701

Most recent permit activity: Amendment issued June 15, 2011 – 5-year renewal  
 Permit Expires: June 15, 2016  
 Units in operation: 1107-MSWLF-1996 (cell 6);  
 1107-CDLF- (Phase 4 vertical expansion); and  
 HHW Collection Facility

Comprehensive Inspection

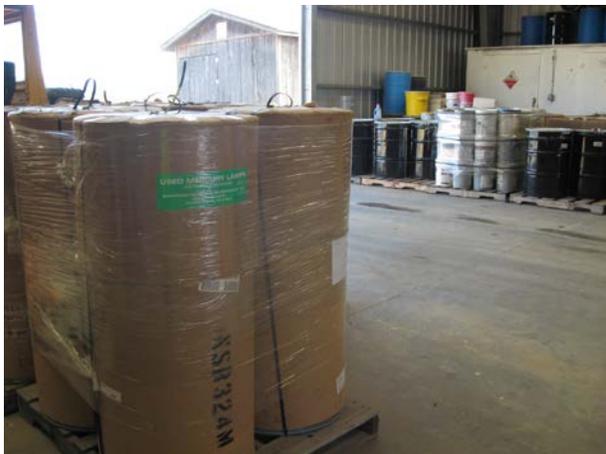
9. Alternate Cover Material (ACM) records were reviewed (being managed and maintained by S. Hunter) for 12/1/10 through 9/13/11.
10. The convenience center/drop-off area was well maintained with minimal windblown. Batteries and used oils were kept under cover.
11. The HHW/electronics/paint area was well maintained. Florescent lights were protected and containerized, electronics were maintained on pallets, paints are consolidated prior to removal from the facility. (see photo below)

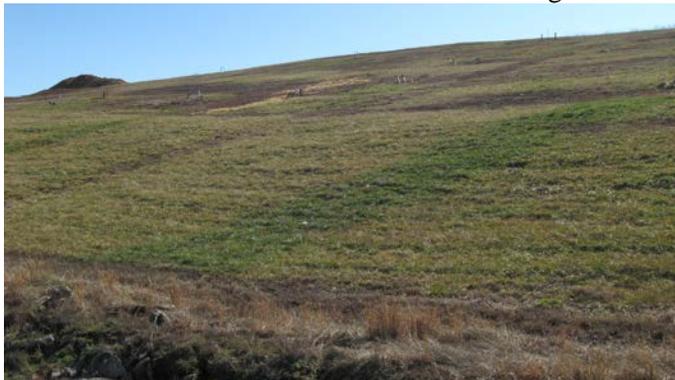
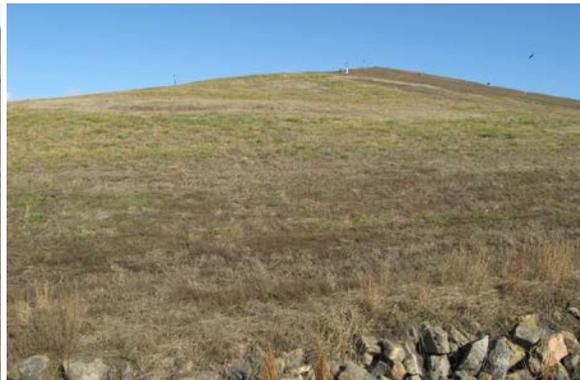
1/12/12

12. The white goods area was controlled and maintained. Propane tanks are collected in a separate roll-off container.
13. Erosion control features appeared to be maintained. Intermediate vegetation was established and maintained with a few areas around the leachate lines and gas headers in need of attention.

14. The mulch/T&P grinding area was established in a way to separate clean wood wastes from yard waste and the mulch generated from yard waste and the City of Asheville street sweepings was being utilized as ACM in accordance with the facility Operations Plan. Minimal unapproved materials were noted at this location. The drainage and surface water controls could use improvement.

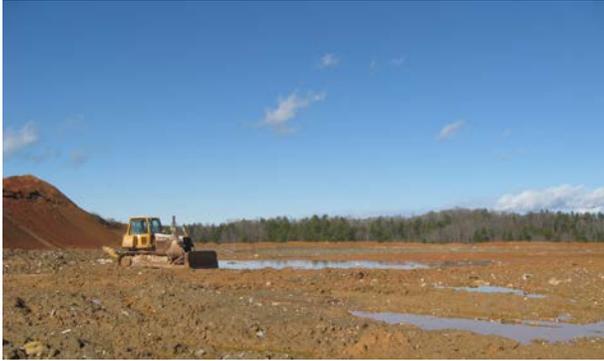
1/12/12

16. The working face of the MSWLF was inspected:
  - a. Recent heavy rain had contributed to some ponding at the working face – however, the facility is a permitted bioreactor which allows for controlled infiltration of surface water and recirculated leachate into the working face (through, in part, ponds and/or trenches). Additionally, the facility was preparing to lay horizontal leachate recirculation lines which required a level surface and which then increased the

occurrence of surface water retention.
