**FACILITY COMPLIANCE INSPECTION REPORT**  
**Division of Waste Management**  
**Solid Waste Section**

<b>UNIT TYPE:</b>										
Lined MSWLF		LCID		YW		Transfer		Compost	SLAS	<b>COUNTY: Chatham</b> <b>PERMIT NO.: 19-08</b> <b>FILE TYPE: COMPLIANCE</b>
Closed MSWLF		HHW		White goods		Incineration		T&P	FIRM	
CDLF		Tire T&P / Collection	<b>X</b>	Tire Monofill		Industrial Landfill		DEMO	SDTF

**Date of Site Inspection:** February 4, 2014

Metro Energy Corporation Scrap Tire Collection and Processing Facility  
 3313 Bowers Store Road  
 Silk Hope, NC 27344

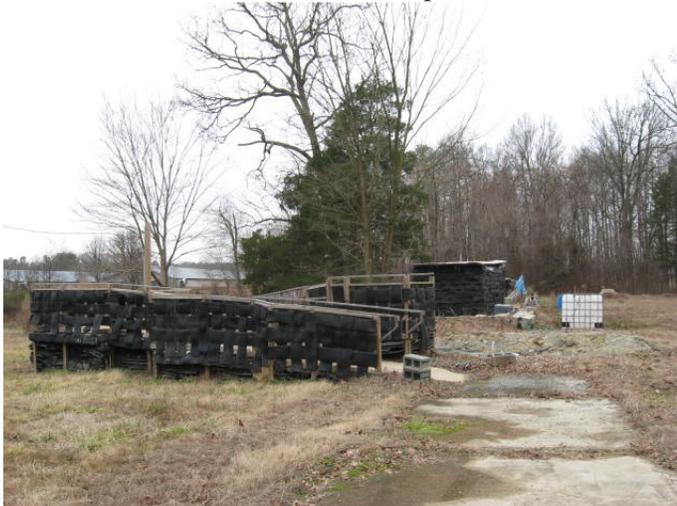
Mobile home [removed] access ramp (front view)

16. Processed tires were used in the construction of the mobile home access ramp. Mr. Tucker stated that the access ramp is an engineered-approved structure.
17. Processed tires were used to construct the first-row of a fence (right-rear of lot).
18. Mr. Tucker stated that he plans to place another building on site, making use of the access ramp, and continue construction on the processed tire fence.
19. It was agreed the access ramp and processed tire fence remain on site for future use/construction.
20. If the facility remains open, ensure a fire safety survey is conducted annually. Mr. Tucker stated that he has requested that a fire safety survey be conducted.
21. The Silk Hope Volunteer Fire Department will address an emergency at the facility.
22. The facility is secured by a chain.
23. The facility has proper signage.

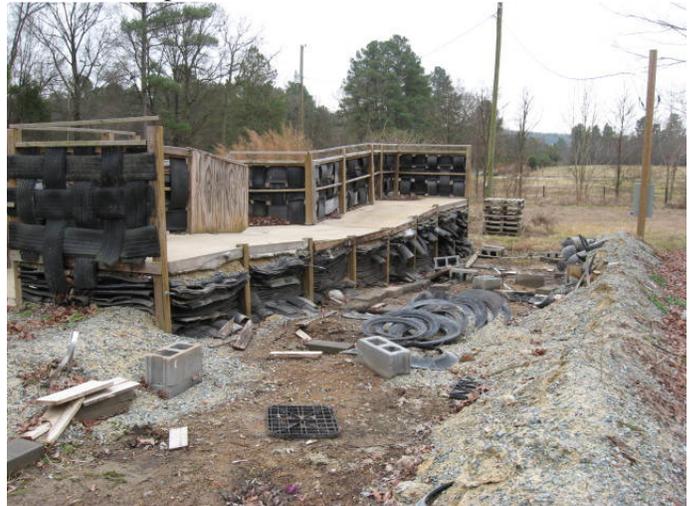
Access ramp (rear view) and soil foundation/berm

9. It was agreed that by March 14, 2014, Mr. Tucker will remove and properly dispose of/reuse the remaining processed tires in the scrap tire storage area, processed tires associated with the two dilapidated storage sheds, and any processed tires on the property not associated with the soil foundation/berm of the mobile home [removed]. Processed tires used in the construction of the foundation/berm shall be completely covered with soil.

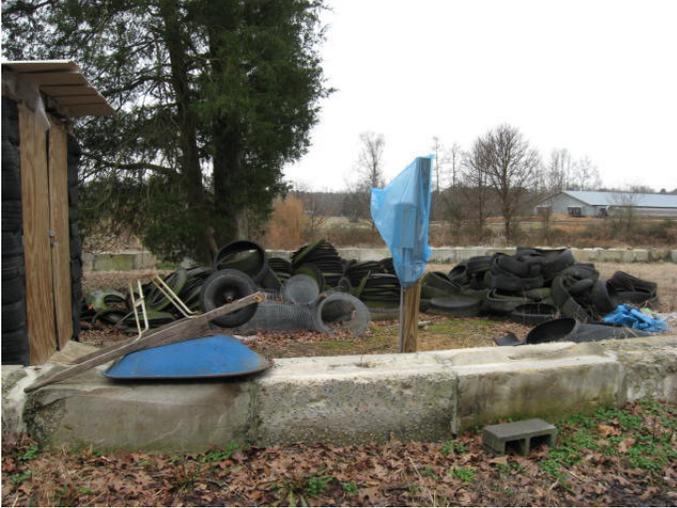
4. There were three small piles of processed tires (doughnuts, alligators, and sidewalls) in the scrap tire storage area. The processed tires equate to ~ 50 scrap tires.

6. At the time of the inspection there was grass in the scrap tire storage area. Ensure the scrap tire storage area is kept free of grass, underbrush, and other potentially flammable vegetation [and items] at all times.

Processed tires (cut into doughnuts, alligators, and sidewalls) in scrap tire storage area

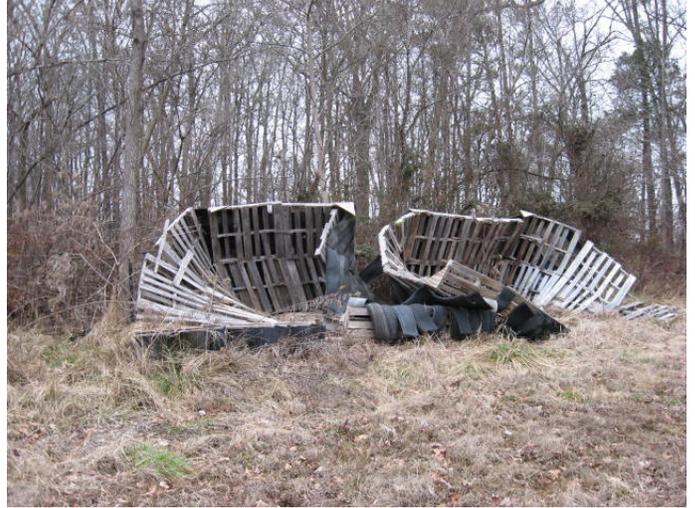
Two dilapidated storage sheds

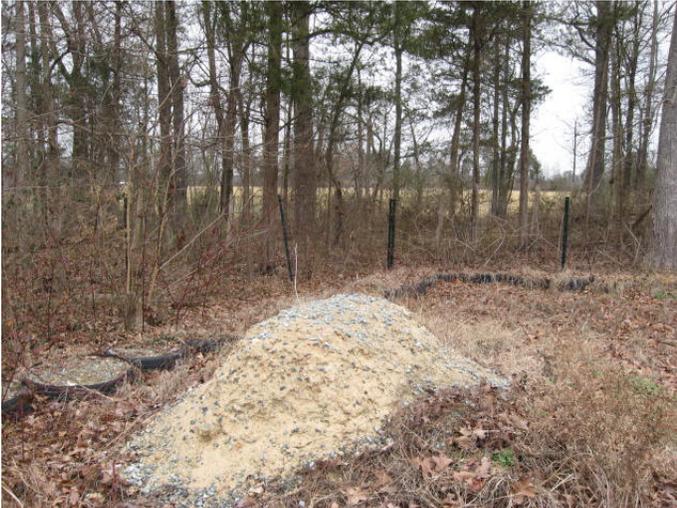
Processed tires ("L" pattern atop ground),  
1<sup>st</sup> row of fence
