FACILITY COMPLIANCE INSPECTION REPORT
Division of Waste Management
Solid Waste Section

Craven Land Clearing and Inert Debris Landfill (LCID Landfill)
 356 Sanders Lane
 Clarks, NC

Comprehensive Facility Compliance Inspection

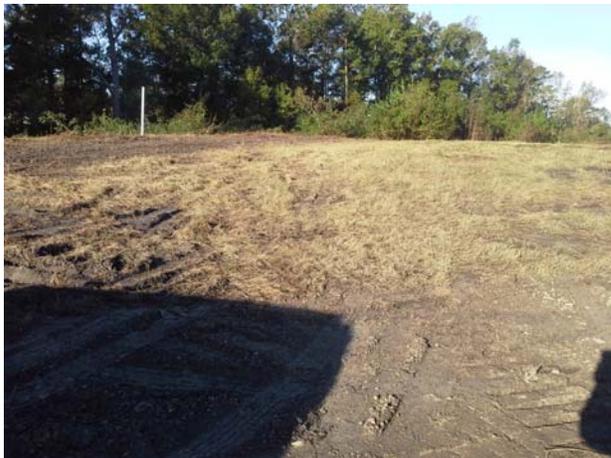
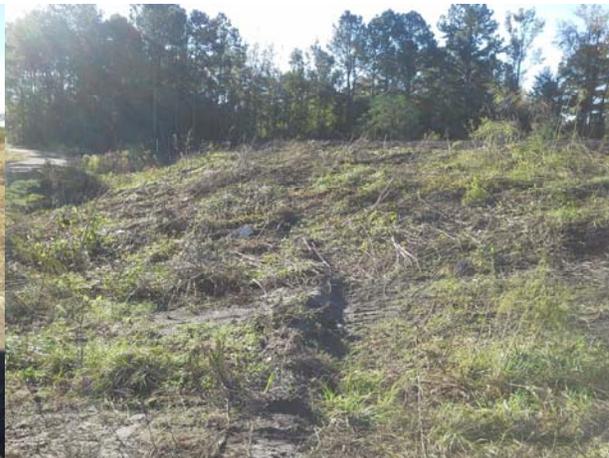
- 5) Overall, the Facility sideslopes have a well-established coppice-type cover crop of native warm season grasses. Some small trees, brush, and other woody vegetation was observed growing on the landfill sideslopes. The Facility operator has made much progress in removing the trees, brush and other woody vegetation. *As per our conversation, please continue working to remove all trees, brush, and woody vegetation from all landfill sideslopes and maintain a cover crop suitable to prevent erosion of your landfill cap system.

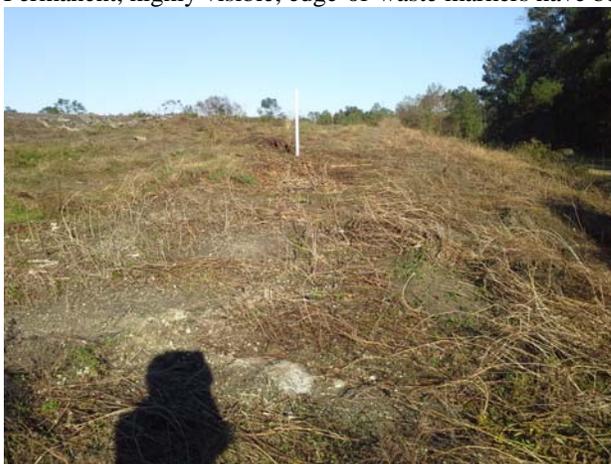
6) Permanent, highly visible, edge-of-waste markers have been placed delineating the landfill waste disposal area.
