FACILITY COMPLIANCE INSPECTION REPORT
Division of Waste Management
Solid Waste Section

Date of Site Inspection: 12 March 2014

Cieszko Construction Company LCID Landfill
 NC Hwy 101 Havelock, NC

Comprehensive Facility Compliance Inspection

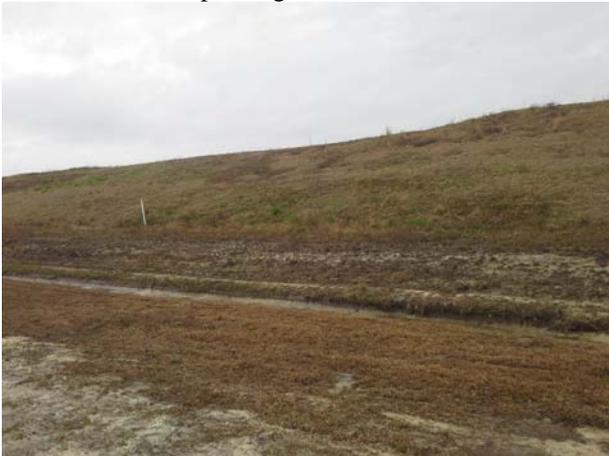
- 7) The surface water ditches have recently been cleaned and were free of excess vegetative growth and appear to be functioning properly at this time.
- 8) This Facility has highly visible, permanent, edge-of-waste markers in place delineating the landfill waste disposal footprint.
- 9) Overall, the Facility sideslopes have a well-established cover crop of native warm season grasses and are being maintained at a slope not greater than 3:1. No areas of erosion were noted during this Facility Compliance Inspection.

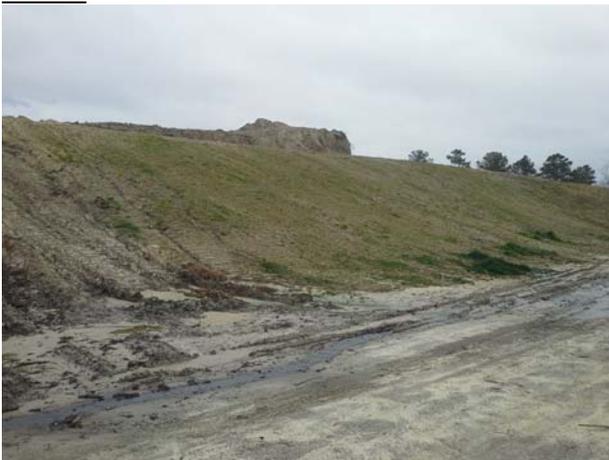
- 10) Portions of the landfill sideslopes have recently been covered, graded, and seeded. The newly seeded cover crop has germinated. *Please monitor these areas to ensure that a cover crop suitable to prevent erosion of your landfill cap system is properly established. Please re-seed and mulch any areas where the cover crop fails to properly establish and prevent erosion.

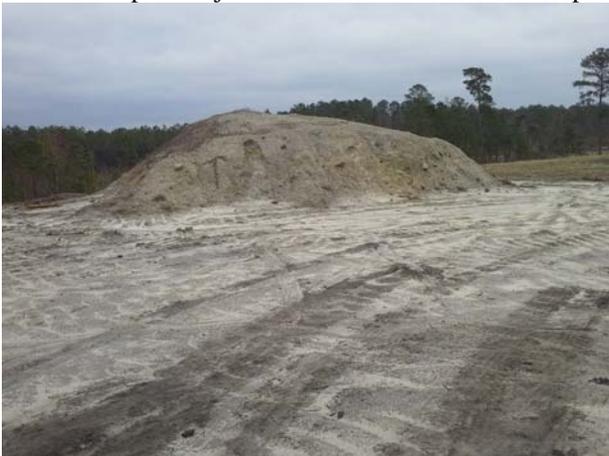
- 11) Soil is stockpiled adjacent to the landfill and on the top lift in an area adjacent to the active working face for use as cover.

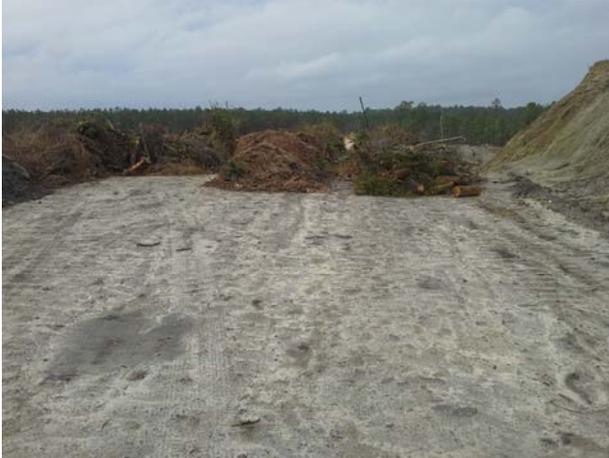
13) The active working area is compact and well managed at this time.
