FACILITY COMPLIANCE INSPECTION REPORT
Division of Waste Management
Solid Waste Section

Snow Hill LCID Landfill, Claude Lee Road Road, Hope Mills, North Carolina 28384

PURPOSE OF SITE VISIT: Comprehensive Inspection

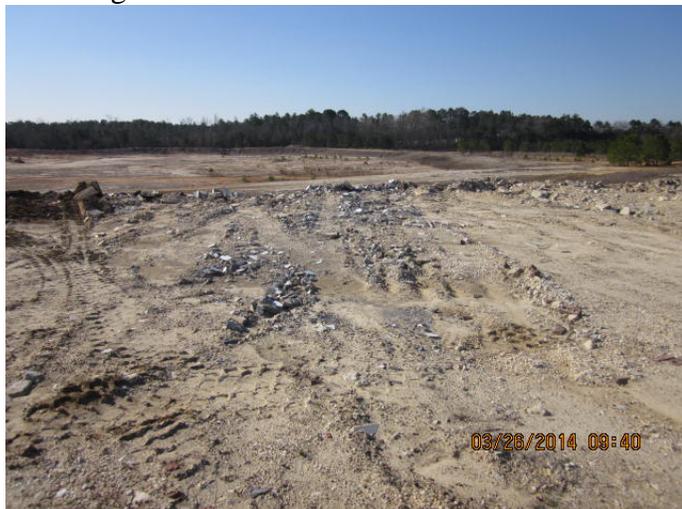
3. Excavation, grading and fill material side slopes shall not exceed 3:1. Vertical side slopes with exposed waste was observed at the landfill during this inspection.

South side facing E. Exposed waste, painted.

11. All exposed waste must be covered and provisions for a ground cover sufficient to restrain erosion accomplished within 30 working days.
12. **The permitting branch has not received the registered professional engineer's certification that this landfill has been constructed in accordance with the approved plans. Submit the written certification that the waste disposal unit has been constructed in accordance the permit and approved plans to Elizabeth Werner Permitting Branch (919-707-8253).**

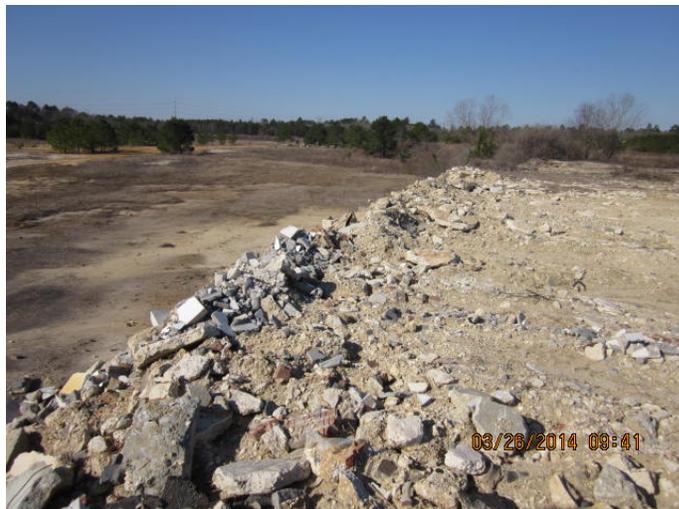
8. The facility shall only accept those solid wastes which it is permitted to receive. Unacceptable waste (i.e.: plastic, metal and painted block) was observed in the landfill during this inspection. **All unacceptable waste must be removed and disposed of properly at a facility permitted to receive the waste. Recommend staff responsible for dumping at or operating the landfill receive training on the permit conditions and operations plan for this facility to ensure unacceptable waste is removed right away.**

Painted block and metal south side slope facing SW.

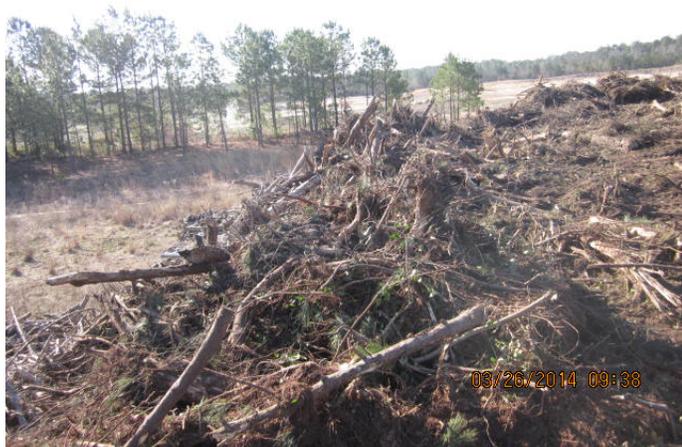
4. **Solid waste shall be restricted to the smallest area feasible and compacted as densely as practical into cells.** There are two working faces at this landfill. One for yard waste and one for inert debris and asphalt.

Working face (YW) facing E.

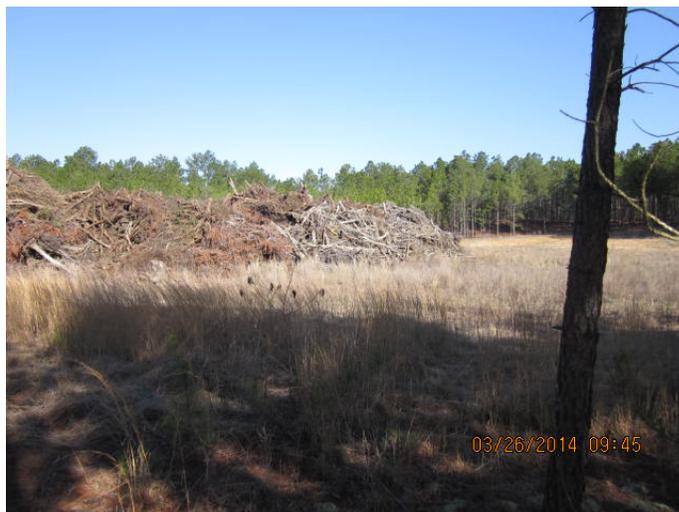
Working face (YW) facing NW.

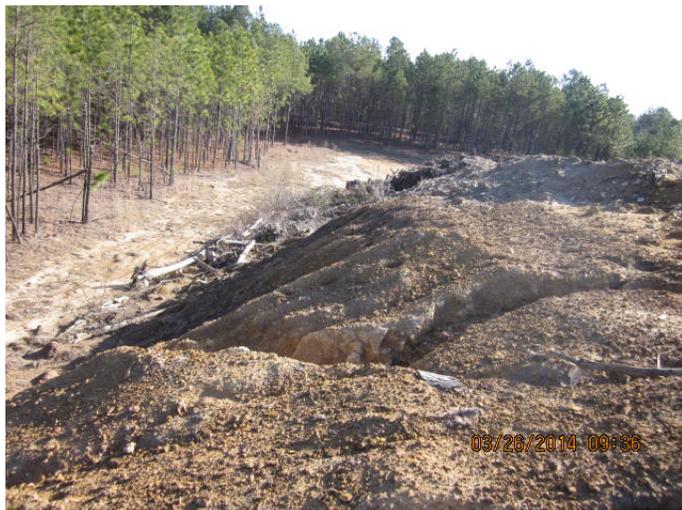
Erosion on side slopes and top of waste NE end.

9. Provisions for ground cover sufficient to restrain erosion must be accomplished within 30 working days or 120 calendar days upon completion of any phase of landfill development.

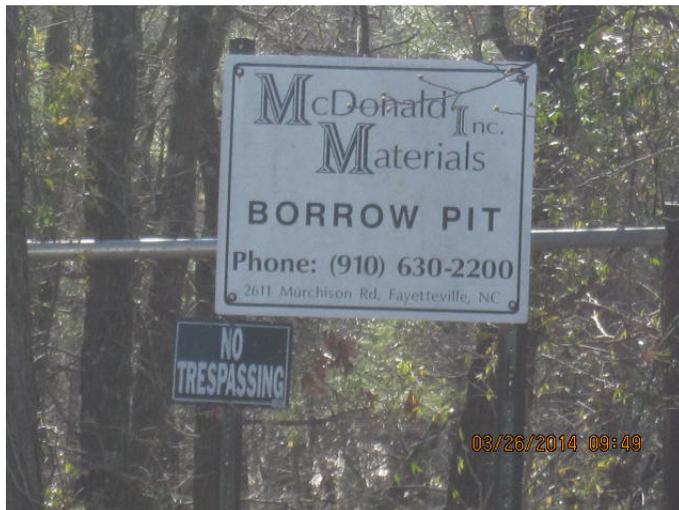
1. This is a landfill that requires a permit, thus the sign posted at the entrance needs to be corrected in accordance to the rule.
2. It appears that the trees have been cleared for the landfill footprint. Ensure that any grading activities in this area did not reduce the separation of the fill area to the groundwater.

Sign at gate to be corrected, needs permit number.

- 5. 15A NCAC 13B .0566 (4):** Adequate soil cover shall be applied monthly or when the active area reaches one acre in size, whichever occurs first.
- 6. 15A NCAC 13B .0566 (16)** states that "A sign shall be posted at the facility entrance showing the contact name and number in case of an emergency and the permit number. The permit number requirement is not applicable for facilities not requiring an individual permit."
