FACILITY COMPLIANCE INSPECTION REPORT
Division of Waste Management
Solid Waste Section

Dare County Landfill
 NC Highway 64 West
 East Lake, NC

Inactive; Closed MSWLF under Subtitle D

Partial Facility Compliance Inspection

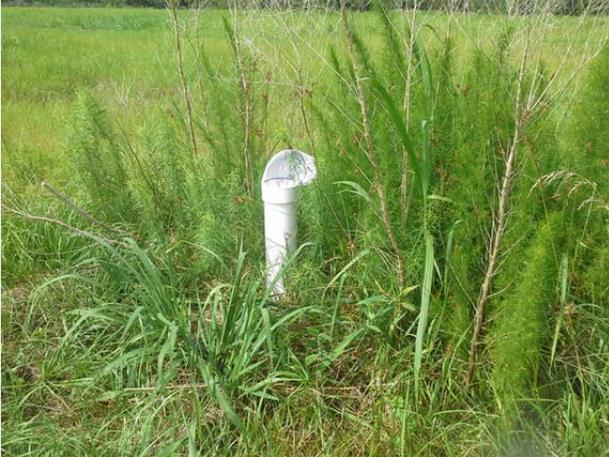
- 5) Permanent, highly visible, Edge of Waste markers are in place and are being maintained as required.
- 6) This Facility manages landfill gas through a passive venting system. Brush and woody vegetation has been allowed to grow around some of the vents and one of the vents was observed as having the top broken off. *Please clear the area around the vents of brush and repair the broken vent as soon as possible. To prevent damage to the vents by maintenance equipment, please ensure that the area around the vent system is maintained clear of high grass and brush.

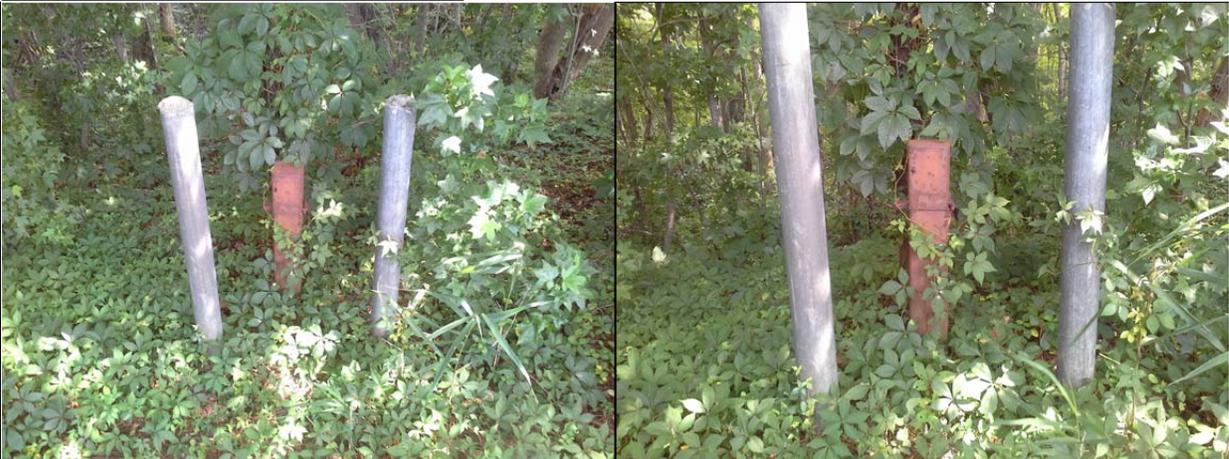
- 7) The Facility monitoring wells were reviewed. Access to some of the wells has grown up with brush. Some of the wells were unsecured and lacking functioning locks. *Please clear the access to all wells and ensure that they are properly labeled and secured with functioning locks.

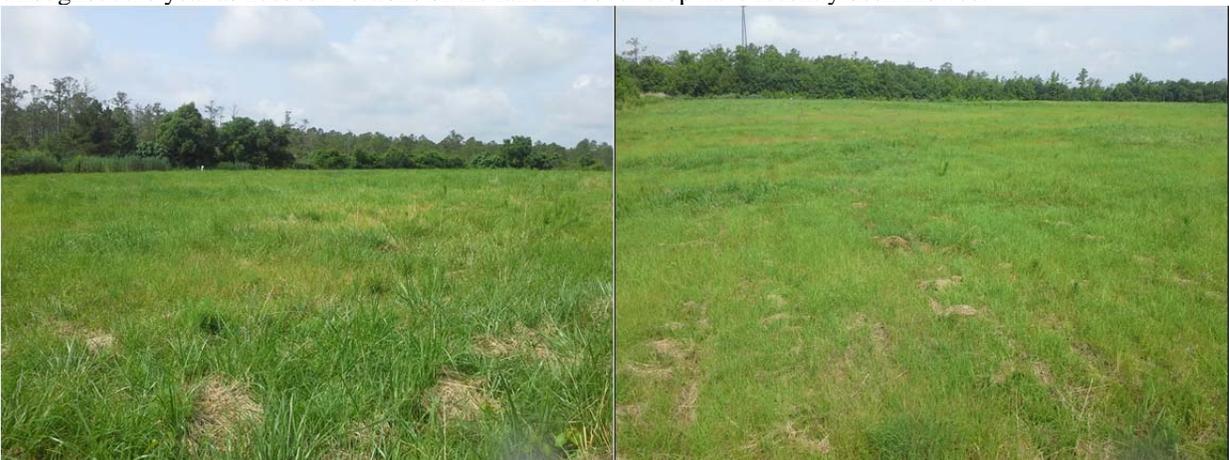
- 8) Overall, this Facility has a well-established cover crop of native warm season grasses. The cover crop is mowed throughout the year as needed. Portions of the landfill cover crop have recently been mowed.

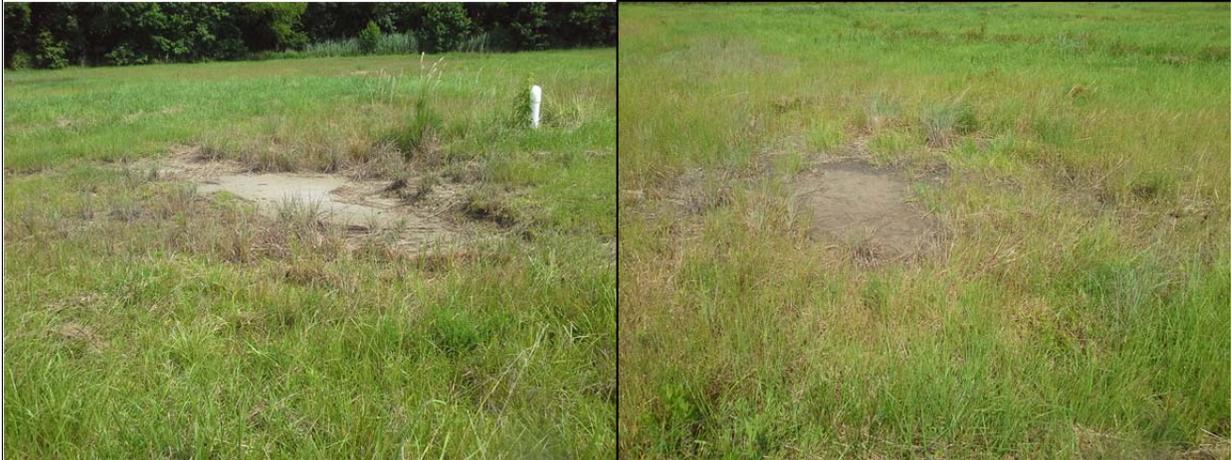
- 9) Several areas of sparse cover were observed. *Please seed and mulch these areas to establish a groundcover suitable to prevent erosion of your landfill cap system.

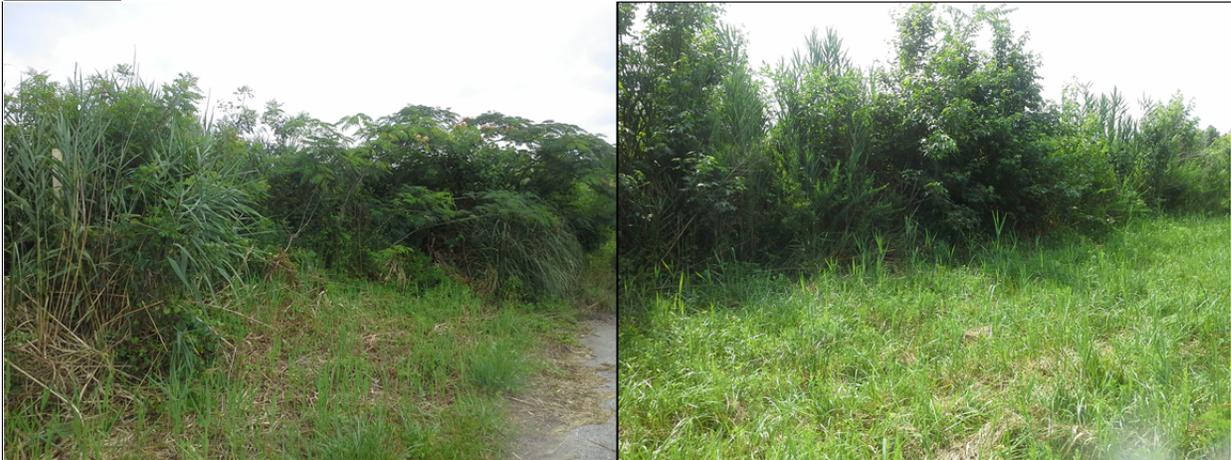
- 10) Brush and other woody vegetation were observed growing on portions of the Western, Southern, and Eastern sideslopes. *The mowing machine was out of service for repairs during this Facility Compliance Inspection. As soon as possible, please complete mowing operations by mowing all Facility sideslopes and removing all brush and other woody vegetation.

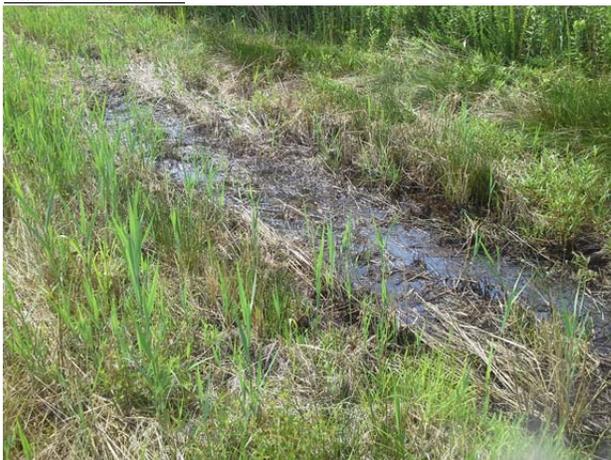
- 11) Areas of differential settlement were observed in several areas around the landfill. Some of these areas were observed retaining surface waters. *Please fill and graded these areas to promote the positive drainage of all surface waters away from the landfill.
