FACILITY COMPLIANCE INSPECTION REPORT

Division of Waste Management Solid Waste Section

Dare County C&D Landfill
 1603 Cub Road
 Manns Harbor, NC 27953

2803-20140625INSP

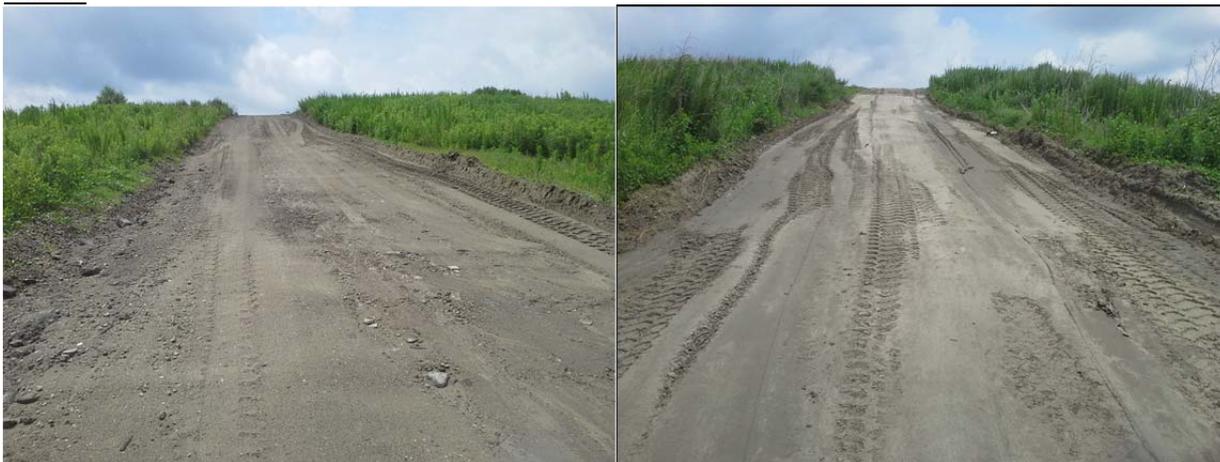
- 10) Permanent Edge of Waste markers are in place and are being maintained as required.
- 11) Facility monitoring wells were reviewed during this Facility Compliance Inspection. All the wells were readily accessible, properly labeled, and secured with functioning locks.
- 12) The seep that was observed near the western access road at the toe of Cell #3 has been repaired. No further seeping was observed.
- 13) The erosion was noted in the previous Facility Compliance Inspection Report (2803-20140514INSP) as being observed on the access road to the top of Cell #3 has been repaired. *Please monitor these areas for erosion and make repairs as needed.

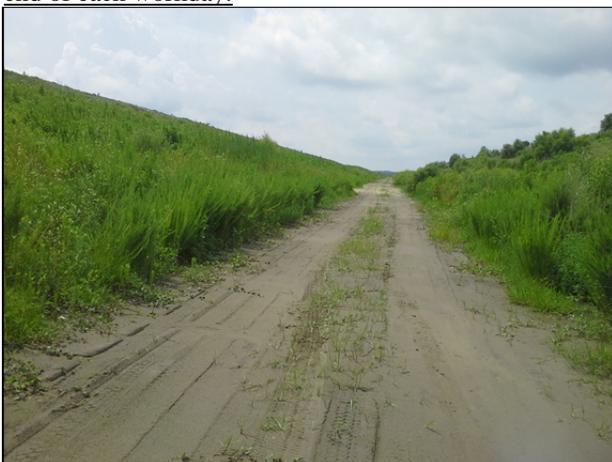
- 21) Cover on the sideslopes of Cell #4 was much improved; however, waste coverage was still incomplete at the transition to the current active lift. *Please ensure that all waste is adequately covered and that the soil cover is maintained on all Facility sideslopes.

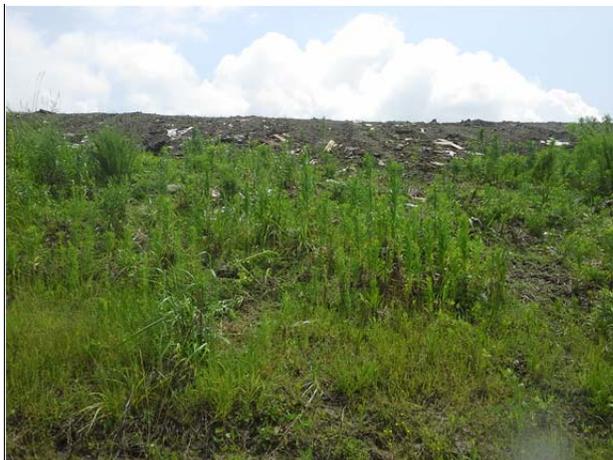
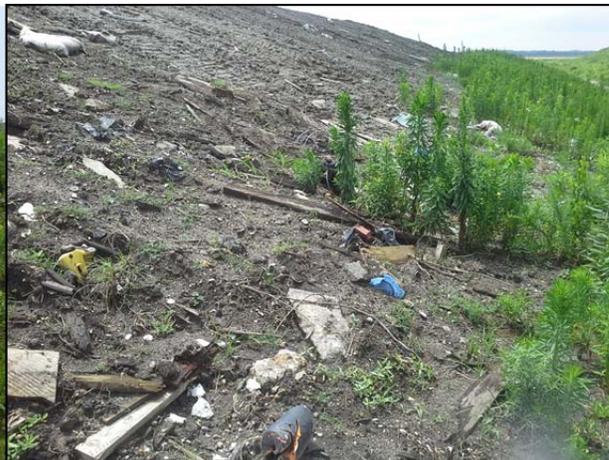
- 22) Overall, the closed areas of the landfill have a well-established cover crop of native warm season type grasses.
- 23) Brush and other woody vegetation was observed growing on the sideslopes of closed Cell #3. *The mowing machine was out of service for repairs during this Facility Compliance Inspection. As soon as possible, please complete mowing operations by mowing all Facility sideslopes.
