FACILITY COMPLIANCE INSPECTION REPORT
Division of Waste Management
Solid Waste Section

Date of Site Inspection: September 10, 2013 (Site Meeting) **Date of Last Inspection:** June 27, 2013

Currin Brothers, Inc. LCID Landfill No. 2
 1810 Coley Road
 Durham, NC 27703

Comprehensive Inspection/Site Meeting

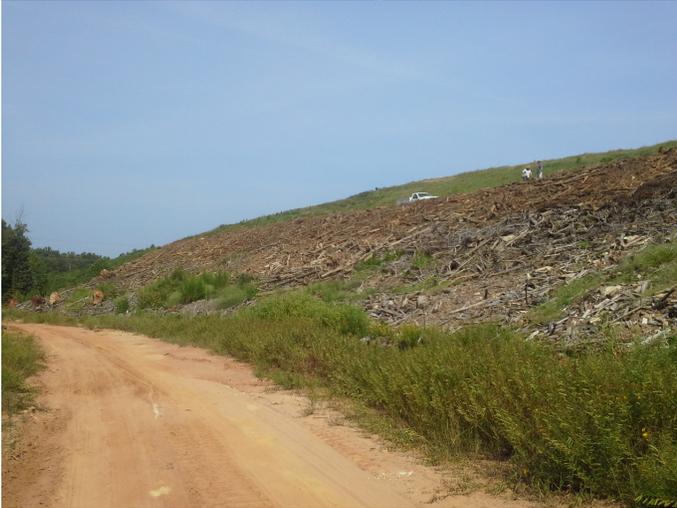
9. The facility primarily receives land clearing debris (LCD).
10. At time of inspection the open area/uncovered LCD was approximately 435' long and 54' high totaling 23,490 ft² or > ½ acre.

Intermediate uncovered side slope (~23,490 ft²)

16. The intermediate side slope appeared compacted although the upper layer of LCD was uncovered.
17. The facility and its consultant are in discussion with SWS-Permitting Branch regarding an alternative method of managing LCD at this location. If the facility does not obtain approval for an alternative method of operation, the LCID landfill rules must be adhered to within 30 days of notification by the permitting branch.

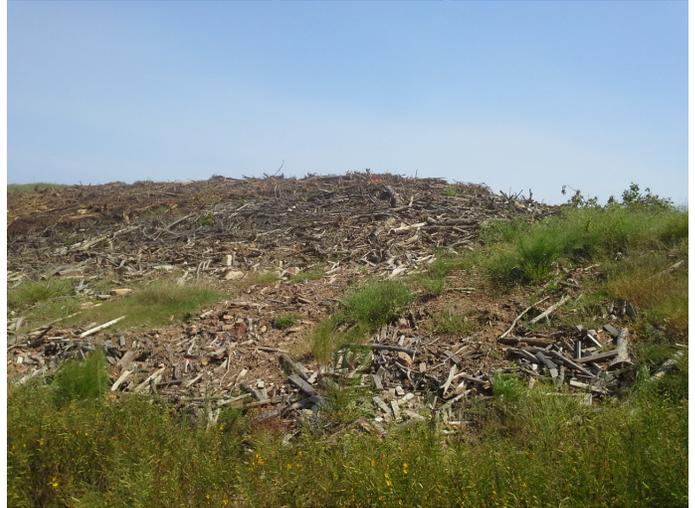
13. The LCD on the intermediate side slope is compacted such that soil (naturally occurring in LCD, overs from atop the landfill, and transferred onto the side slope during rainfall) fills the voids between the material. After which, only the top layer of LCD is uncovered. As the height of the intermediate side slope expands, LCD left uncovered at the base is buried somewhat flush within the soil/at grade.

14. Uncovered LCD at the base of the intermediate side slope has been in place for ~ 1 year. As each bench is constructed the depth of LCD uncovered increases, from bottom to top/active area.

Intermediate side slope, bottom - top

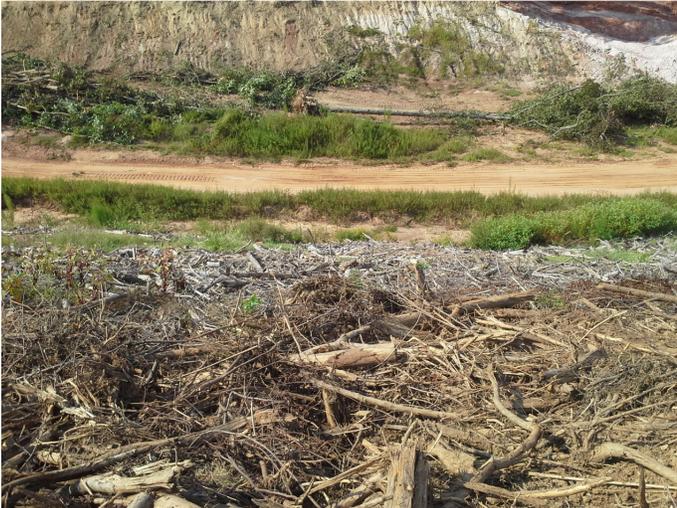
Intermediate side slope, top – bottom

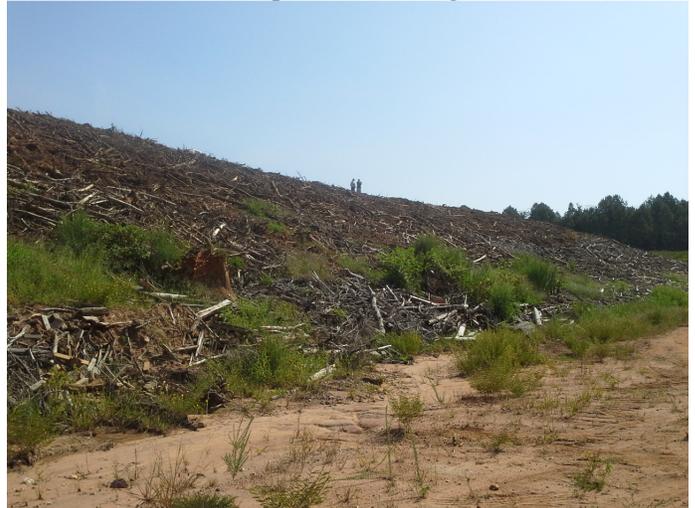
11. Material received is placed in benches. When a new bench is created LCD is placed atop soil covering the previous bench. Material is compacted into ~ 10 foot lifts, expanding laterally towards the side slope of the previous bench. The LCD constituting a bench is routinely compacted and covered with soil. As it expands, the side slope/working face is covered with additional material.

Intermediate side slope, ~ 54 feet high (~ 10 foot lifts)
