FACILITY COMPLIANCE INSPECTION REPORT
Division of Waste Management
Solid Waste Section

Date of Site Inspection: July 26, 2013

Edgecombe Co. MSWLF Transfer
 2797 Colonial Road
 Tarboro, North Carolina 27886

Comprehensive Audit

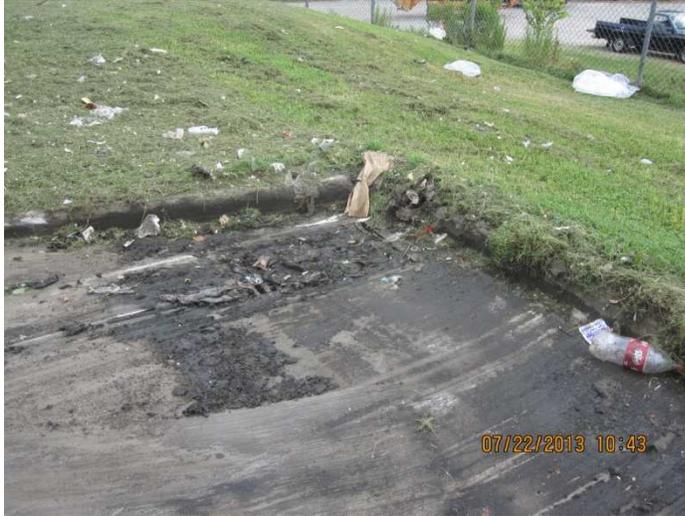
Grate for drain from turn ramp. Trash and anything that falls on the ramp is washed toward the grate conveyed down a pipe and onto the ditch around the base of the transfer building. A method needs to be found to screen runoff so waste is not washed down the grate or into the ditch.

11. **Cummings indicated that plans have been discussed to fill and pipe the ditch on the eastern side of the building. This ditch tends to collect blown waste and is difficult to clean. Covering the ditch will not prevent waste from being washed into the pipe from the turn ramp.**

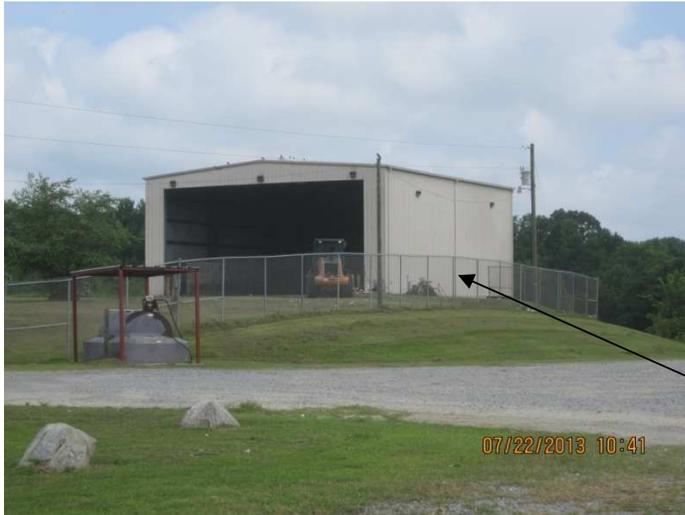
The wind fence on the eastern side of the building needs to be extended to the building wall.

9. There were two fire extinguishers in the transfer building, both were charged. There is also a 1 ½ inch hose bib inside the building.
10. **The wind fence on the eastern side of the building needs to be extended to the wall of the building.**

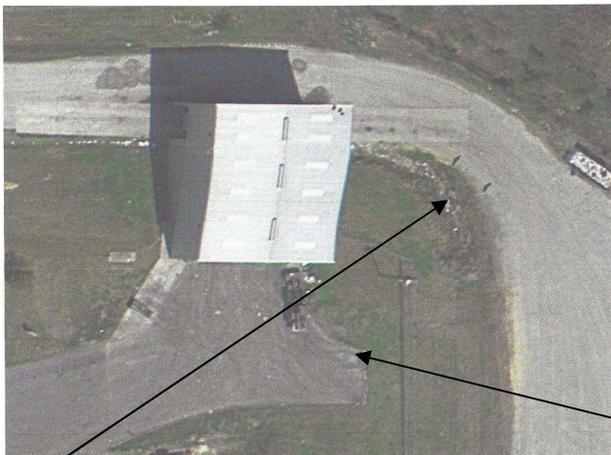
Location of the grate draining the haul ramp
The area to the east of the facility has problems with trash being washed and blown down into the ditch on the eastern side of the property.
