FACILITY COMPLIANCE INSPECTION REPORT
Division of Waste Management
Solid Waste Section

Date of Site Inspection: September 12, 2013

Franklin County Transfer Station
 10 Landfill Road
 Louisburg, NC 27549

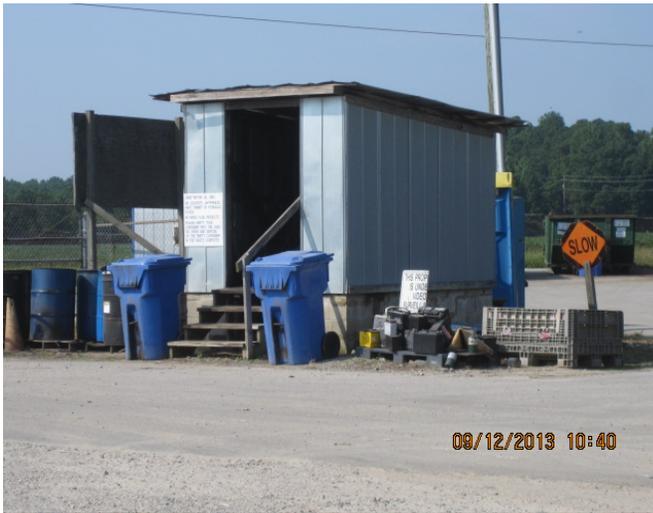
Battery and used oil recycling at convenience site on property

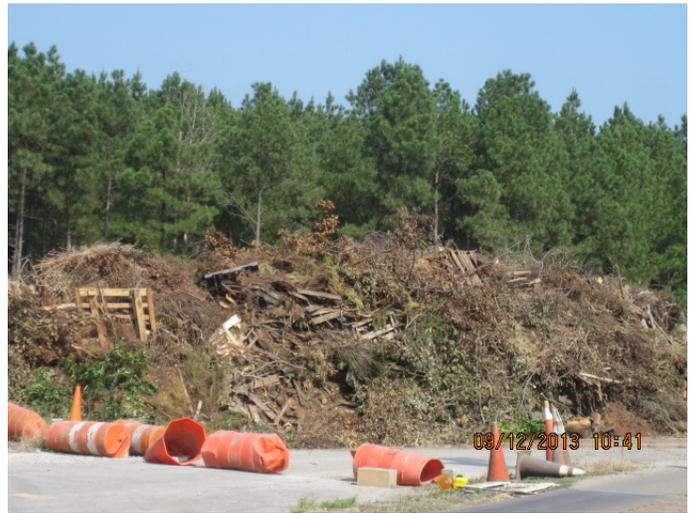
Yard waste area- ground for boiler fuel

13. Waste Screening is being done and records were reviewed.
14. The Yard Waste is ground one or two times a year and the material is taken away as boiler fuel. The area did not have waste in water during this inspection, but **insure site is graded to promote positive drainage away from the waste.**

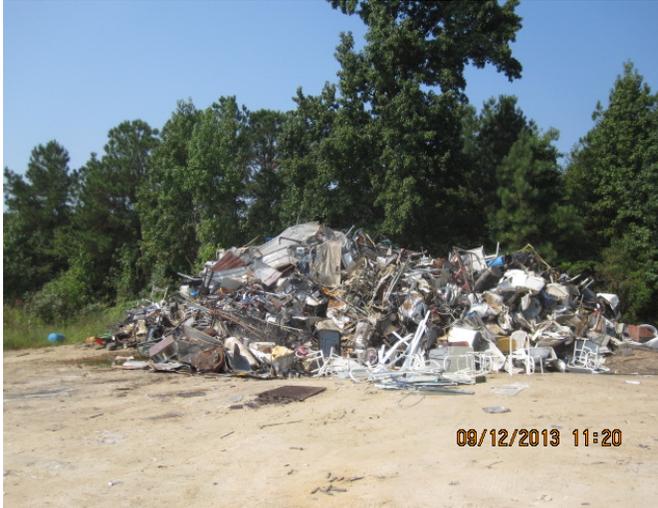
White goods area- pad strongly recommended

5. There was some windblown around the site. Windblown is to be picked up on a daily basis.
6. The paperwork showing CFC removal was not checked during this visit. CFC's are removed by the scrap contractor. The scrap shall not be in water, the area needs to be graded to promote positive drainage away from the waste. **The pile of broken scrap pieces mixed with soil is to be removed and disposed of at a permitted facility.** It is strongly recommended that a white goods pad be installed. Contact Bill Petrakis, NCDENR, 919-707-8290, for information on a white goods grant.

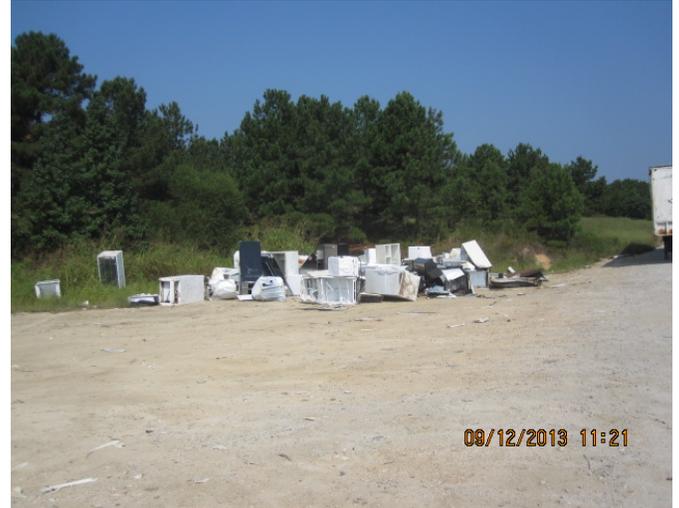
Refrigeration units to have CFC's removed

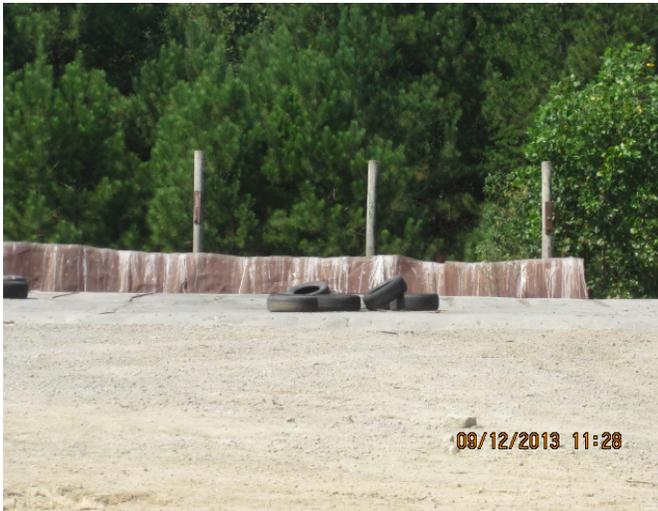
Tire drop off area at old transfer station

7. The scrap tires are being removed within 10 days. The old transfer facility is used for the unloading of citizens tires into the open top trailer.
8. The facility's leachate tanks are checked weekly. I would recommend that the grass, directly over the leachate collection tanks, must be mowed to insure adequate observation. **A log must be kept, showing dates of checking and removal.** The removal of the grease is done by Noble and done monthly. The removal of leachate to the waste water treatment plant is done monthly (depending on weather conditions) by Bailey. **Records, including the date and the amount of leachate removed by Bailey and taken to the wastewater treatment plant, must be available.**

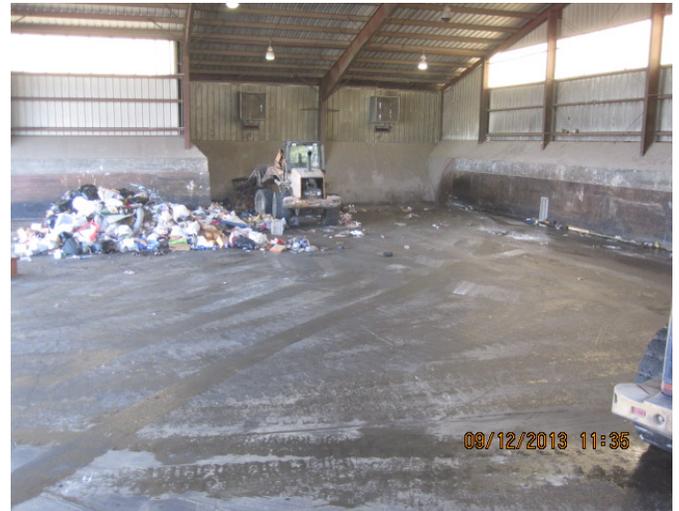
Tipping floor at transfer facility

9. Bids are being taken on the repair of the tipping floor. The floor is not in good repair at the area of the metal plate at the edge of the loading bay.

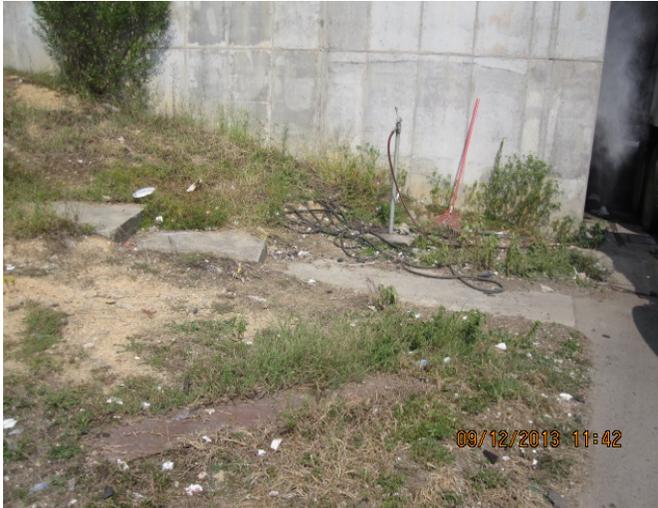
Areas outside of trailer loading area- need to be raked on a more frequent basis

1. Municipal waste may be stored on-site in leak-resistant trailers, with watertight covers, a maximum of 24 hours except that minimal amount of waste may be stored for a maximum of 72 hours when the facility is closed during a weekend or holiday. Storage of waste must not cause any nuisance, such as odor or attraction of vectors. The loaded trailers were not covered. The Operator stated that the hauling company covers prior to hauling. **Corrective actions are needed to ensure the trailers are covered after being removed from the transfer trailer loading area.** A vulture was observed on the waste in one of the trailers.

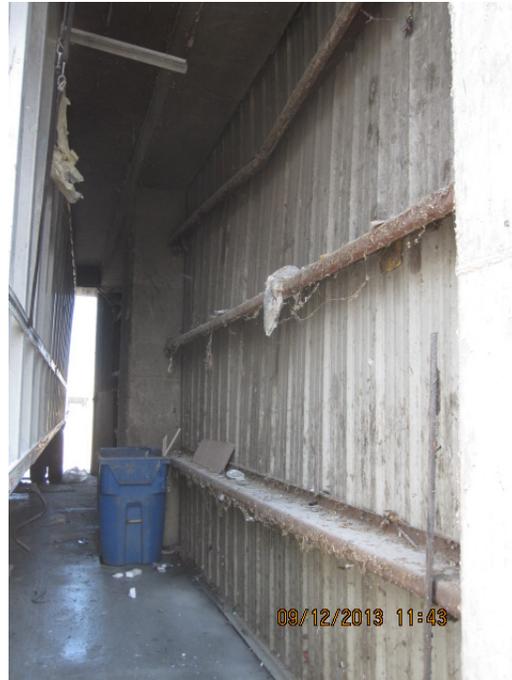
Wall behind trailer in loading area- needs to be cleaned on a more frequent basis

10. The interior of the walls and the metal cross beams in the loading area need to be cleaned on a more frequent basis. The facility needs to be maintained in a clean and sanitary condition.

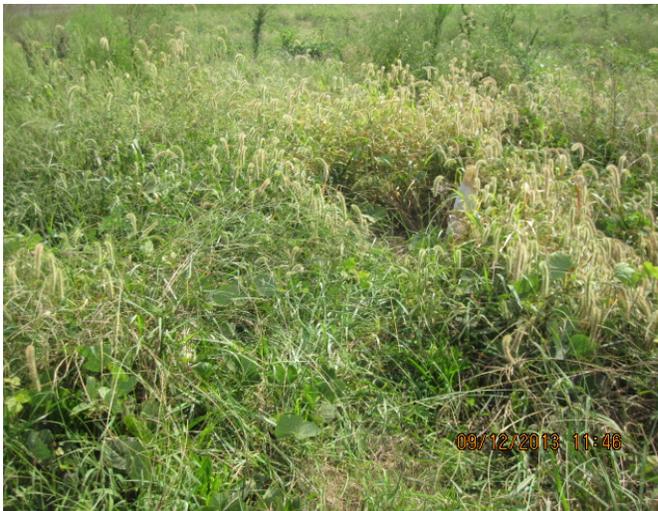
Grass above leachate tanks to be kept mowed

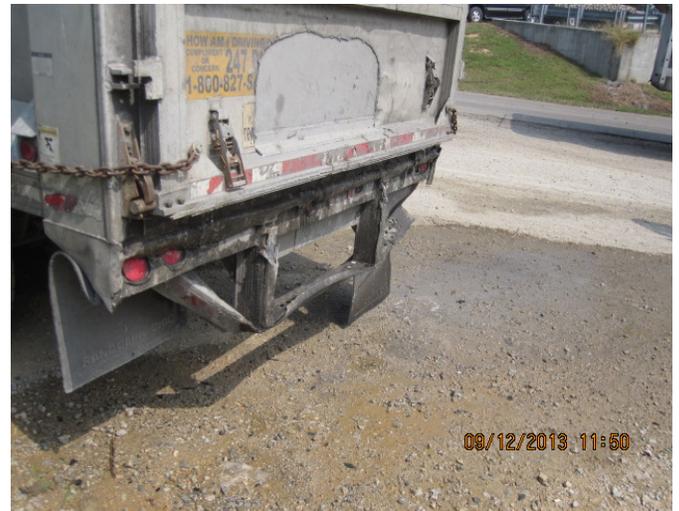
Loaded trailer leaking leachate

2. One of the loaded trailers parked on the slope was leaking leachate. The gravel driveway was wet from the leaking trailer down approximately 75 feet and then ended up going into the grassy area to the outside of the gravel access road. **Corrective actions need to be underway to ensure trailers are leak resistant.** Trailers that are leaking need to be repaired. A plan needs to be developed that will address corrective actions that could include placing a container under the leak and collecting the liquid to be disposed of in the leachate collection system.

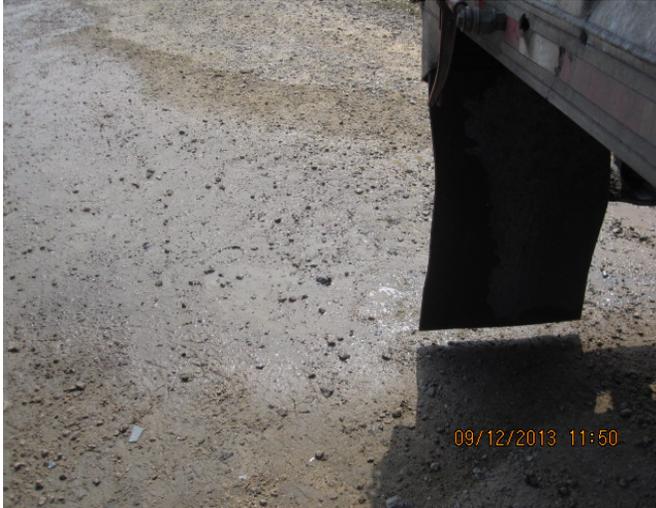
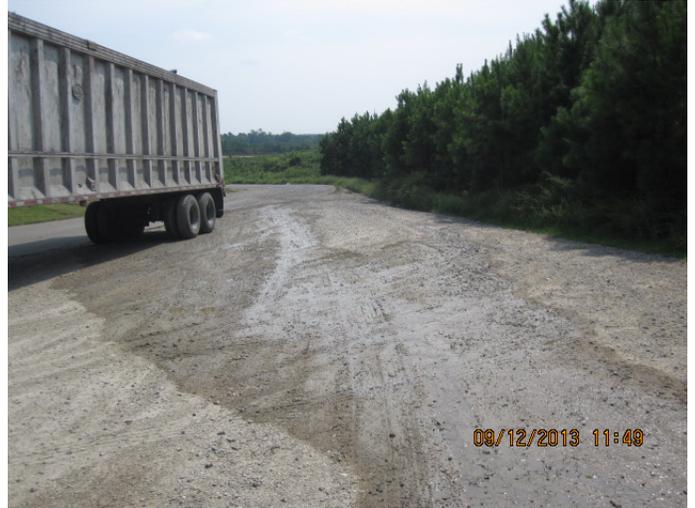
Leachate from loaded trailer going down gravel access road, about 75 feet, to grassy area on right

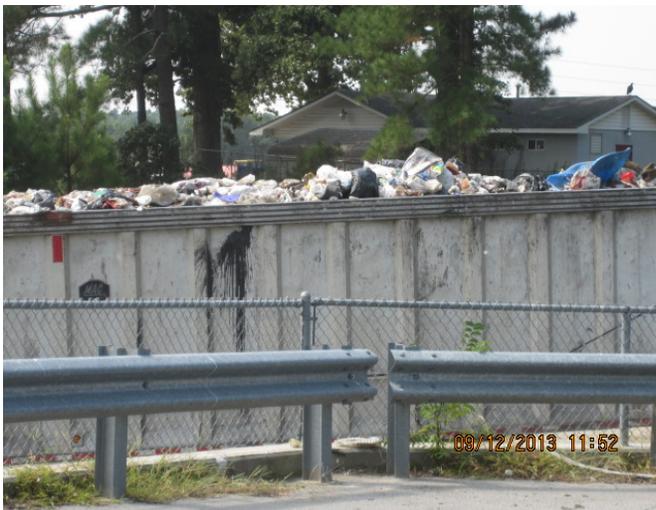
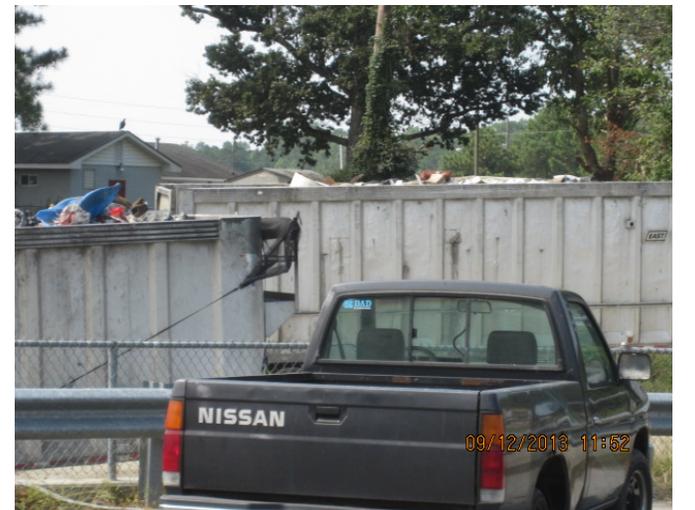
Loaded trailers with no covers
