FACILITY COMPLIANCE INSPECTION REPORT
Division of Waste Management
Solid Waste Section

Date of Site Inspection: August 26, 2013

Greene County Construction and Demolition Landfill and Closed MSWLF
 105 Landfill Rd.
 Walstonburg, North Carolina 27888

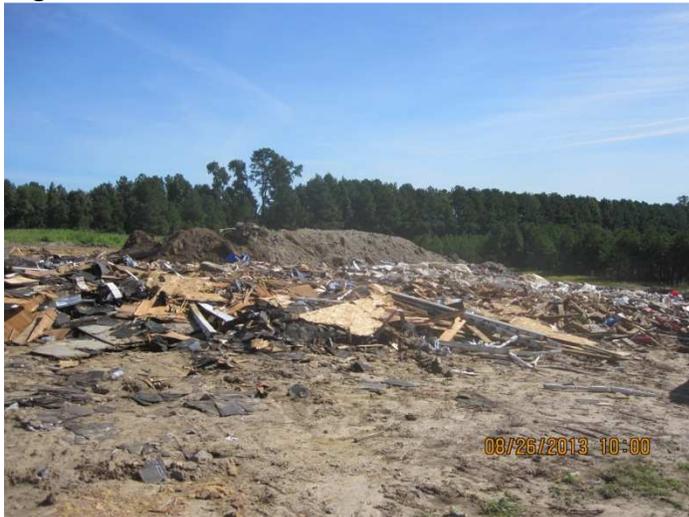
Working face is kept small

14. Scrap tire collection is by Central Carolina Tire. Tires are temporarily stored on the in trailers on the site.
15. The working face was small, no non-approved waste was observed.

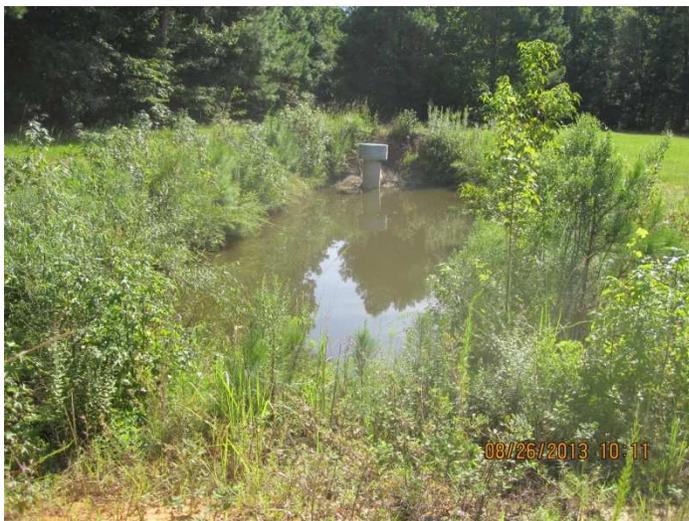
Sedimentation basin

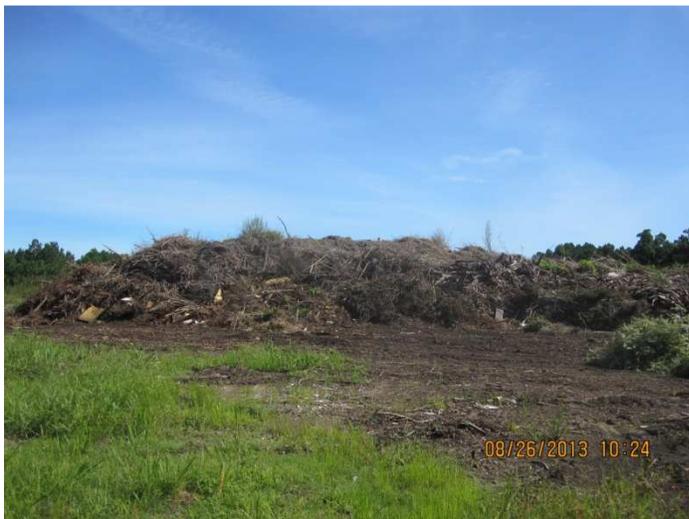
Yard waste area, material needs to be ground

12. Yard waste facilities shall follow the time and temperature requirements listed in 15A NCAC 13B .1406(10) for all yard trash feed stocks. The temperature requirements include the compost process being maintained at or above 55 degrees Celsius (131 degrees F) for 3 days and aerated to maintain elevated temperatures. Yard trash is defined within 130A-290(a)(45) as solid waste consisting solely of vegetative matter resulting from landscaping maintenance. Leaves from landscaping maintenance and grass clippings are considered yard trash. **The yard waste on site needs to be ground.**

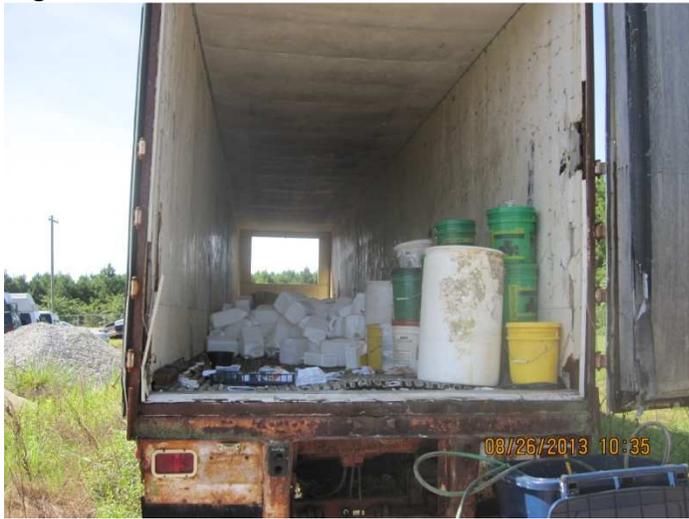
Pesticide container collection area

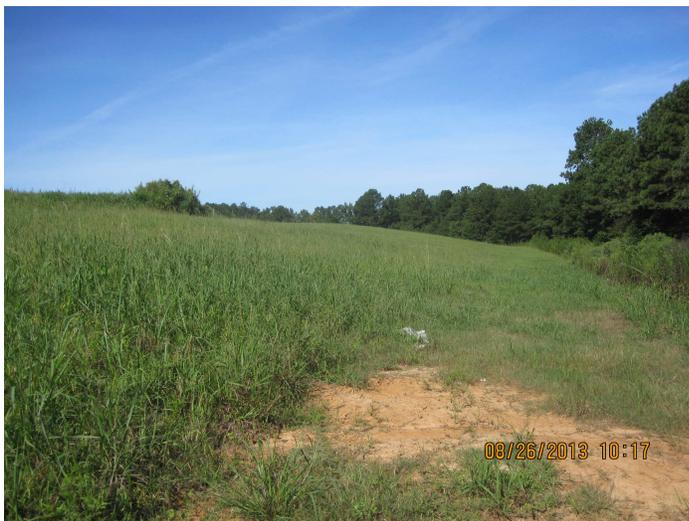
Northern slope of the landfill

20. The slopes and top of the closed MSWLF appear to be well covered and stabilized with grass. No woody vegetation was observed.

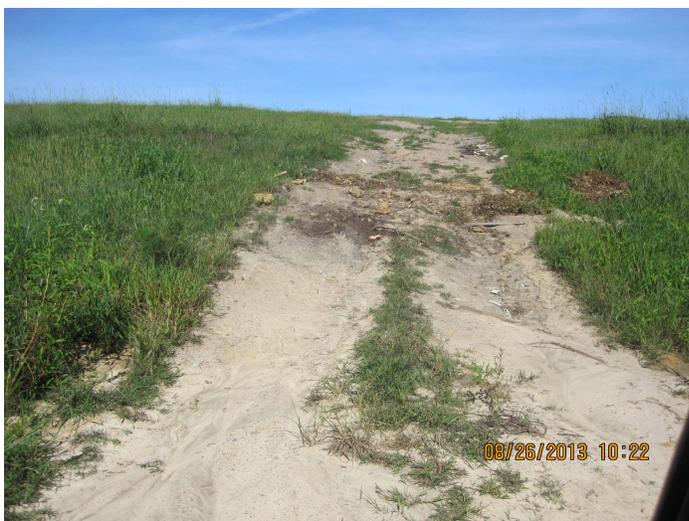
Path on the old landfill being used by heavy equipment, another route should be found.

18. Jones indicated that the facility does not normally accept regulated asbestos.
19. Equipment is being driven up one slope of the closed area of the landfill. Another route needs to be found to move equipment and the slope stabilized.
