**FACILITY COMPLIANCE AUDIT REPORT**  
**Division of Waste Management**  
**Solid Waste Section**

Date of Audit: 3/05/14                      Date of Last Audit: 2/11/11

McDowell MSW – Closed October 7, 1994  
 2849 NC Hwy 226 S.  
 Marion, NC 28752

Comprehensive Audit.

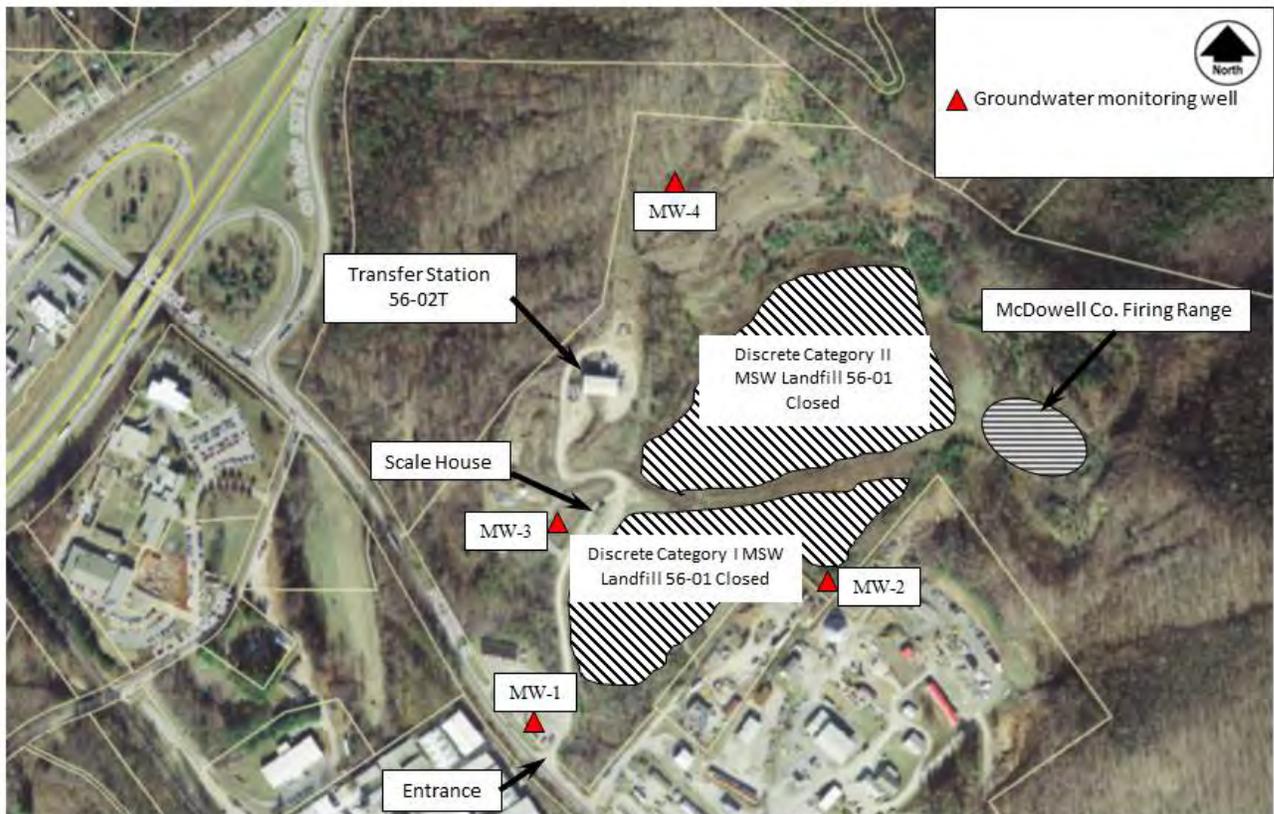
Figure #1. McDowell County GIS aerial. (Approximate limits of Waste disposal areas and monitoring well locations.)

- The closed McDowell County municipal solid waste (MSW) landfill consists of two separate areas: “Discrete Category I Landfill” and “Discrete Category II Landfill”. (Figure 1)

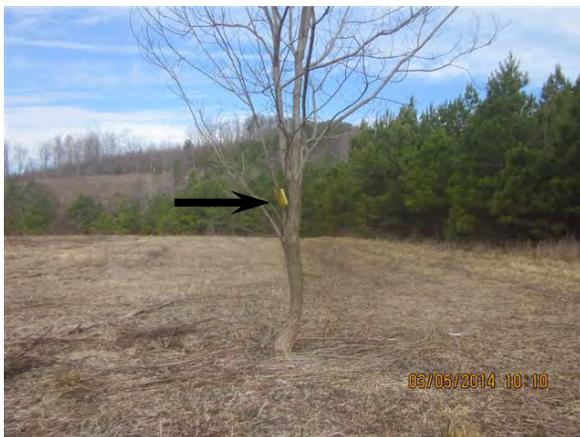
The “Discrete Category II” landfill’s cap had been recently mowed. Inspection of the mowed area found multiple areas of woody vegetation concentrated in the northern and western areas. (Photos #1 and #2)

1. Small tree near the northern edge of the “Discrete Category II” landfill. (Note the 4 ½” x 7 ½” yellow field book in the tree for scale.)

- e) **Ensure that all monitoring wells have a permanently affixed identification plate which can be correlated with an updated site map.**
  - f) **Remove all woody vegetation and trees from the caps of the landfills; repair and re-grade the caps where needed to correct the effects of settlement, subsidence, erosion.**

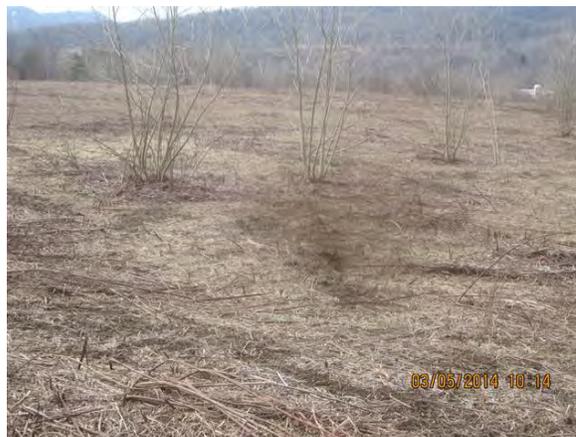
2. Woody vegetation on the northern segment of the cap of the “Discrete Category II” landfill.

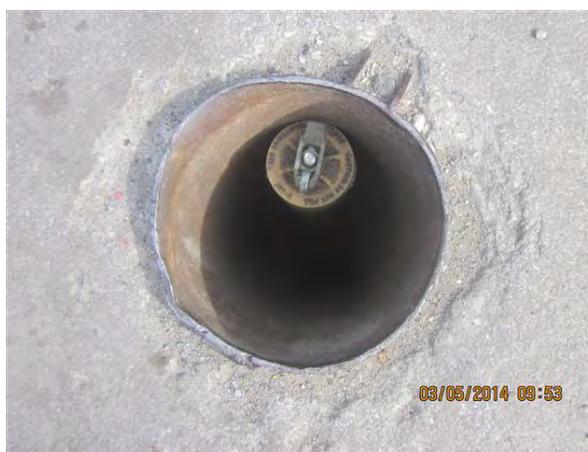
8. Close-up of the “flush mount” ground water monitoring well. Note the absence of the required “flush mount” cover.

- (ii) **the well head is completed in such a manner so as to preclude surficial contaminants from entering the well.**
  - d) **Ensure that all groundwater monitoring wells are equipped with a steel outer well casing or flush-mount cover, set in concrete, and other measures sufficient to protect the well from damage by normal site activities;, and**

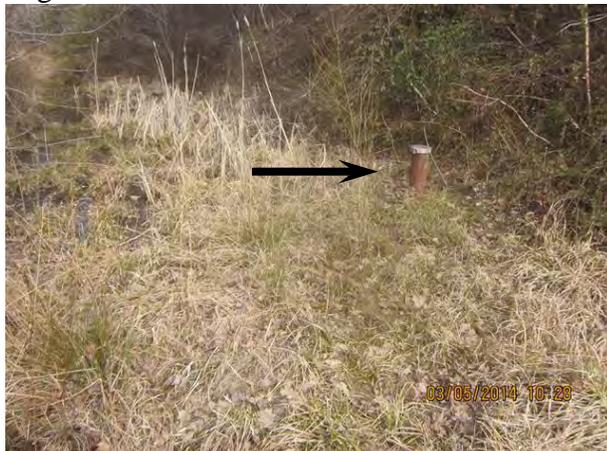
9. Ground water monitoring well MW-2 located off the SE quadrant of "Discrete Category I"

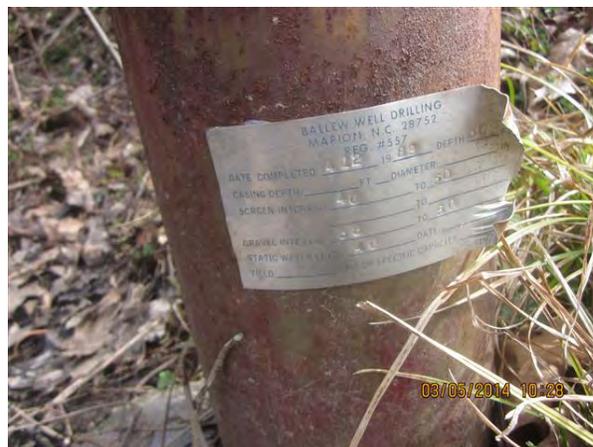
10. Well tag on ground water monitoring well MW-2 in photo #9.

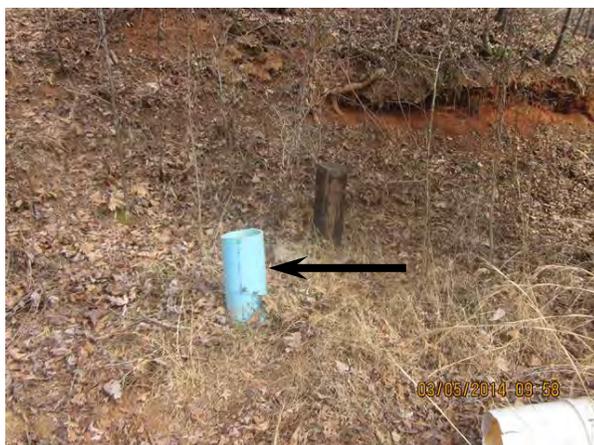
11. Ground water monitoring well MW-4 located north of the transfer station.

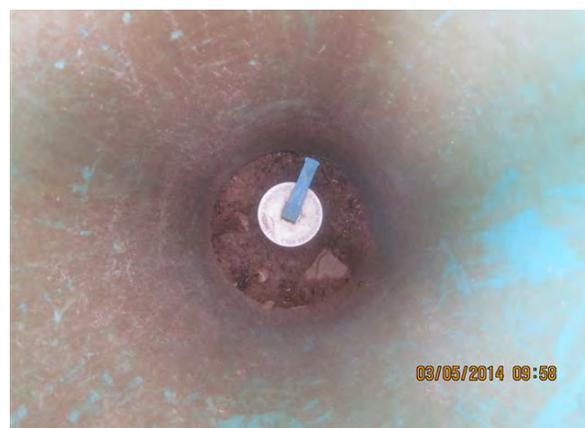
12. Looking down the outer casing to MW-4 located north of the transfer station at the cap to the well. (Note that the well is not properly secured with a lock.)

- b) **Secure all groundwater monitoring wells with locking well caps.**
  - c) **Ensure that all well casings are terminated no less than 12 inches above land surface unless all of the following conditions are met:**

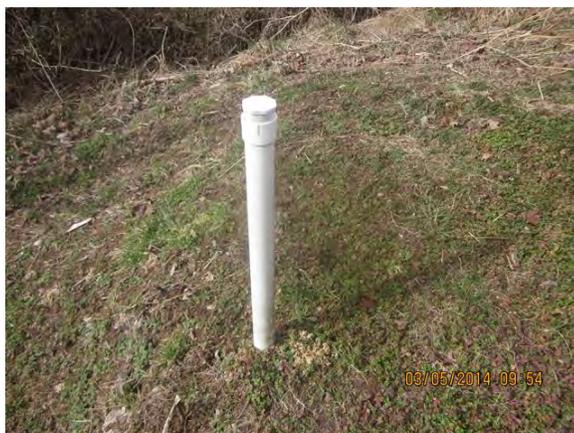
13. MW-3 located southwest of the scale house. (Note that the well is not properly secured with a lock, nor it is not marked with a unique ID / well tag.)

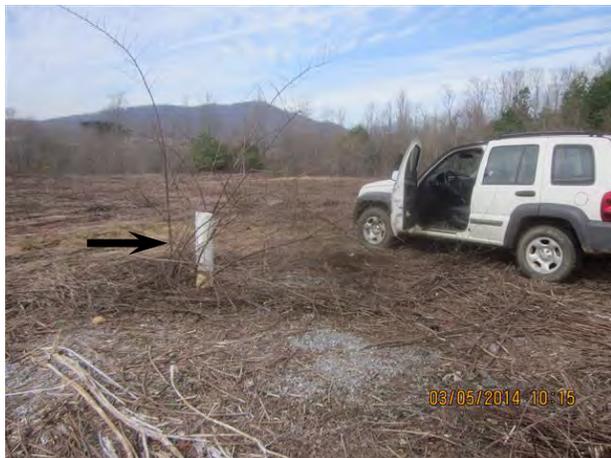
5. During the inspection, what appeared to be two of the tree methane extraction wells that were approved for installation by the SWS on 12/06/07, were located. These wells are not, and never have been put into use. (Photos #15 & #16)

15. Six inch diameter white PVC methane extraction well located near the center of “Discrete Category II Landfill”. Note that the well is not capped.

- g) Submit either a proposal for completing the methane extraction project, or a plan for terminating the project. If the project is to be terminated, please ensure that the landfill gas recovery properly abandoned in accordance with 15A NCAC 2C .0113 (b)(1), entitled “*Abandonment of Wells*”. Please contact Jaclynne Drummond to discuss your proposed course of action for the methane extraction project:

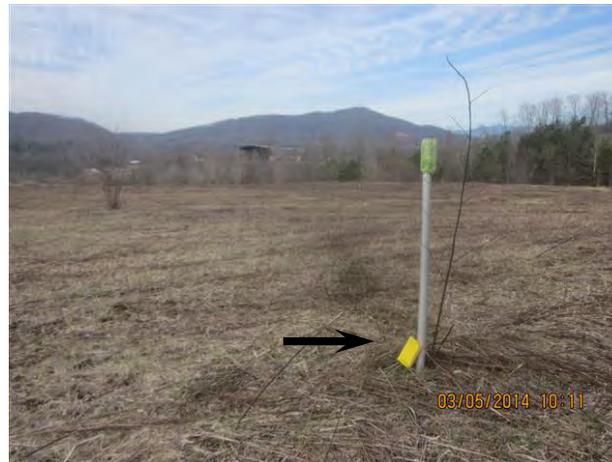
16. Two inch diameter white PVC methane extraction well located northern quadrant of “Discrete Category II Landfill”. (Note the 4 ½” x 7 ½” yellow field book in for scale.)
