Date of Audit: 11/18/13

McDowell County Transfer Station  
 3809 NC Hwy 226 South  
 Marion, NC 28752

Comprehensive Compliance Inspection

**FACILITY COMPLIANCE INSPECTION REPORT**  
**Division of Waste Management**  
**Solid Waste Section**

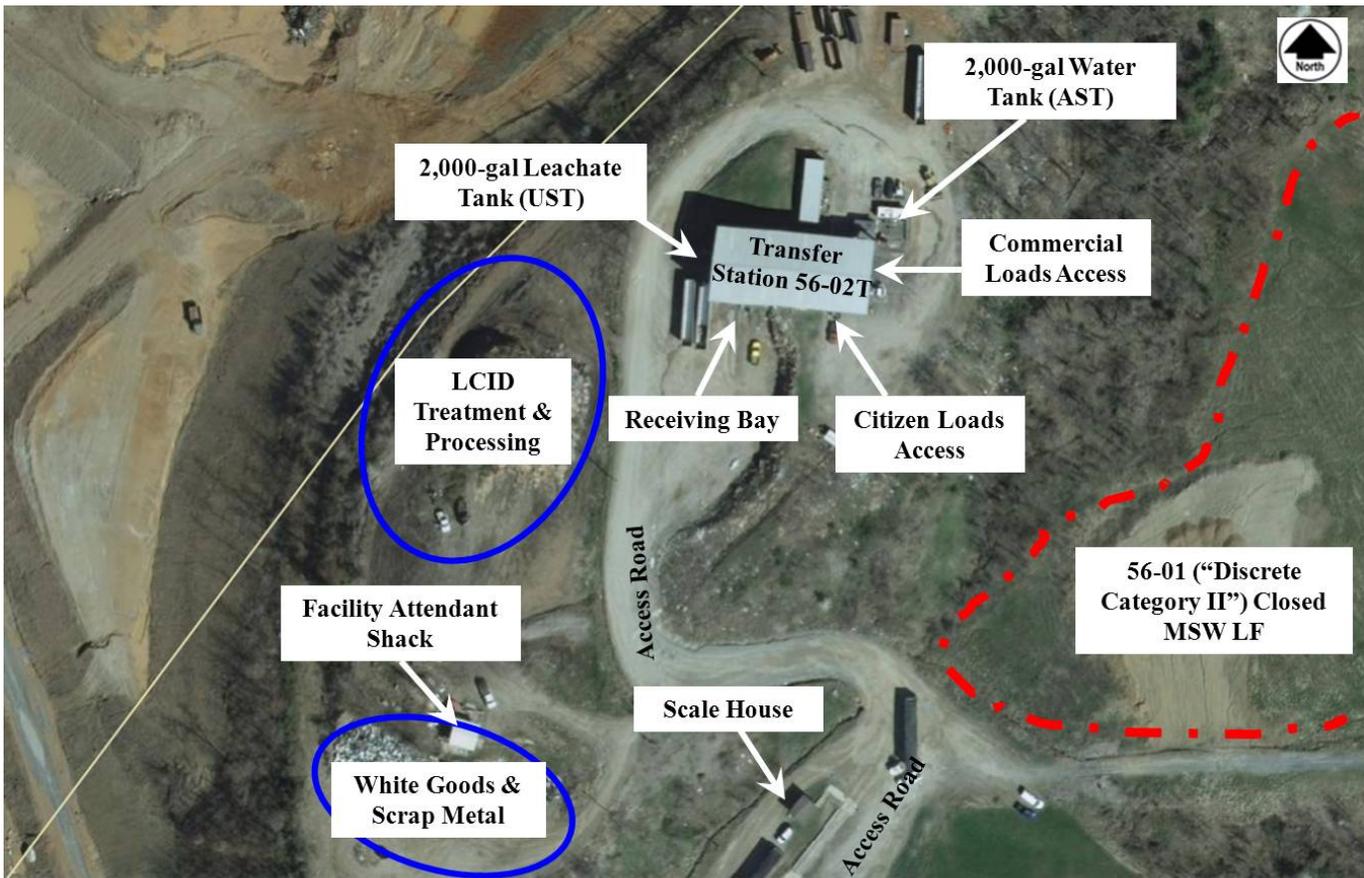
**McDowell County is in violation of 15A NCAC 13B .0201(h) by failing to maintain the McDowell County Transfer Station in a sanitary condition. The interior walls of the transfer station need to be washed down and the receiving bay floor, and walls need washing. (See photos #1 and #2 below.)**

*To correct this violation and be in compliance with 15A NCAC 13B .0201(h) within 14 days from receipt of this Notice, McDowell County must wash down and otherwise clean the interior walls of the transfer station, the receiving bay floor, and the receiving bay walls.*

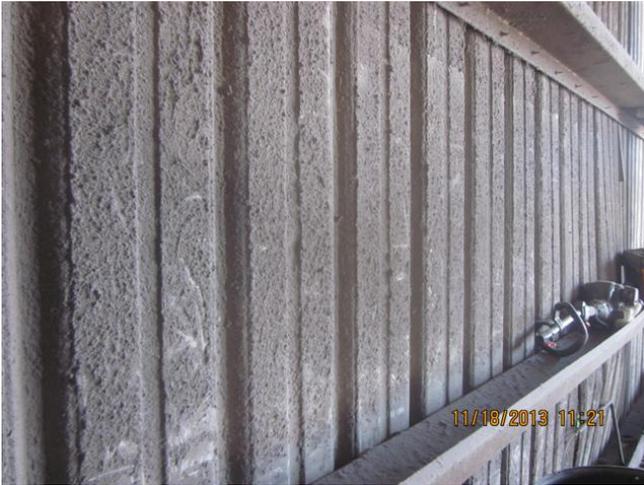
10. The walls of the transfer facility have some debris buildup and will need to be washed. (Photos #1 and #2)

1. Looking down the north interior wall of the transfer station which is coated in grime and must be cleaned.

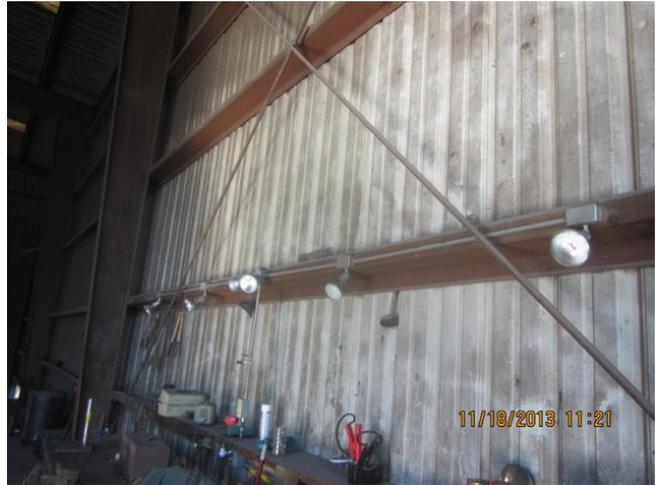
2. Looking at the eastern section of the north interior wall of the transfer station that has been partially cleaned.

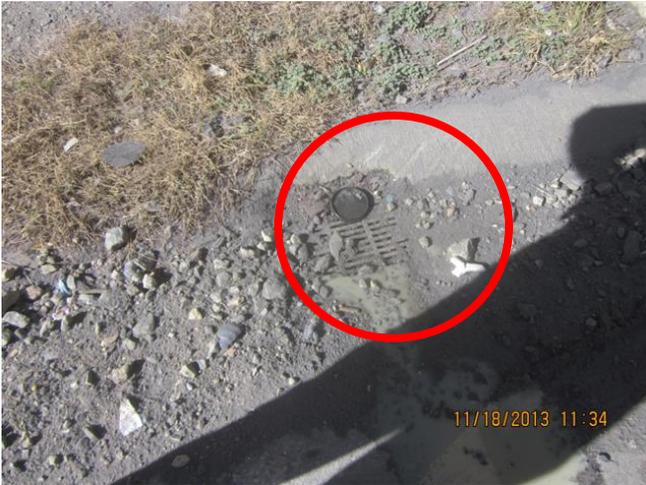
17. Leachate and wash down water from the transfer station is captured by two floor drains in the receiving bay and directed to the 2,000-gallon leachate holding tank. (Photo #3)

3. One of the two “floor drains” locate just outside of the sieving bay for the collection of leachate.

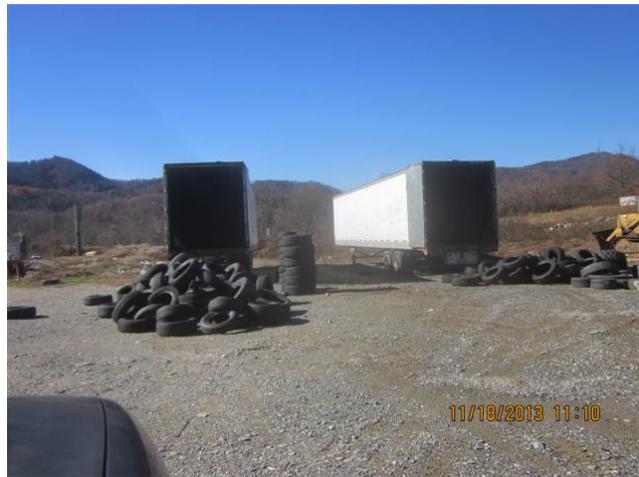
19. Scrap tires are stored in two semi-trailers. *US Tire* collects the tires and transports them to their Concord, NC facility for final processing. (Photo #4)

4. Two semi-trailers used for the collection and storage of scrap tires.

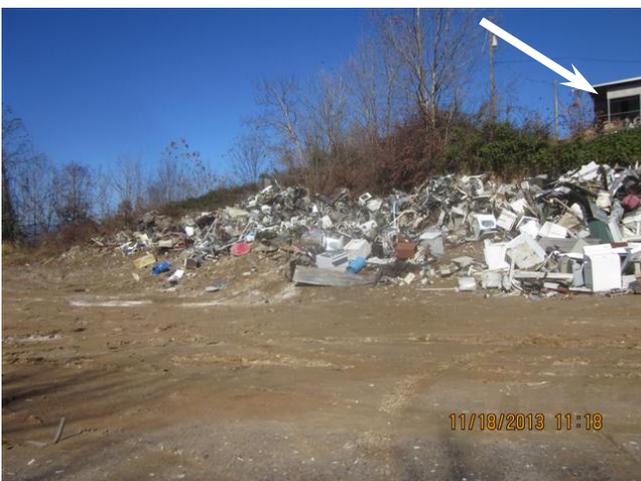
20. Scrap metal is staged west of the scale house. This operation is overseen by an attendant who also oversees the white goods and treatment and processing operations. (Photo # 5)
21. *Tri Sate Scrap Metal, Inc.* (a.k.a. *Mountain Metals Recycling*) out of Asheville, NC collects all scrap metal and transports it to their Asheville facility for final processing.

5. Scrap metal staging area. (Note the attendant’s shack on the hill overlooking the white goods.)

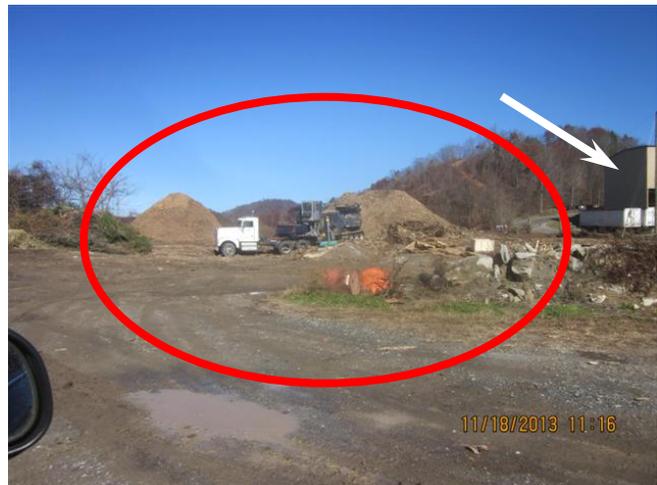
6. Wood grinding operations. (Note the transfer station in the right background.)

25. Wood wastes (land clearing debris, yard and garden wastes, and clean unpainted wood wastes) are ground by outside contractors with the lowest bid. This is done on an “as needed” basis which is happening about once a year. *Cason Company* of Marion was on site during the inspection and was completing the most recent grinding event of approximately 1,500-tons of waste. (Photo #6) In accordance with their contract, *Cason Company* is responsible for final disposition of the ground wastes. The cost of this grinding event for McDowell County was \$15.00 / ton.
