**FACILITY COMPLIANCE INSPECTION REPORT**  
**Division of Waste Management**  
**Solid Waste Section**

**Date of Site Inspection:** July 16, 2013

Martin County C&DLF  
 1445 Landfill Rd.  
 Williamston, North Carolina 27892

Comprehensive Audit

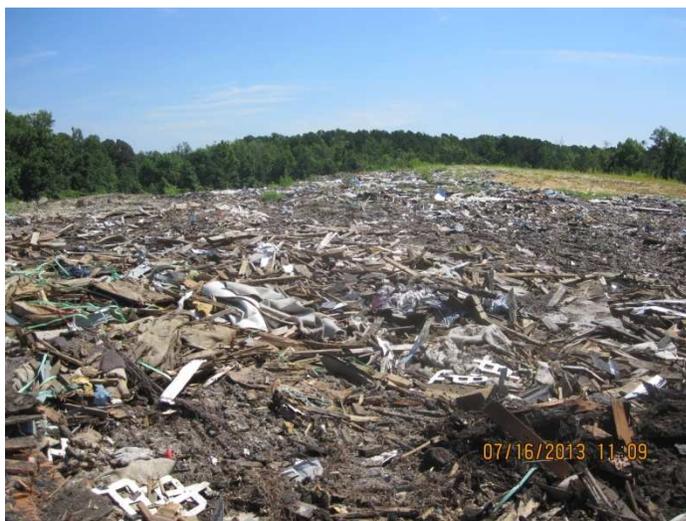
cover.

Much of the top of the landfill lacks sufficient

(f) Cover material requirements. (1) Except as provided in Subparagraph (3) of this Paragraph, the owners and operators of all C&DLF units must cover the solid waste with six inches of earthen material when the waste disposal area exceeds one-half acre and at least once weekly. Cover must be placed at more frequent intervals if necessary to control disease vectors, fires, odors, blowing litter, and scavenging. A notation of the date and time of the cover placement must be recorded in the operating record as specified in Paragraph (n) of this Rule. **The Martin Count C&D Landfill is in violation of this rule in that an area exceeding one half acre in size has been left uncovered. This situation was noted in the previous inspection. In order to be in compliance, within 30 days of the receipt of this Notice of Violation cover all exposed waste with 6 inches of suitable fill material leaving only a small area as the working face.**

(g) Spreading and compacting requirements. (1) C&DLF units must restrict solid waste into the smallest area feasible. **The Martin County C&D Landfill is in violation of this rule in that an area exceeding one acre in size has been left uncovered. This situation was noted in the previous inspection. In order to be in compliance, within 30 days of the receipt of this Notice of Violation cover all exposed waste with 6 inches of suitable fill material leaving only a small area as the working face.**

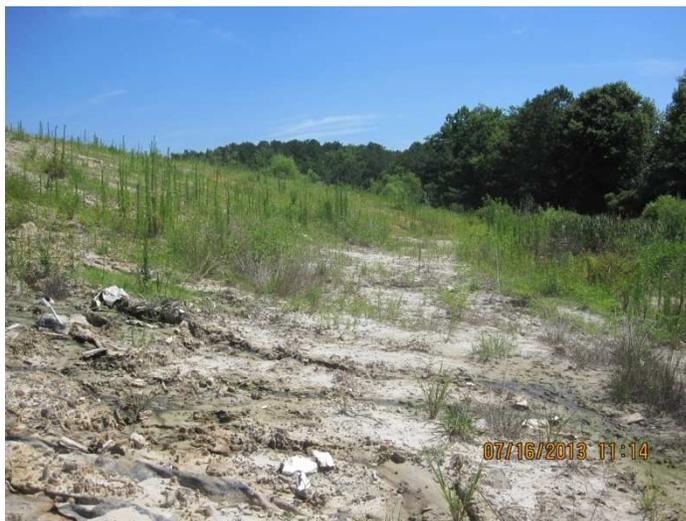
several areas

Southern slope showing leachate break outs in

(l) Drainage control and water protection requirements. (4) Leachate must be contained on-site or treated prior to discharge. An NPDES permit may be required prior to the discharge of leachate to surface waters. **The Martin County C&D Landfill is in violation of this rule in that leachate was observed breaking out along a roughly 100 foot section of the southern slope of the landfill, then flowing into the drainage swale the base of this area of the landfill. This swale drains into a sedimentation basin. In order to bring this landfill into compliance immediately take whatever steps necessary repair and plug the leachate breakouts and perform the testing specified in item 21 below.**

- 20) The drainage area at the base of the landfill needs to be reworked so that runoff is transported to the sedimentation basin.**
- 21) Remove the leachate contaminated soil from below the footprint and the swale. This soil can be placed on the top of the landfill. Sample the soil and leachate according to the method listed below:**
- Submit a sampling plan for Solid Waste Section review and approval prior to conducting the sampling activities. Submit plan to Ben Barnes P.O. Box 23, Elm City, North Carolina 27822.
  - The sampling plan should include sampling methodology and a figure depicting the sampling locations.
  - A summary report (in electronic format) containing the results of the assessment should be submitted to the Solid Waste Section within 30 days of receiving the analytical results from the NC certified laboratory.

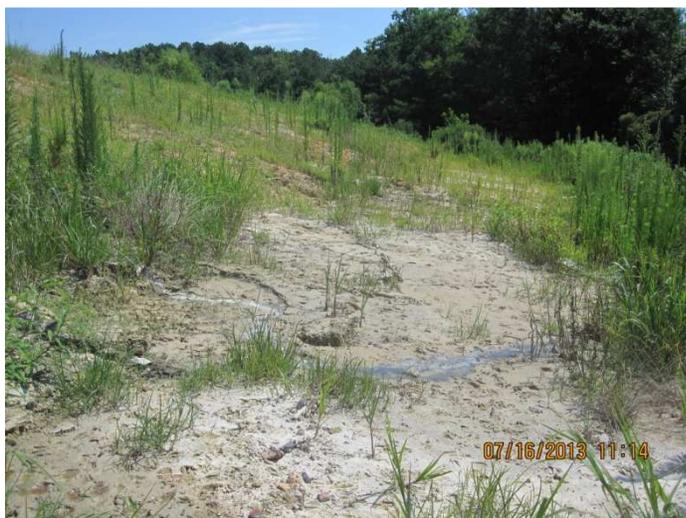
landfill

Leachate breakouts on the southern slope of the

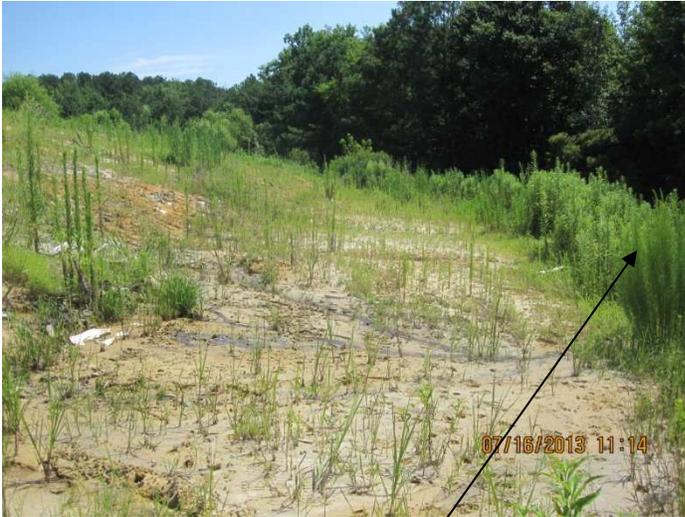
landfill

Leachate breakouts along the southern slope of the

Area of the drainage swale
