**FACILITY COMPLIANCE INSPECTION REPORT**  
**Division of Waste Management**  
**Solid Waste Section**

**Date of Site Inspection:** January 28, 2014

Red Rock Disposal LLC/Waste Industries, Inc. C&D Landfill  
 7130 New Landfill Drive  
 Holly Springs, NC 27540

Follow up inspection.

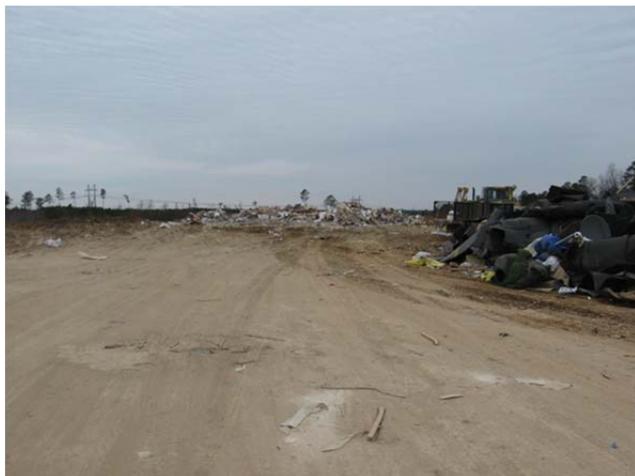
10. The working face was approximately one-half acre at the time of the inspection. **C&DLF units must cover the solid waste with six inches of earthen material when the waste disposal area exceeds one-half acre and at least once weekly. Cover must be placed at more frequent intervals if necessary to control disease vectors, fires, odors, blowing litter, and scavenging.** All loads should be incorporated in to the working face by the end of the day. No unpermitted waste was noted.

Working face from the east

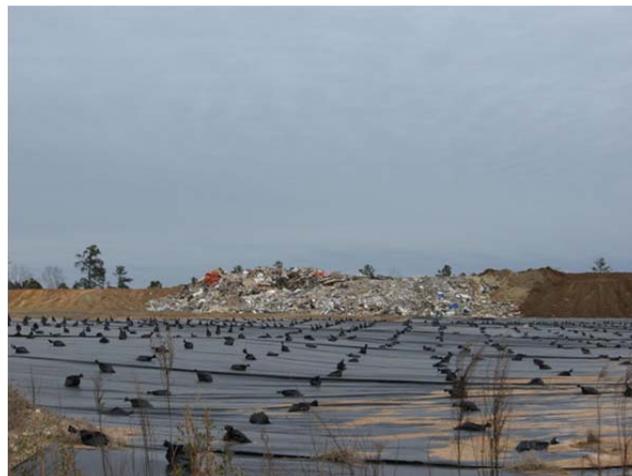
Working face from the south

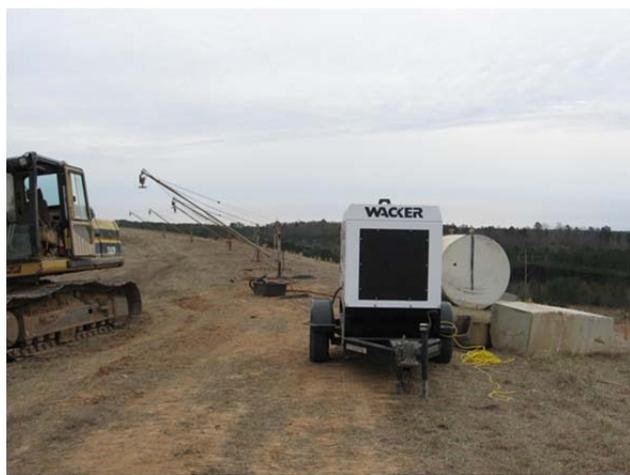
11. Edge of waste is marked by white 4"x4" wooden posts installed ~ every 50 feet. These are numbered and well maintained.
12. A full container of waste was observed next to the concrete crusher during the inspection. A container in that location should not be used for long term storage of waste. Additionally, the container was in poor condition and should be replaced or repaired. Per 15A NCAC 13B .0104(e) "All containers for the storage of solid waste shall be maintained in such a manner as to prevent the creation of a nuisance or insanitary conditions. Containers that are broken or otherwise fail to meet this Rule shall be replaced with acceptable containers..."
13. The Leachate Evaporation system has been installed and will be tested when electrical issues are resolved and weather conditions are favorable.

Evaporator nozzles, generator, and holding tank

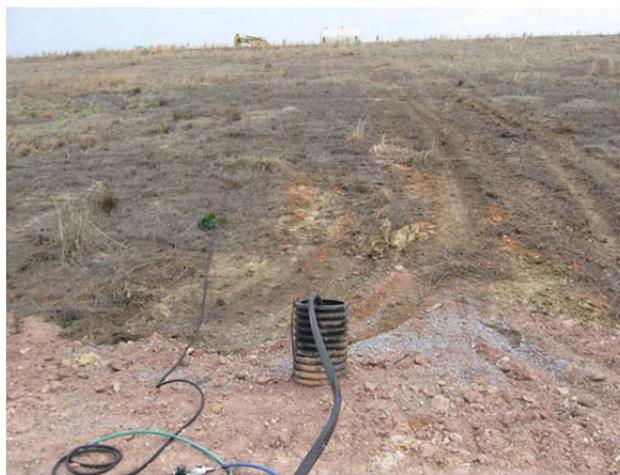
Sump at toe of slope for leachate collection

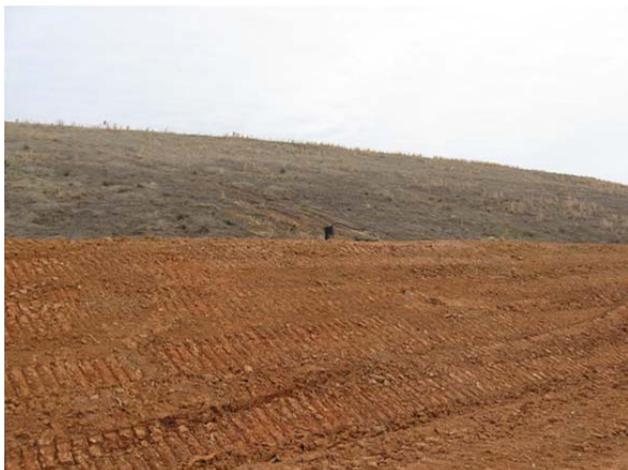
14. The area between Edge-Of-Waste Markers 50 and 52, where during the November 25, 2013 inspection leachate was observed running down the slope and into the storm water ditch, has been repaired. The sump for the leachate evaporation system has been installed in this area to reduce the chance of further leachate break-outs.
15. An area to the northwest of the previously noted leachate seep was also observed to have been recently repaired.

Area of repair (leachate break-out noted in previous inspection)

**All the above noted violations to rules and permit conditions have been resolved. All repaired areas must be established with vegetative groundcover. At a minimum, repaired areas must be seeded and mulched within 30 days.**

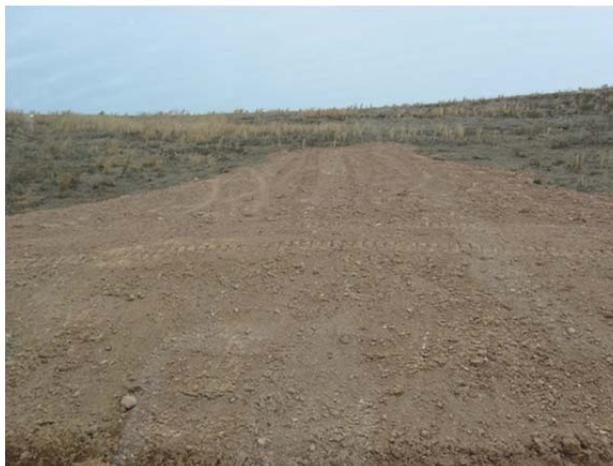
Additional repair
