**FACILITY COMPLIANCE INSPECTION REPORT**  
**Division of Waste Management**  
**Solid Waste Section**

**Date of Site Inspection:** June 10, 2013      **Date of Last Inspection:** October 5, 2012

**FACILITY NAME AND ADDRESS:**  
 Waste Industries Black Creek Road Transfer Facility  
 3031 Black Creek Road  
 Wilson, NC 27893

**PURPOSE OF SITE VISIT:**  
 Comprehensive Inspection

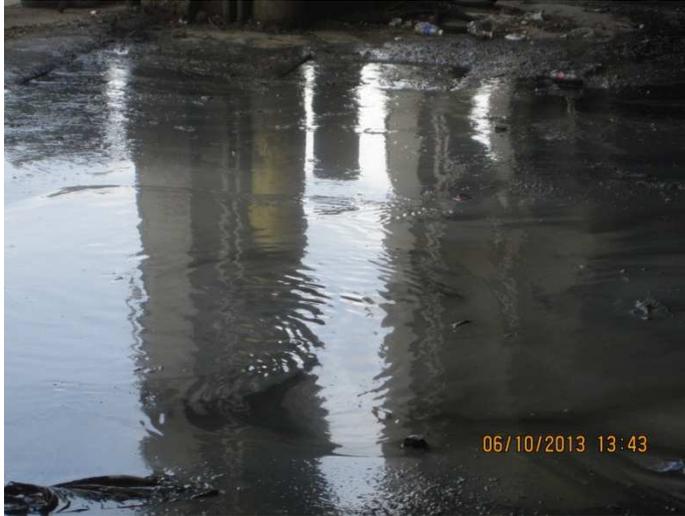
14. Three overhead lights appear to be out.
15. The floor drain on the right bay was clogged during at the time of this inspection causing water to stand in the entrance. This has apparently been a problem.

Clogged floor drain

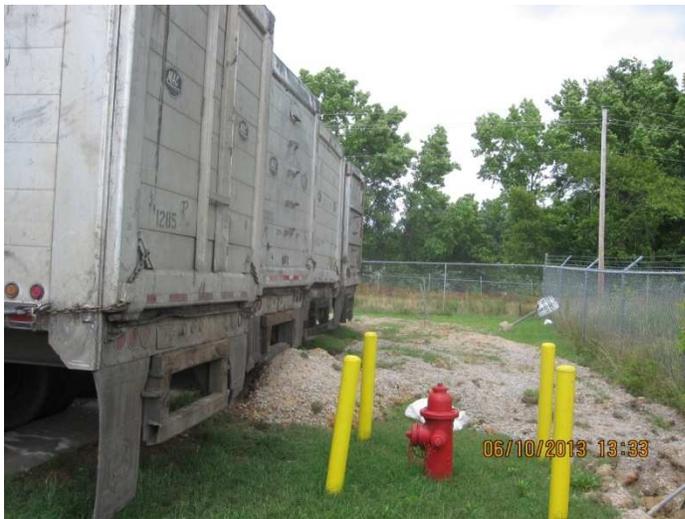
Area behind trailers clean, no sign of leakage

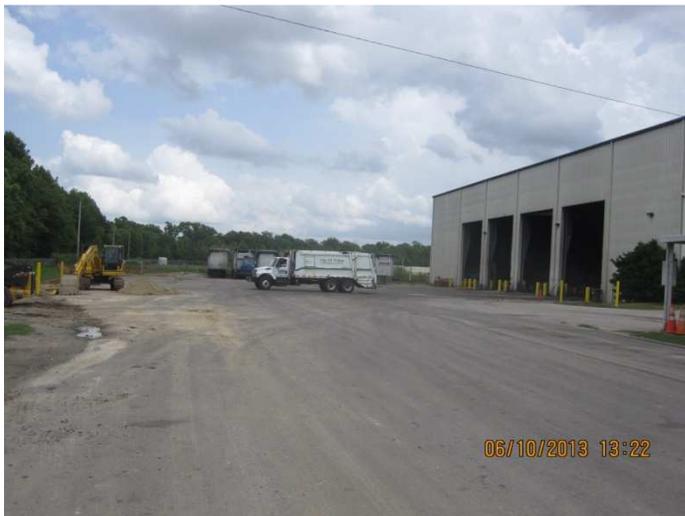
Outside area is being kept clean

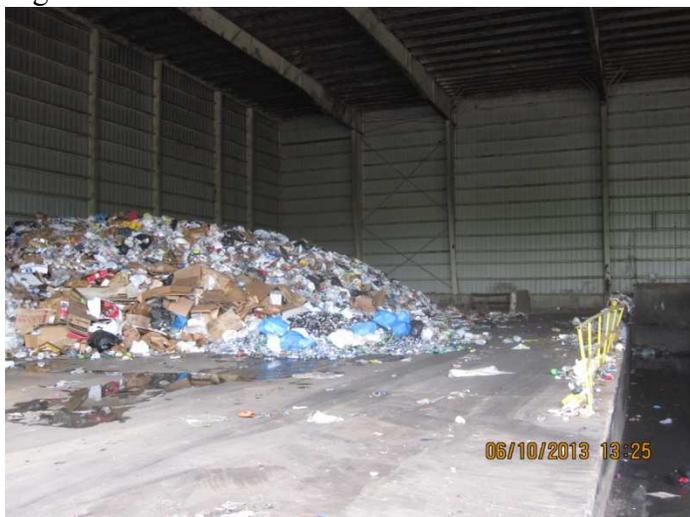
3. The operating hours are Monday thru Saturday 6:00 AM to 8:00 PM.
4. The signage is according to the permit conditions.
5. Recyclables are stored in bay 1 as specified in the Ops Plan.

Recycling area in left bay
