FACILITY COMPLIANCE INSPECTION REPORT
Division of Waste Management
Solid Waste Section

Date of Site Inspection: March 13, 2014 **Date of Last Inspection:** November 3, 2011

Northfield Farms LCID Landfill
 306 W. Old Glencoe Road
 Burlington, NC 27217

Comprehensive Inspection (to ensure that the notified land clearing and inert debris (LCID) landfill is in compliance with 15A North Carolina Administrative Code (NCAC) 13B .0563, .0564, and .0566)

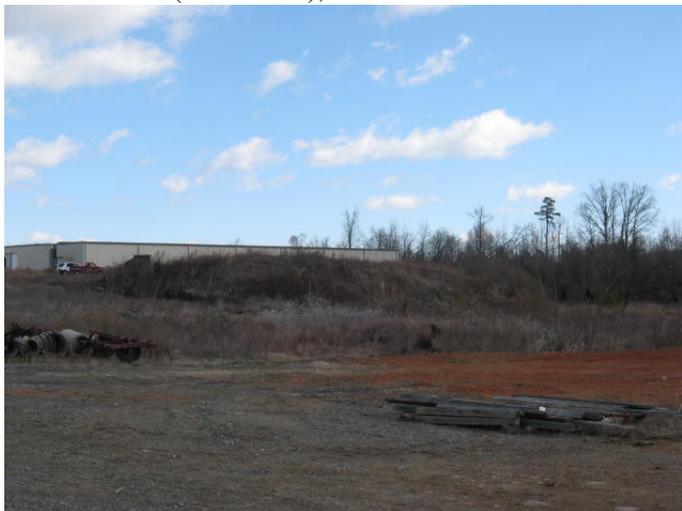
2. The LCID landfill is located on the left at the front of the lot, adjacent to the gravel access road.
3. Mr. Buckland stated that the LCID landfill is used to bury ground vegetative disaster debris. It is not commonly operated except following a disaster. Unground material is not commonly accepted.

4. The LCID landfill is ~ 1.3 acres.
5. The property parcel is ~ 28 acres.
6. The LCID landfill is covered with soil and vegetative material.
7. The LCID landfill appeared to be graded accordingly.

LCID landfill (raised area), left side of lot

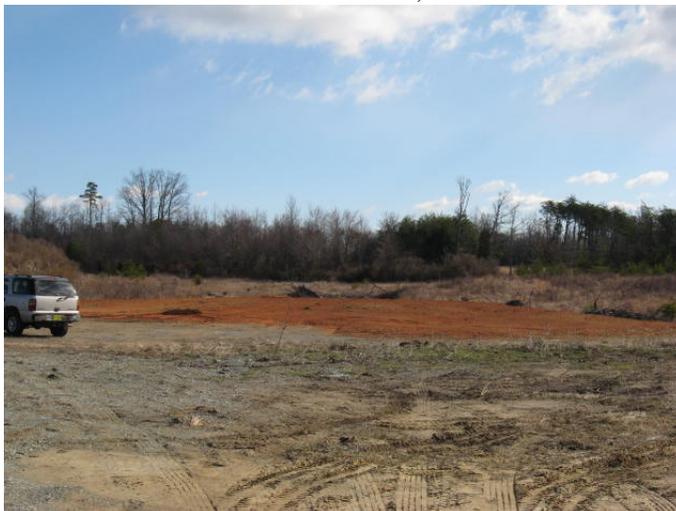
15. An inert debris area (not associated with the LCID landfill) used as beneficial fill has been covered with soil and graded accordingly (left side of lot adjacent to the end of the gravel drive).

Inert debris used as beneficial fill, covered with soil
