**FACILITY COMPLIANCE INSPECTION REPORT**  
**Division of Waste Management**  
**Solid Waste Section**

**Date of Site Inspection: April 8, 2014      Date of Last Inspection: April 7, 2011 (Wes Hare)**

Layden's Sandpit  
 Hwy 344 S Elizabeth City, (Weeksville Rd) T/R Pitts Chapel Rd. T/L up path across from Pitts Chapel (Sand Pitt Rd)  
 Site near end of path on left  
 Elizabeth City, Pasquotank Co.

Inspection of notified LCID site and consultation

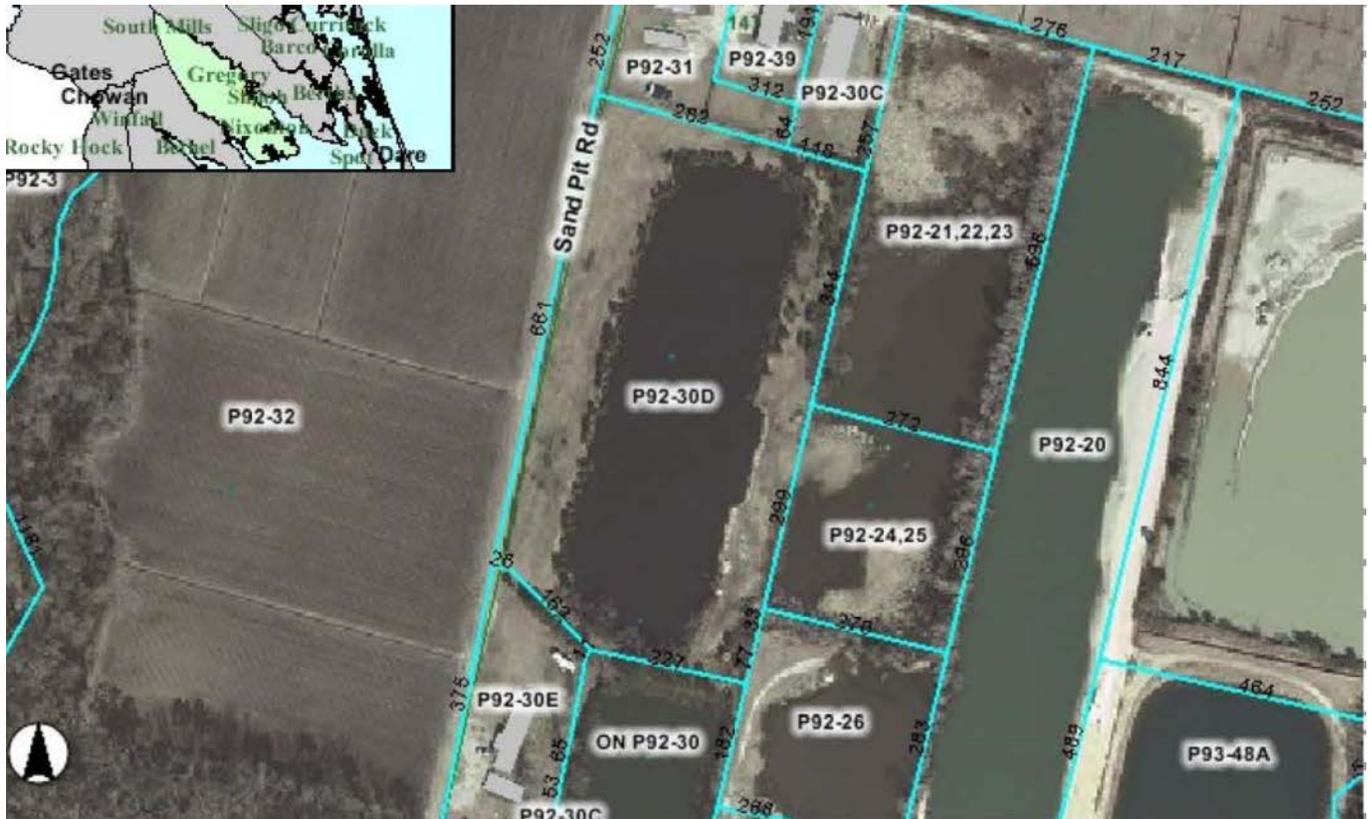
The landfill is recorded on parcel P92-30D but the site visit seemed to indicate that some of the fill area might be located on parcel P92-24,25 or within 100 feet of the property line. Both tracts are currently owned by Johnnie Layden. The exact location of the LCID fill area needs to be established. If the waste has been dumped on more than one tract or the setbacks to the property line are not met, this situation will need to be corrected.

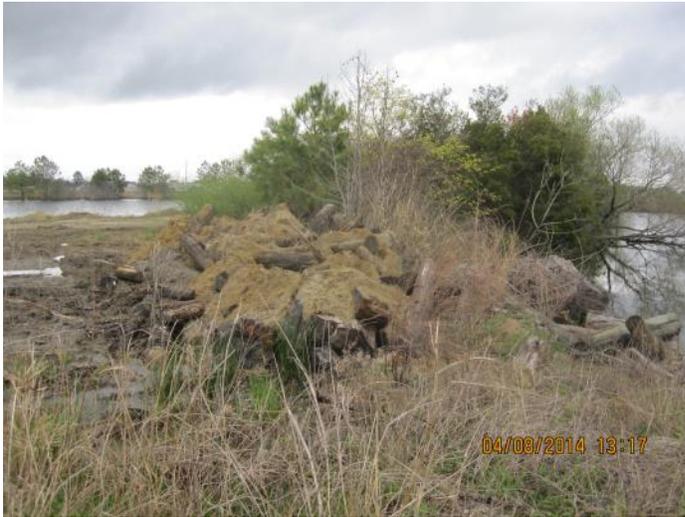
Creosote poles dumped on the site need to be removed.

4. **Non-conforming waste was observed on the surface the site some has been partially covered. This waste including any that is buried must be removed and transported to a facility permitted to receive this type of waste. Receipts from this facility must be provided to Ben Barnes, PO Box 1568, Elm City, North Carolina 27822. Conditions were extremely wet during the time of this inspection. The action required in this comment will need to be begun when conditions are dryer and completed within 30 days of starting.**

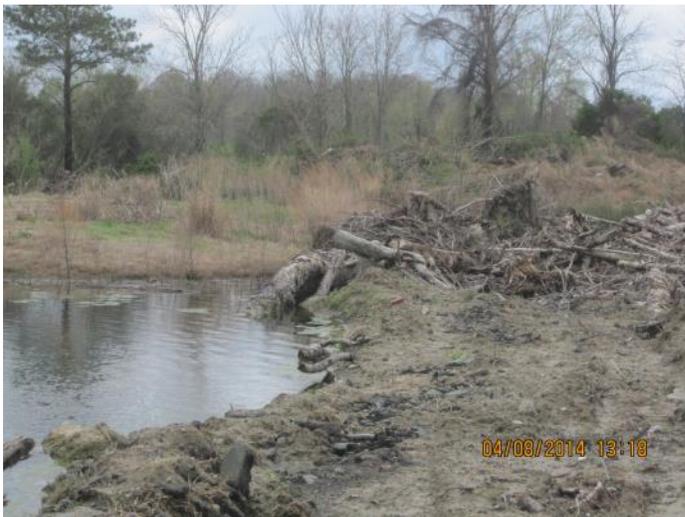
Waste dumped within 50 feet of the pond needs to be moved to satisfy this setback requirement

- (1) **15A NCAC 13B .0564 SITING CRITERIA FOR LAND CLEARING AND INERT DEBRIS (LCID) LANDFILLS (9)** The facility shall meet the following minimum buffer requirements:
- (a) 50 feet from the waste boundary to all surface waters of the state as defined in G.S. 143-212. *Waste has been dumped within 50 feet of the pond. See photos below.*
- (2) **15A NCAC 13B .0566 OPERATIONAL REQ. FOR LAND CLEARING/INERT DEBRIS (LCID) LANDFILLS (2)** the facility shall only accept those solid wastes which it is permitted to receive. *Nonconforming waste including creosote poles, demolition material and corrugated pipe and plastic containers has been dumped on the site.*

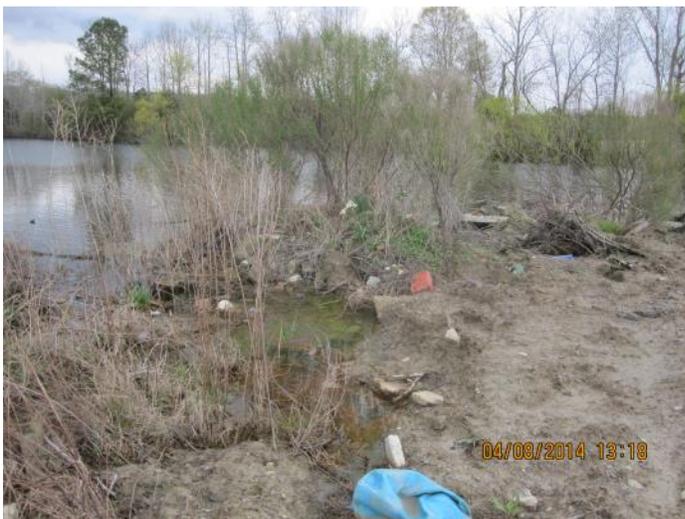
More waste dumped within 50 feet of the pond. Any waste dumped on the site within 50 feet of the pond that conforms with the requirements of 15A NCAC 13B .0566 (2) must be pushed back to meet this setback requirement. The nonconforming waste must be removed and transported to a facility permitted to receive this type of waste.

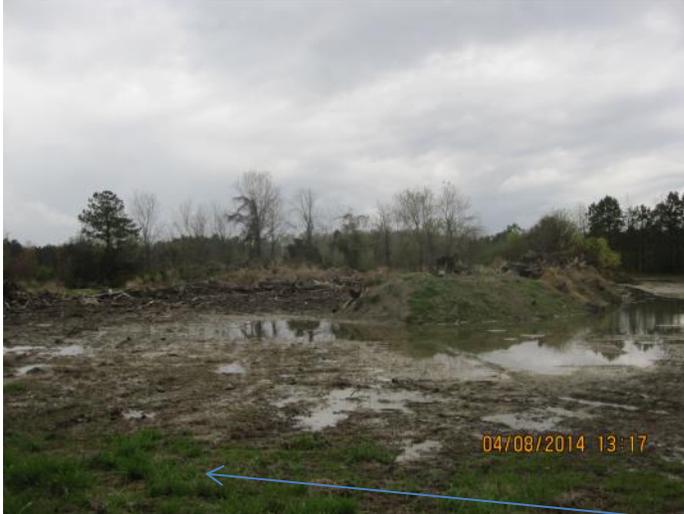
The main dumping area for the landfill, conditions were extremely wet during the day of the inspection.

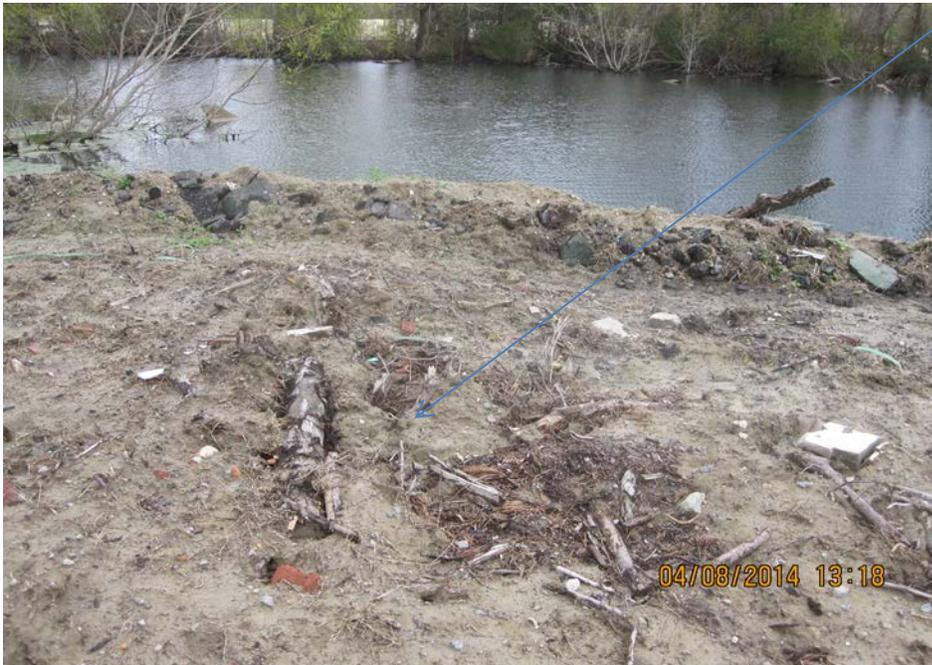
Waste material has been dumped in the area east of the uncovered waste towards the old mine and covered. It is not known if this material was dumped in water. Any waste dumped in water needs to be pulled back to the original ground surface.
