**FACILITY COMPLIANCE INSPECTION REPORT**  
**Division of Waste Management**  
**Solid Waste Section**

**Date of Site Inspection:** February 4, 2014    **Date of Last Inspection:** July 26, 2011

Ricky Beal Grading & Septic Tank Service LLC LCID Landfill  
Walter Lambert Road  
Goldston, NC 27252

Comprehensive Inspection (to ensure that the notified land clearing and inert debris (LCID) landfill is in compliance with 15A North Carolina Administrative Code (NCAC) 13B .0563, .0564, and .0566)

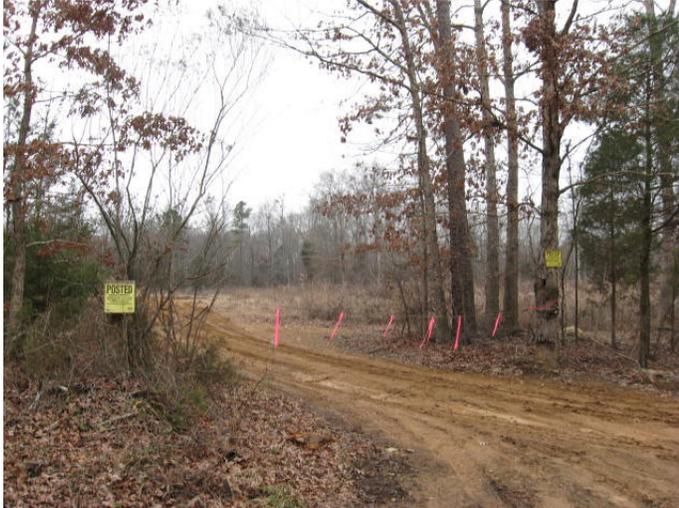
LCID landfill entrance

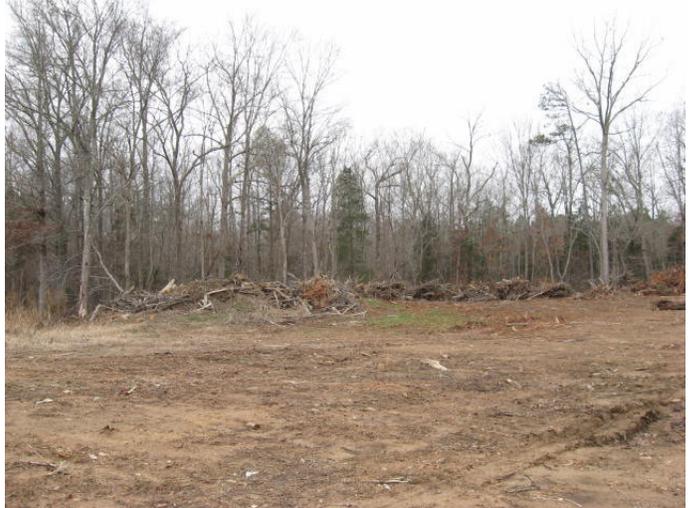
1. The land clearing and inert debris (LCID) landfill is not open to the general public.
2. The LCID landfill appeared to be < 2 acres.
3. The current fill area appeared to be ~ 100 feet in length. Per 15A NCAC 13B .0566(3), "Solid waste shall be restricted to the smallest area feasible and compacted as densely as practical into cells."

Left side of fill area

6. Ensure LCID material is covered with soil by March 2014.
7. Mr. Beal stated that the LCID landfill is > 50 feet from a small pond (adjacent to the fill area).

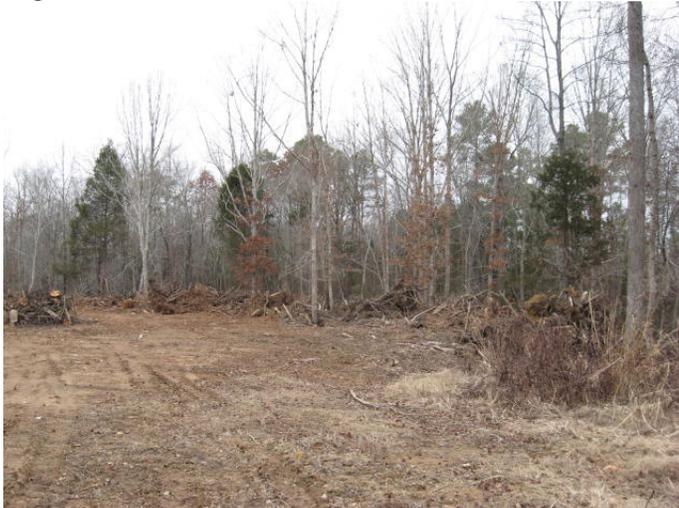
Right side of fill area

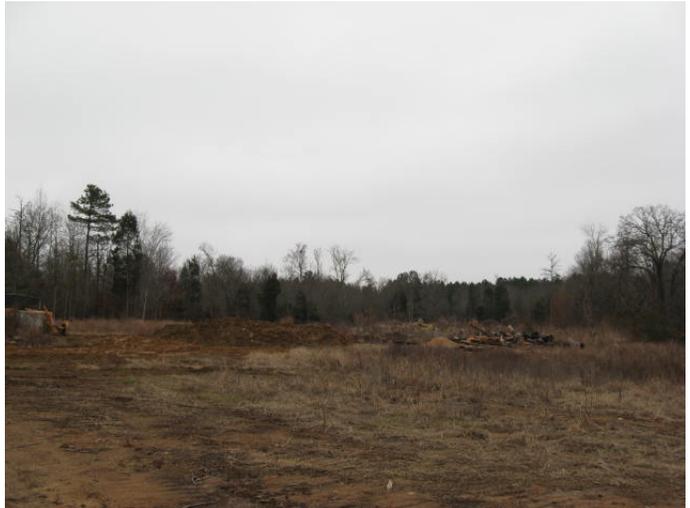
13. Per 15A NCAC 13B .0566(16), "A sign shall be posted at the facility entrance showing the contact name and [phone] number in case of emergency."
14. Logs are stored on the property to be given-away for firewood.

15. Inert debris (rock, brick, and cement block associated with demolition) is stored on site to be sold as fill material.
16. A copy of the Land Clearing and Inert Debris Landfill Notification recorded June 18, 2001 is included with this inspection report.

Stored material for reuse: firewood, inert debris, and soil
