**RE: REACHES 1 TO 3 2015 VISUAL AND VEGETATION MONITORING
WARD TRANSFORMER SUPERFUND SITE, RALEIGH, NORTH CAROLINA**

On behalf of the Ward Transformer Site Trust (Trust), Golder Associates NC, Inc. (Golder) submits the results of the visual and vegetation monitoring of the riparian vegetation for Reaches 1 to 3 for the Phase 2 Removal Action (RA) at the Ward Transformer Superfund Site, Raleigh, North Carolina.

**ATTACHMENT 1
AS-BUILT SURVEY FOR
PHASE 2 REMOVAL ACTION REPAIRS**

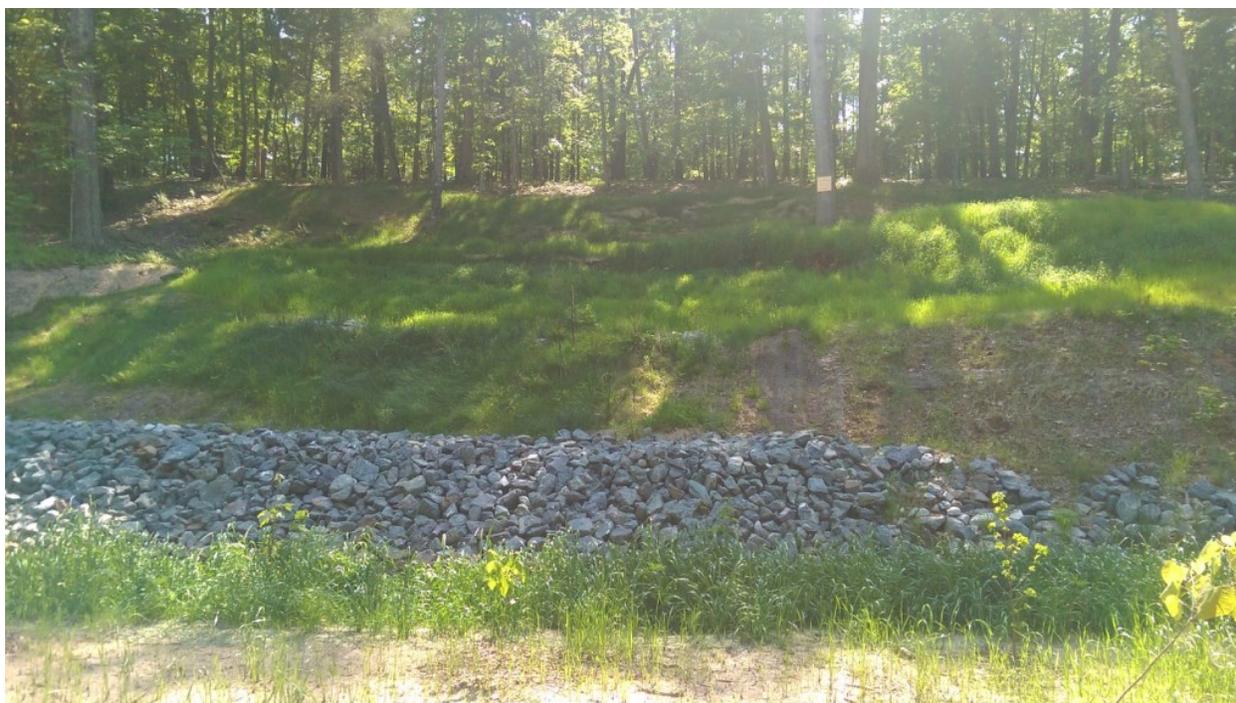
Photograph No. 13
Reach 3 Slide Repair Area
Facing West

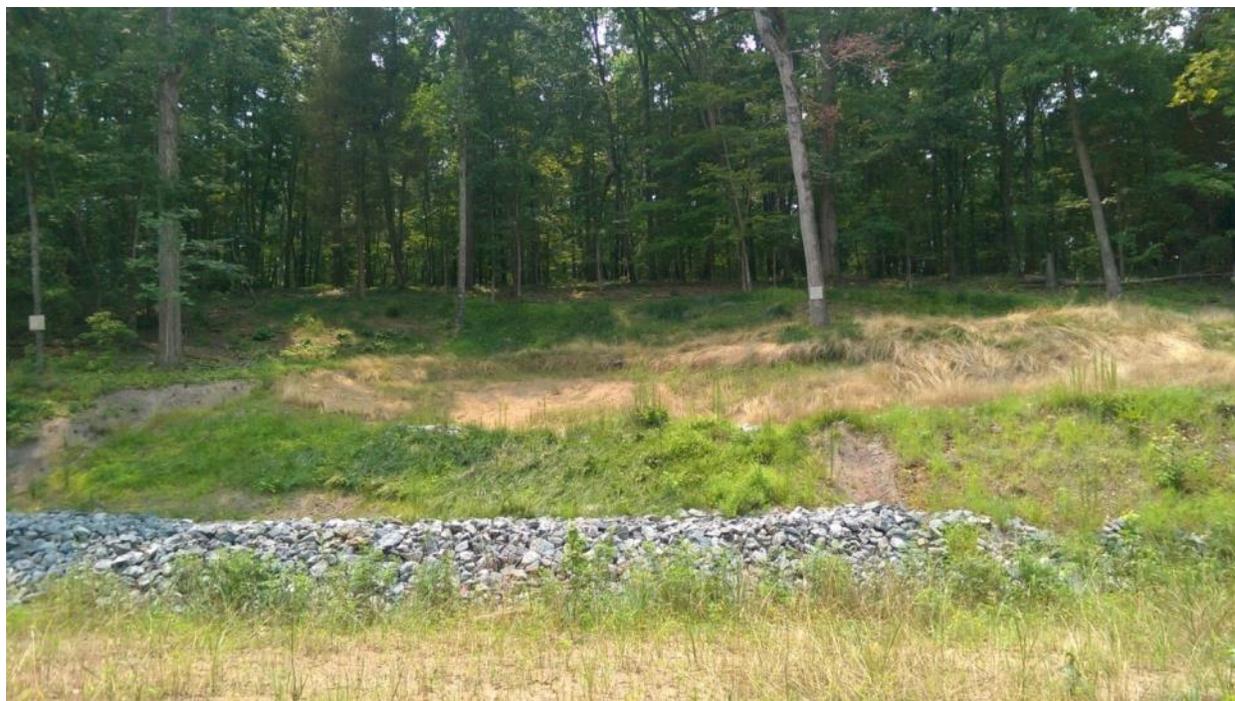
Photograph No. 13
Reach 3 Slide Repair Area
Facing West

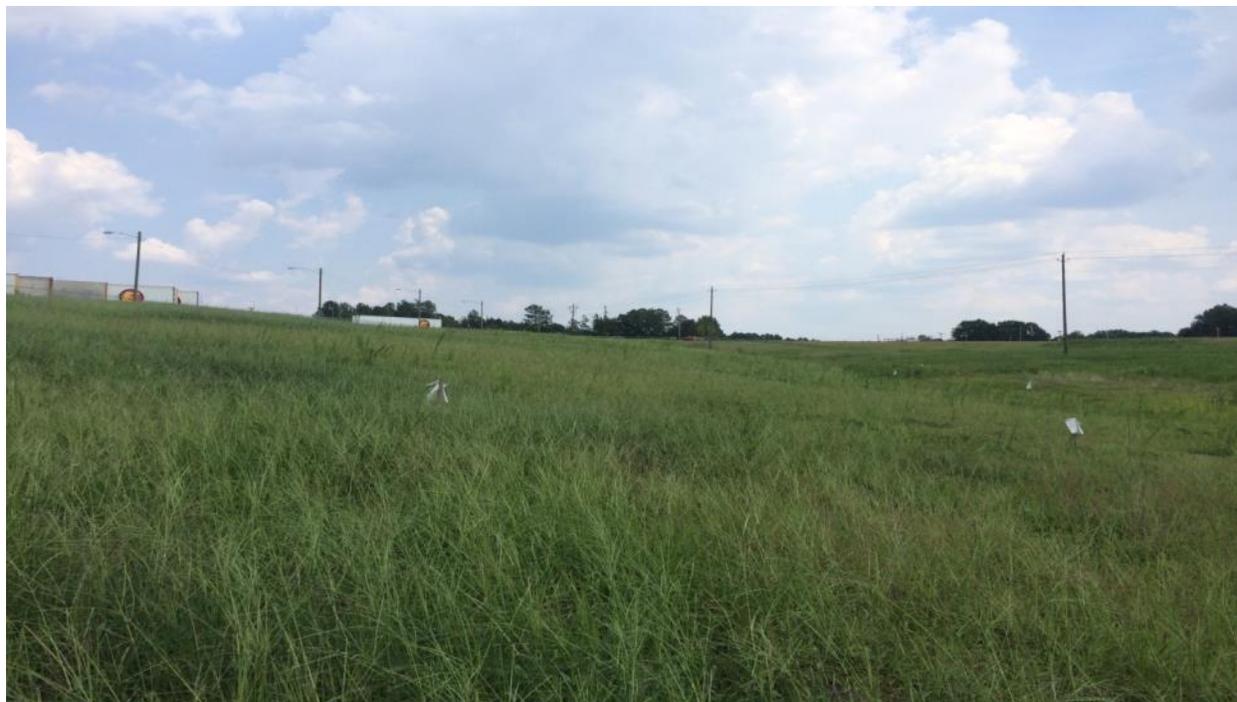
Photograph No. 1
Reach 1 RDU Slope and Channel
Facing Northeast

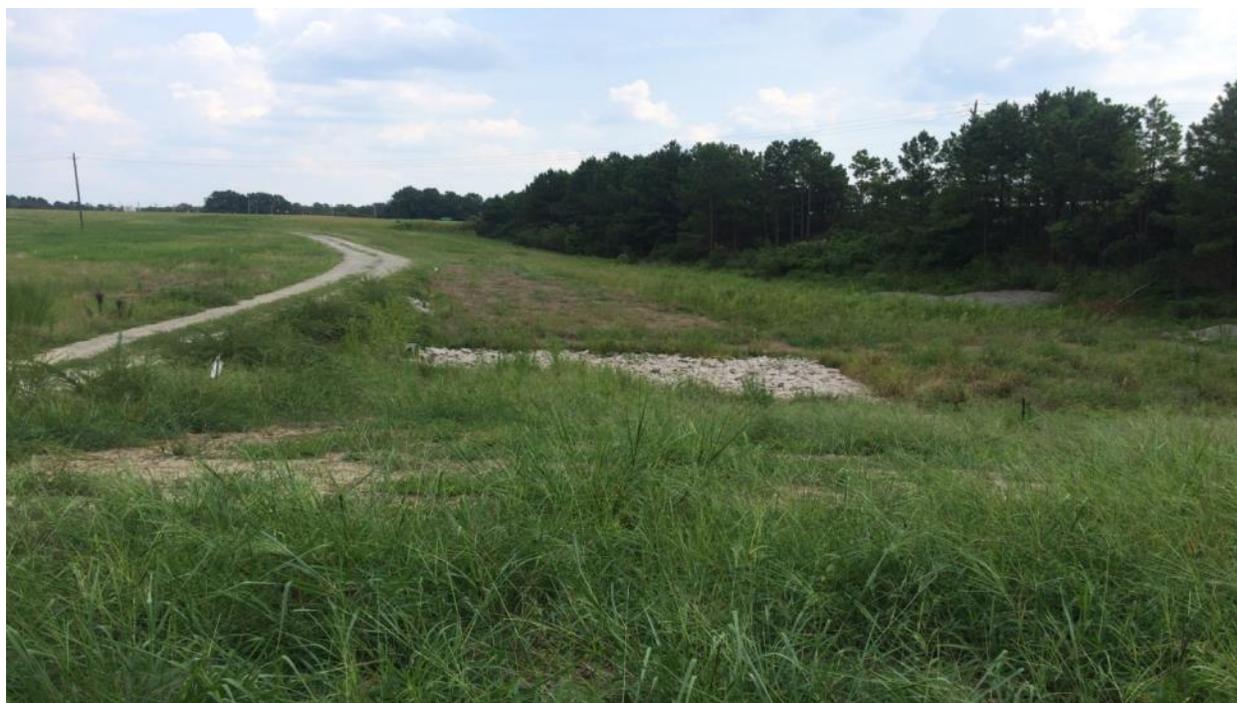
Photograph No. 2
Reach 1 Channel South of Access Path
Facing Southeast

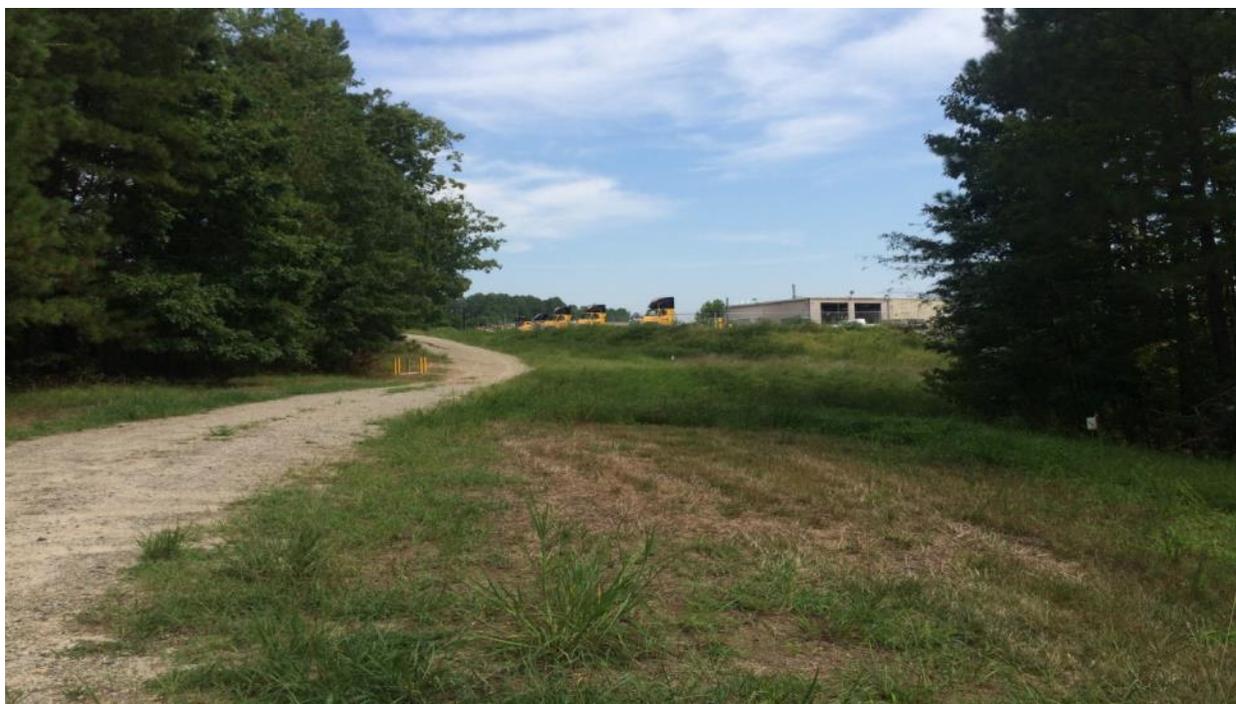
Photograph No. 3
Reach 1 Estes Southwest Corner and RDU Slope
Facing North

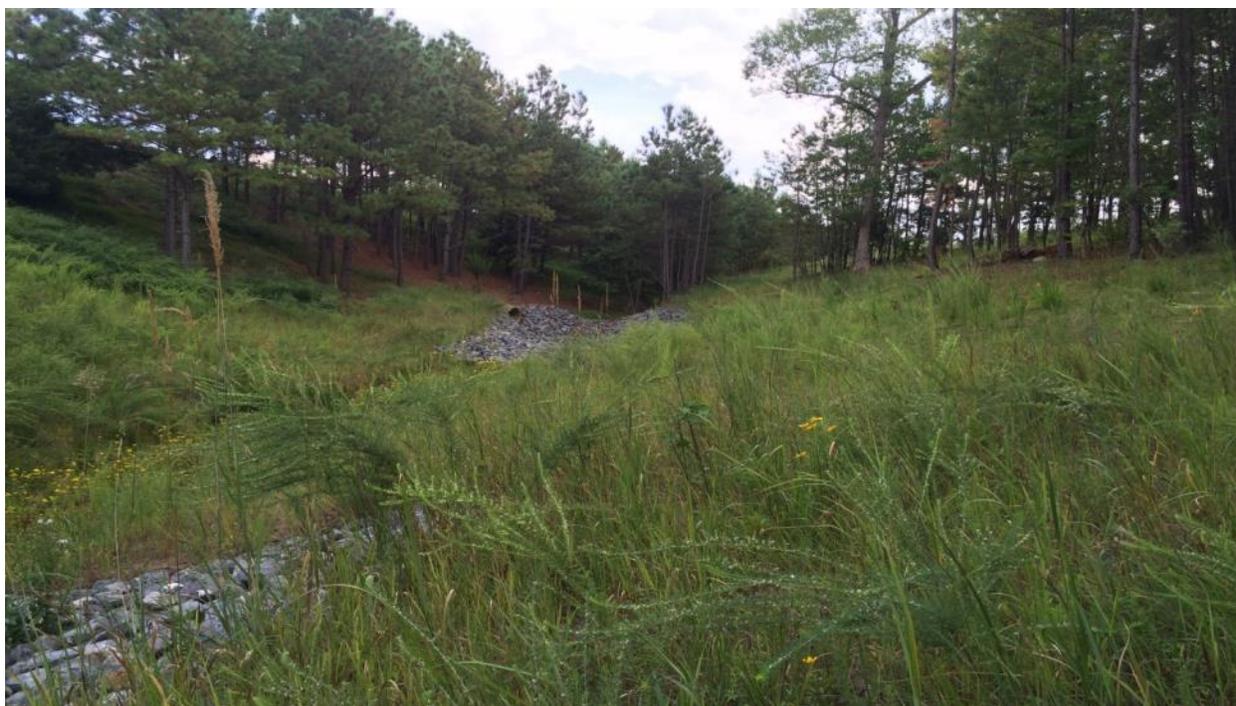
Photograph No. 4
Reach 2 Channel at Former NCDOT Sedimentation Pond
Facing East

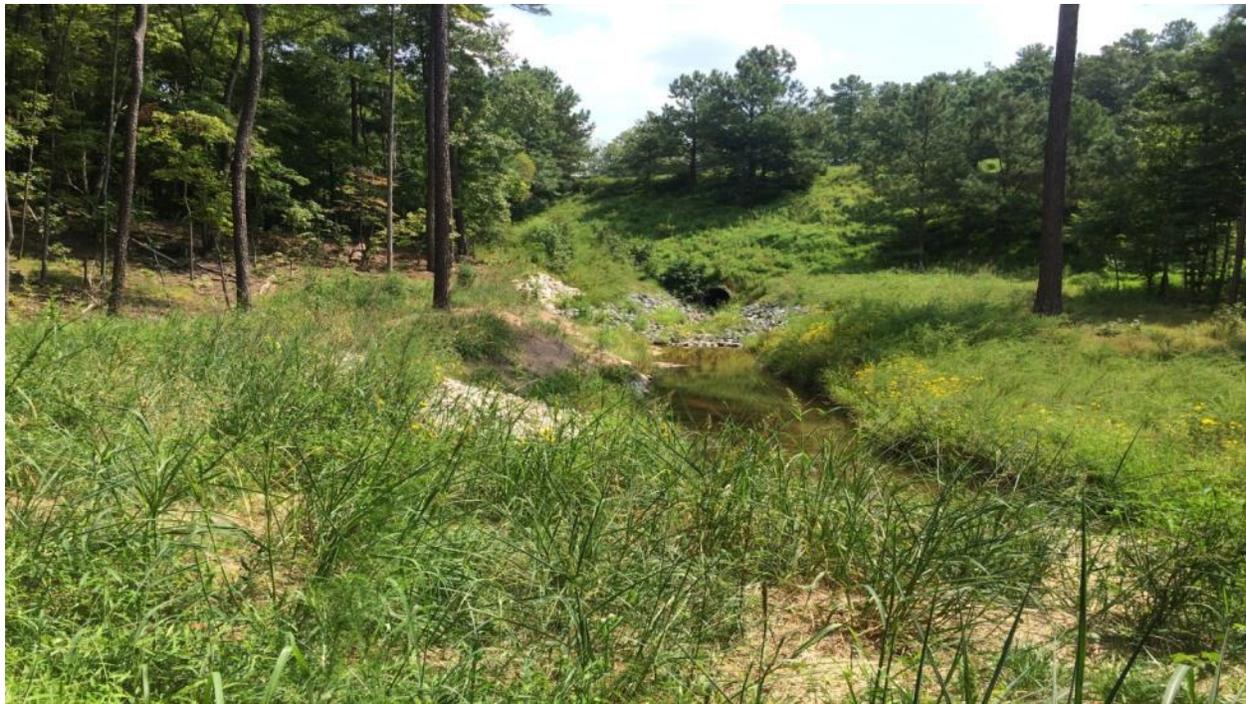
Photograph No. 7
Beginning of Reach 3 Channel
Facing Southeast

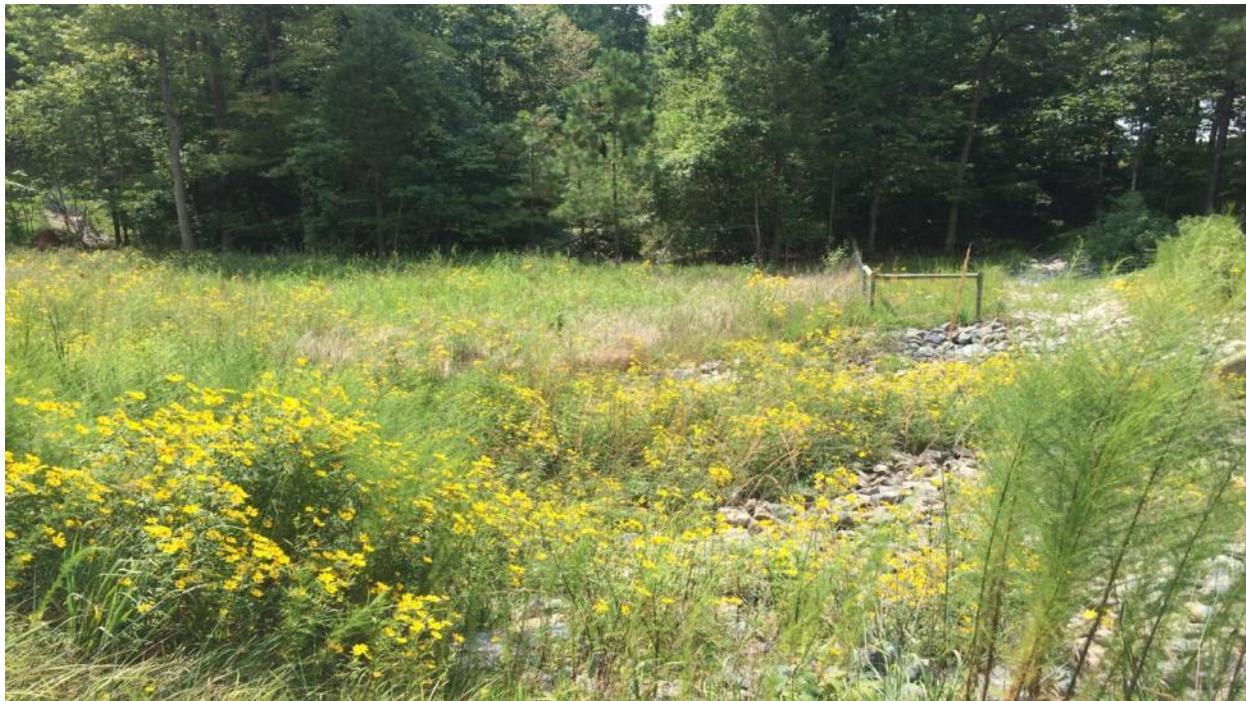
Photograph No. 8
End of Reach 3 Channel
Facing West

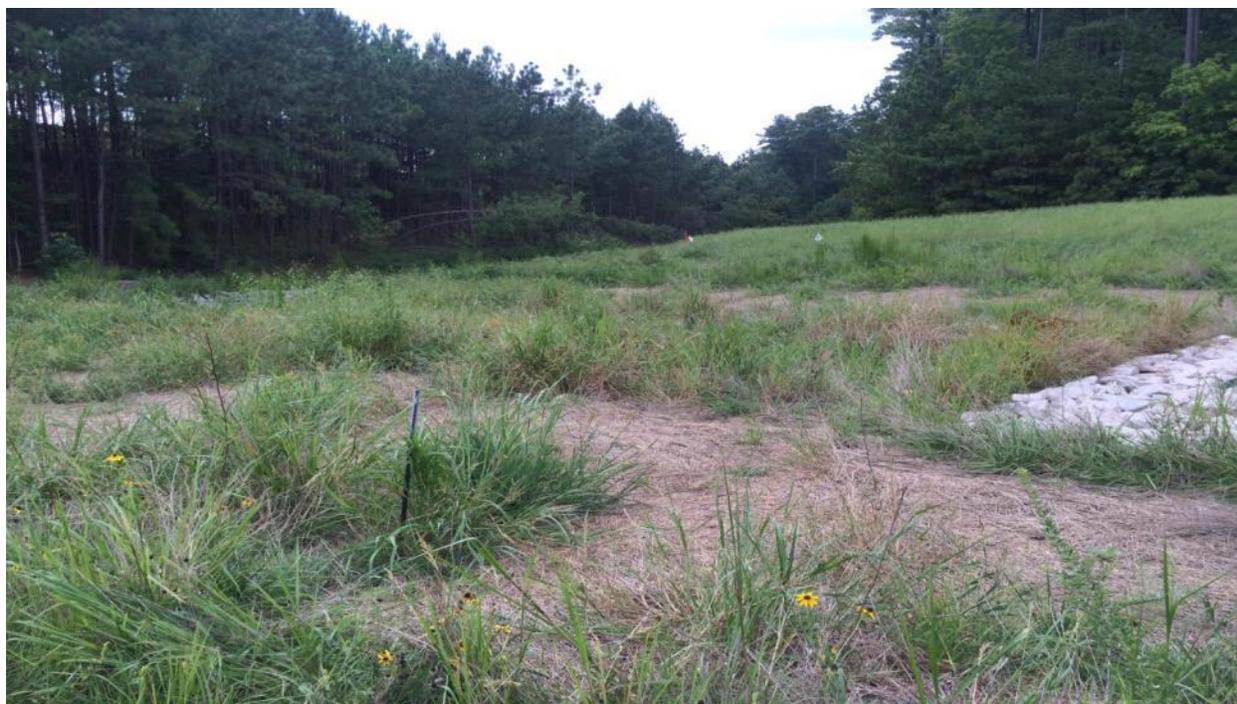
Plot No.	Photo Location	Herbaceous Cover Estimate of Area	Surviving Trees in Plot	Volunteer Trees in Plot
Plot 1	Photograph 9 Reach 1 - from NE corner, facing SW	80	4	8
Plot 2	Photograph 10 Reach 2 - from NE corner, facing SW	80	15	9
Plot 3	Photograph 11 Reach 3 - from NW corner, facing SE	80	11	24
Plot 4	Photograph 12 Reach 1 – from SW corner, facing NE	95	25	157

Photograph No. 9
View of Vegetation Plot 1
Facing Southwest from Northeast Corner

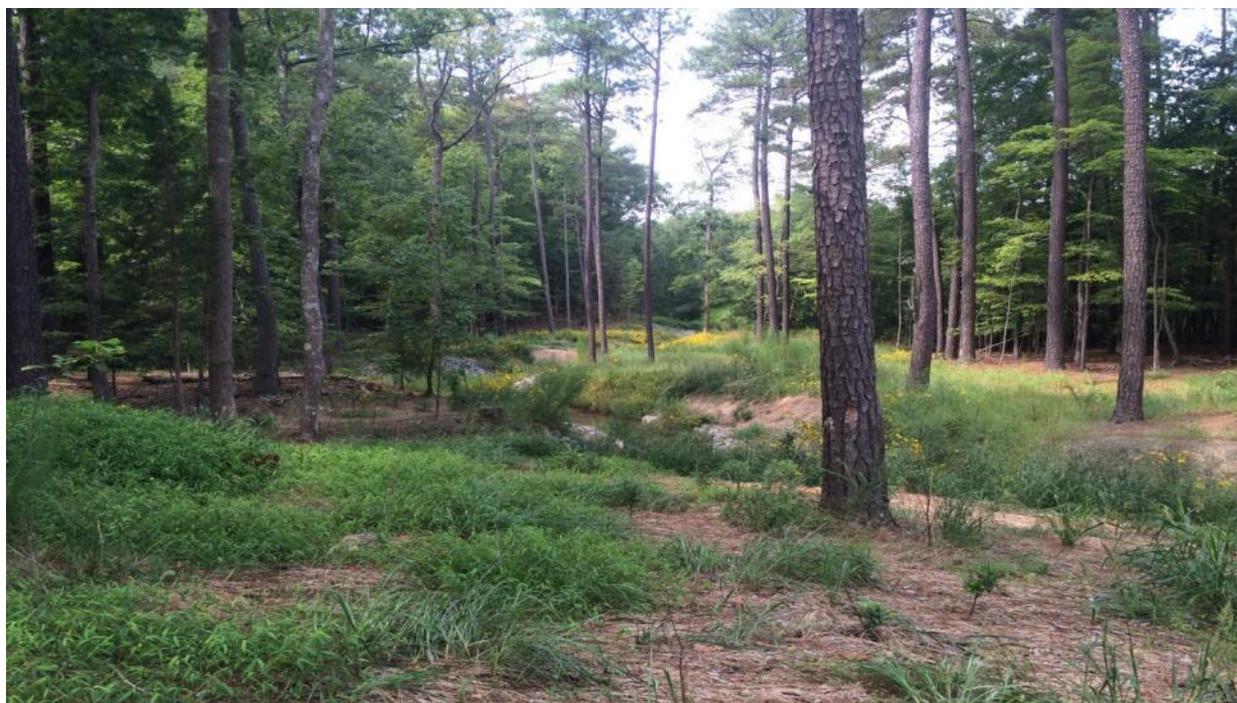
Photograph No. 10
View of Vegetation Plot 2
Facing Southwest from Northeast Corner

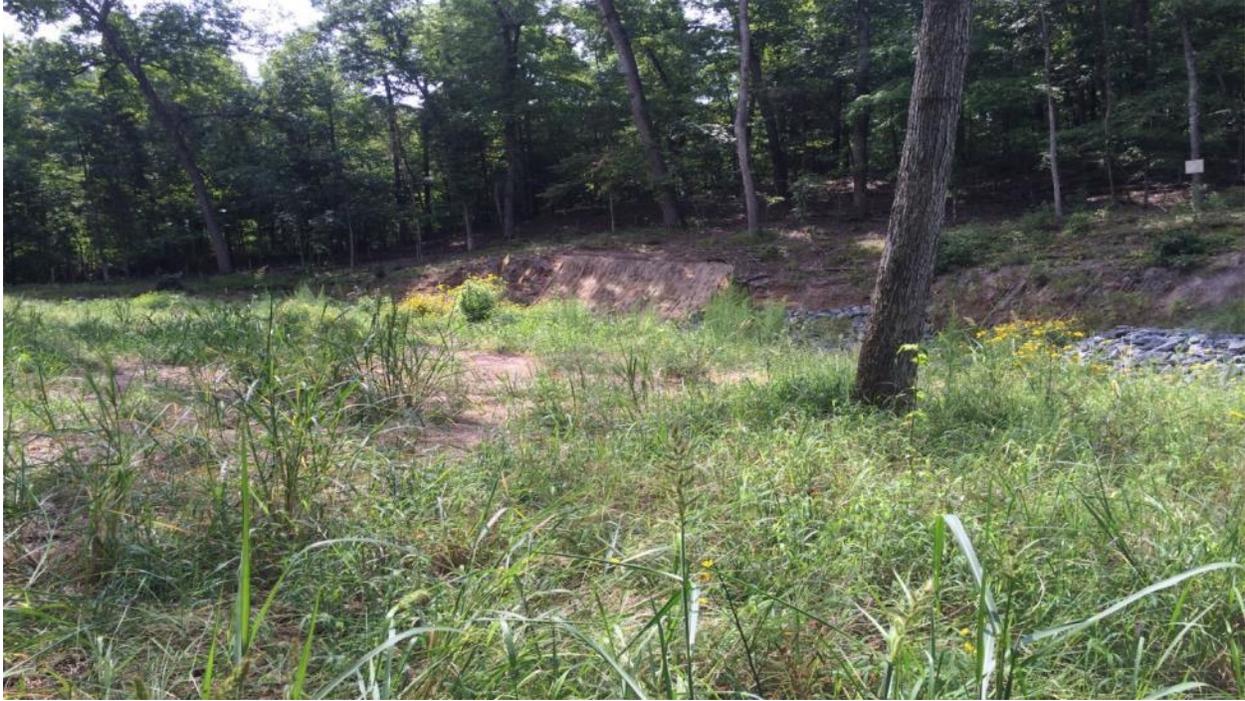
Photograph No. 11
View of Vegetation Plot 3
Facing Southeast from Northwest Corner

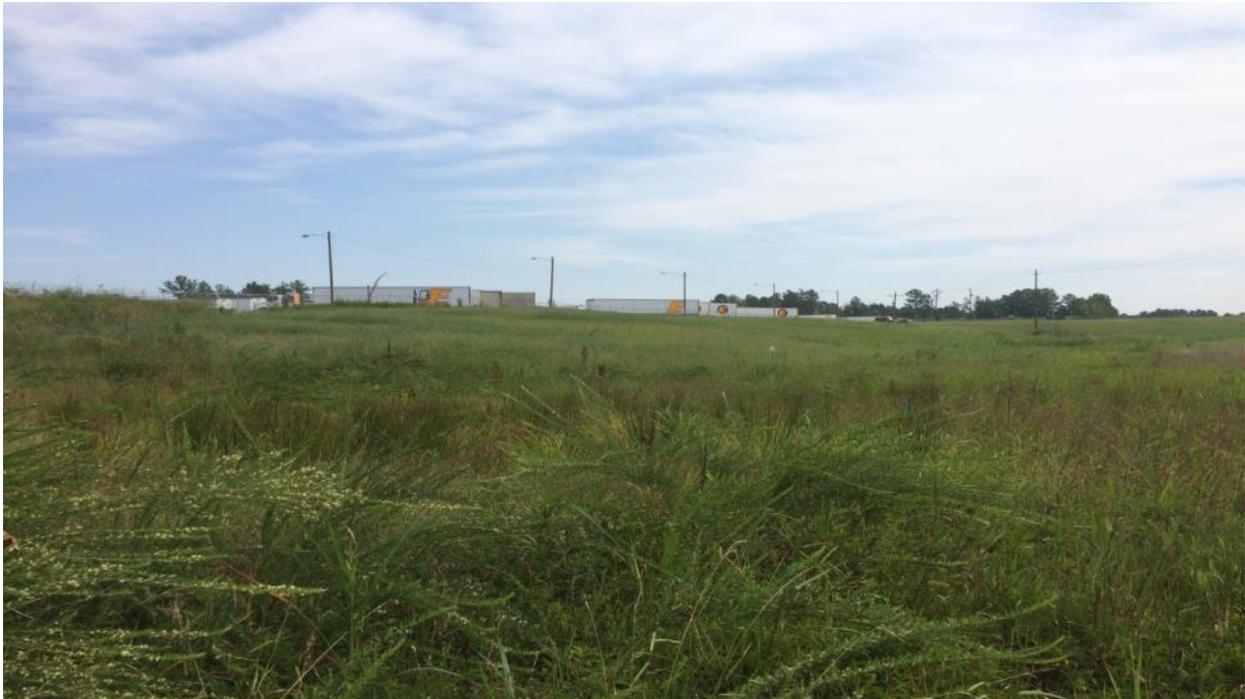
Photograph No. 12
View of Vegetation Plot 4
Facing Northeast from Southwest Corner

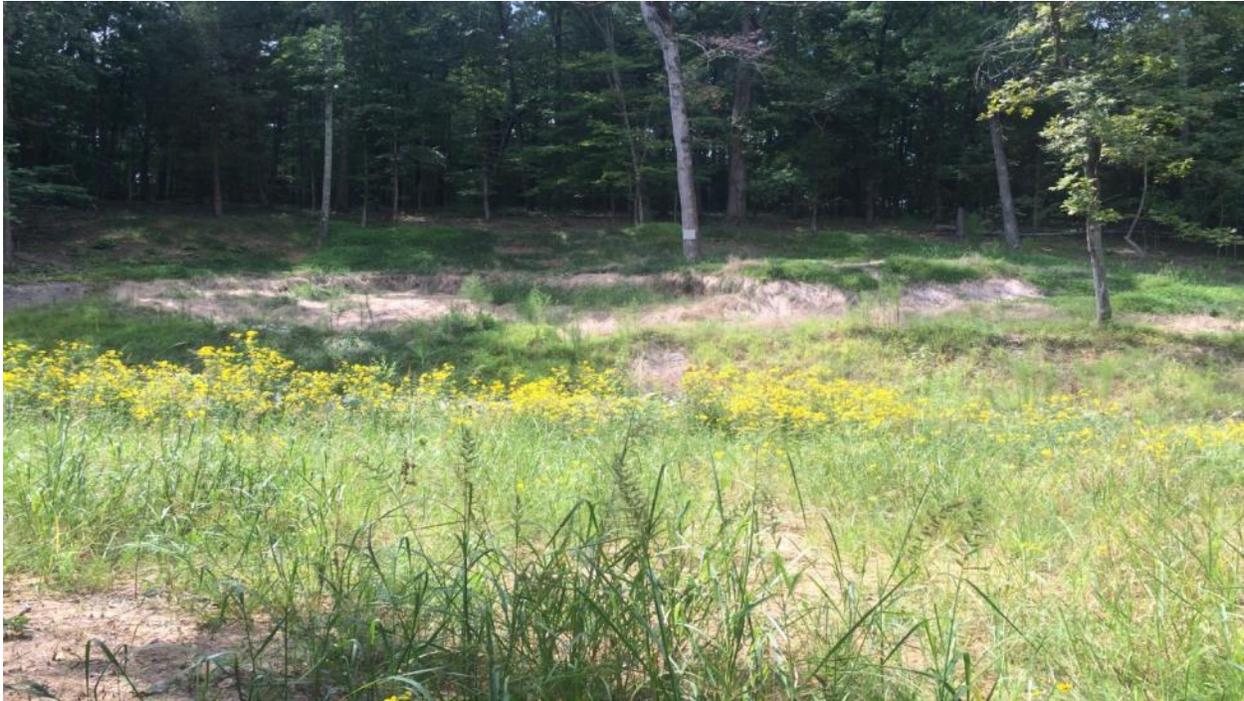
Photograph No. 13
Reach 3 Slide Repair Area
Facing West

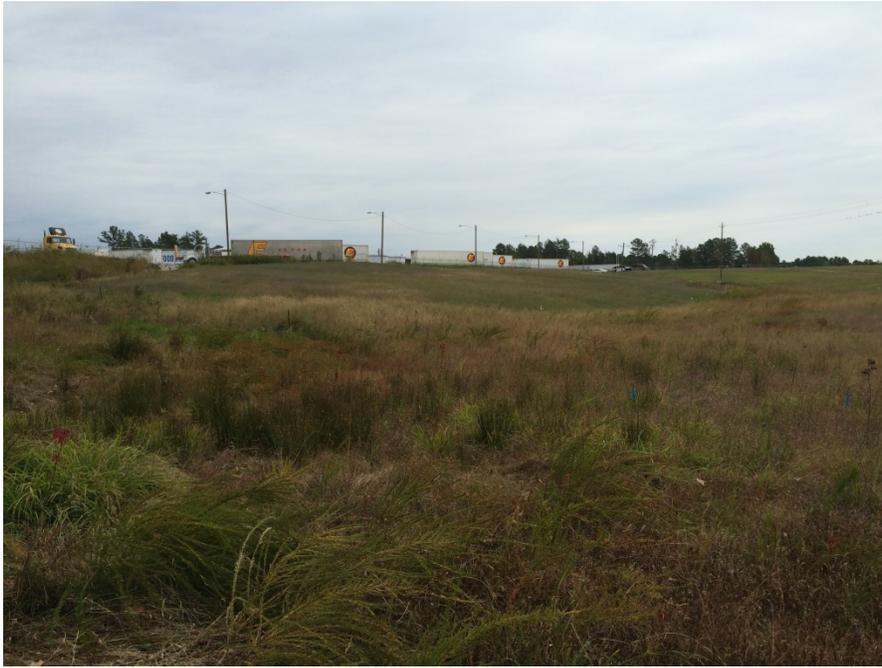
Photograph No. 1
Mowing and Overseeding at Reach 1 Slope
Facing Northeast

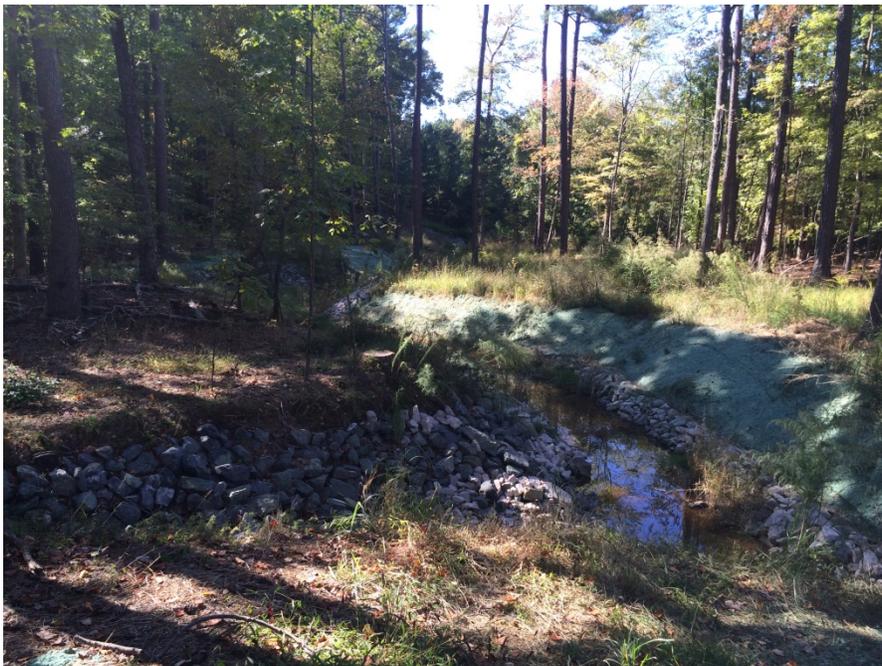
Photograph No. 2
Reach 2 Hydroseeding
Facing West

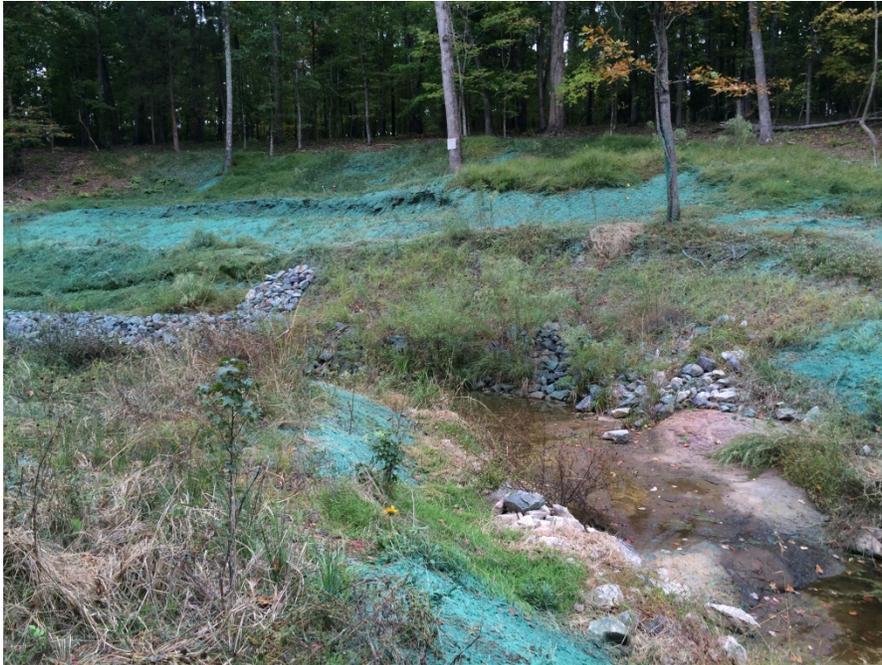
Photograph No. 3
Reach 3 Hydroseeding
Facing South

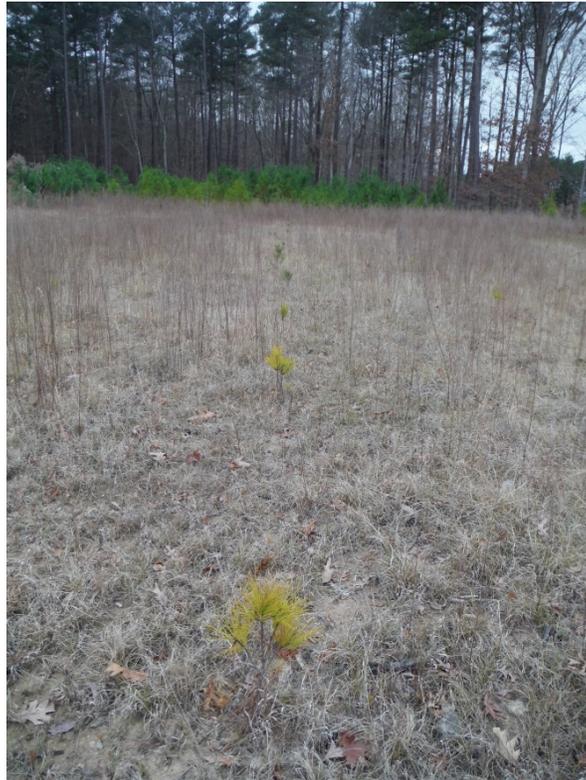
Photograph No. 1
Trees Planted in Former Laydown Area West of Estes Trucking Facility.

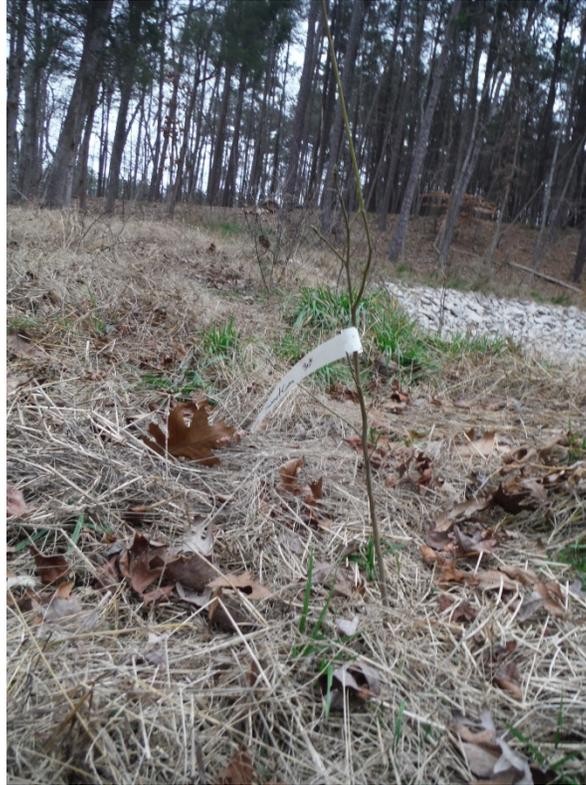
Photograph No. 3
Trees Planted in Reach 3

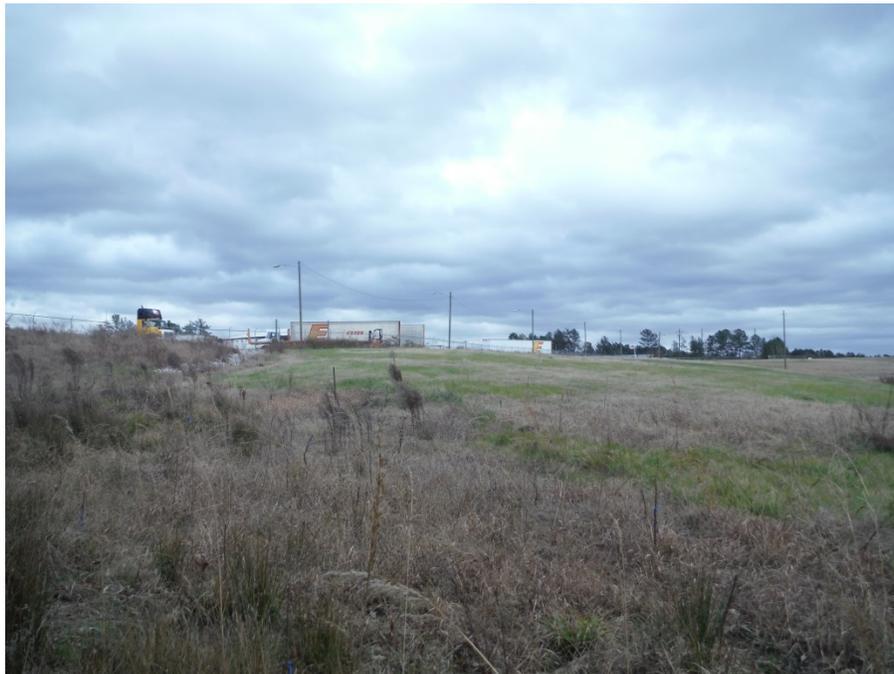
Photograph No. 4
Follow-up on Mowing and Overseeding at Reach 1
Facing Northeast

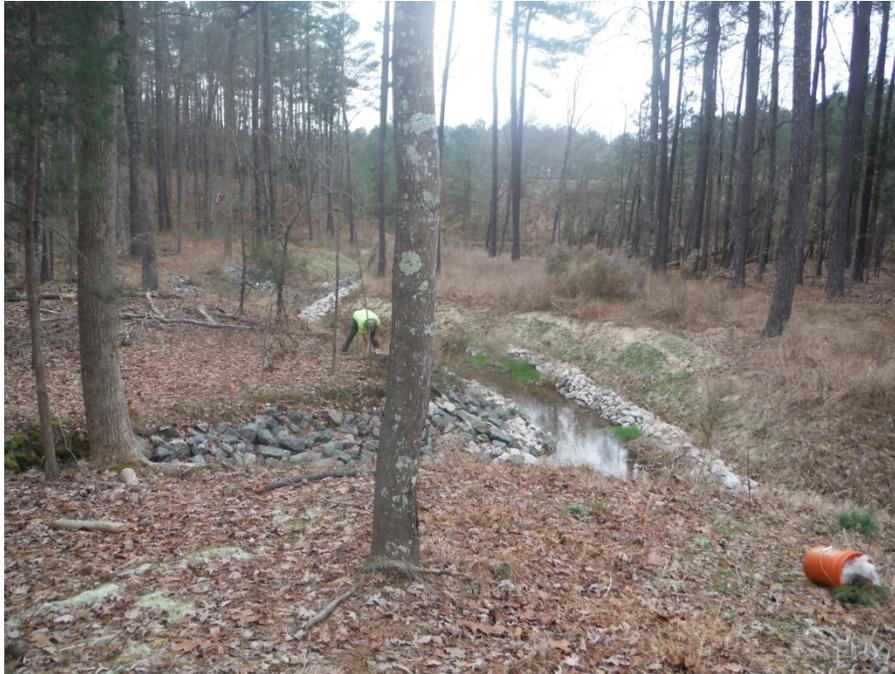
Photograph No. 5
Follow-up Reach 2 Hydroseeding
Facing West

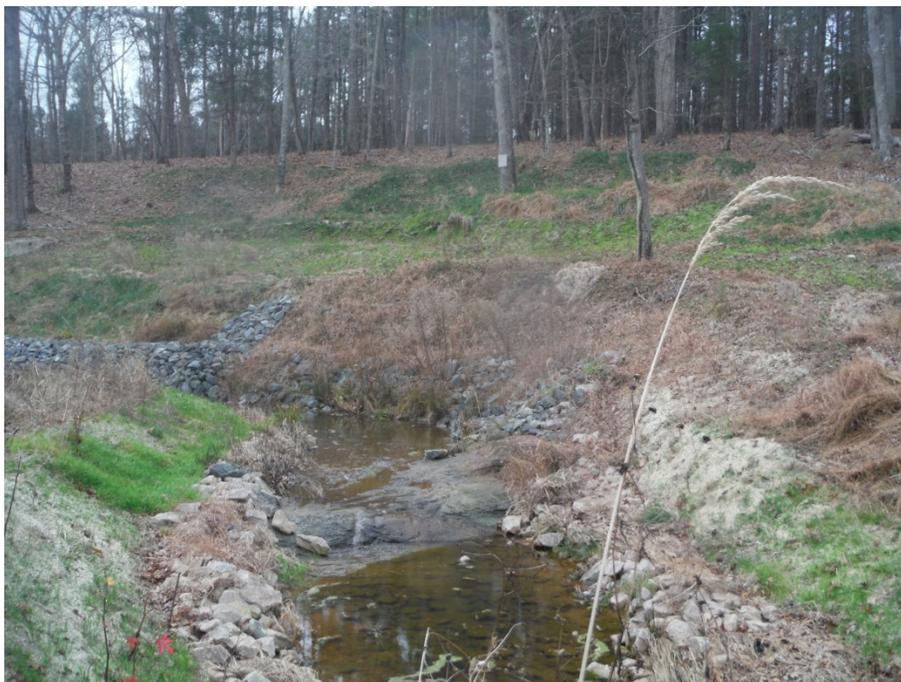
Photograph No. 6
Follow-up Reach 3 Hydroseeding
Facing South
