From: Parris, Bruce
Sent: Monday, July 15, 2013 4:08 PM
To: Ramey, David E
Subject: "Virkler" FW: Phase I Report - AEI
Attachments: Final Phase I ESA Charlotte NC - Project 320548.pdf; Unlisted Virkler Property FOIA 7-12-13.pdf

Attached please find a Phase I report completed July 1 2013 by AEI Consultants. Right before Appendix F is a report done by Steve Hart of Hart Hickman which should be helpful.

12345 Steele Creek Road, Charlotte, North Carolina 28273

Project Number: 320548

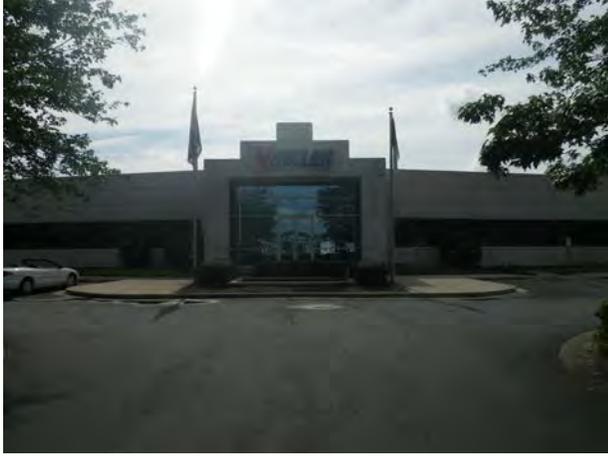
1. Subject Property West Entrance

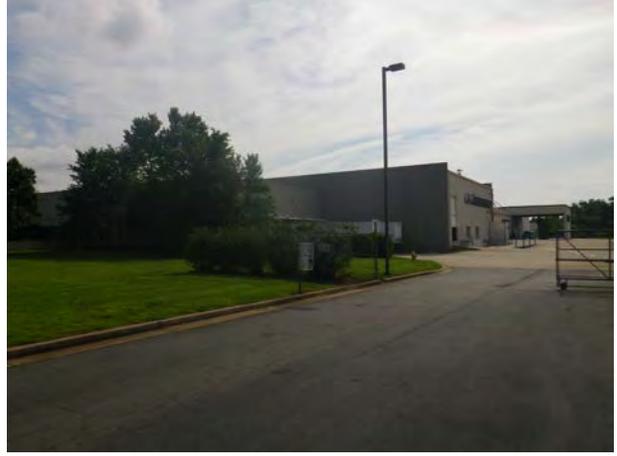
2. Subject Property West Truck Entrance

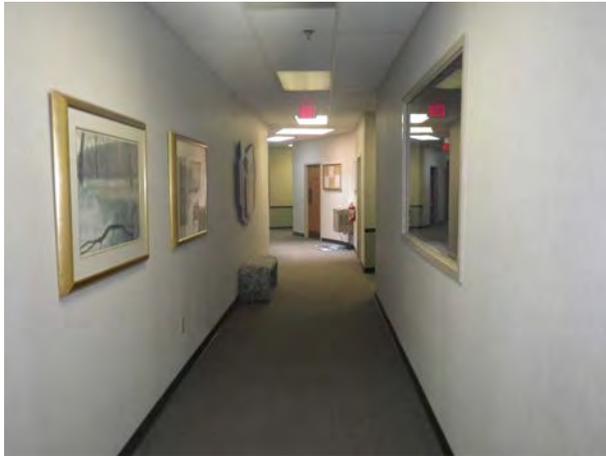
3. Typical Interior Administration Building

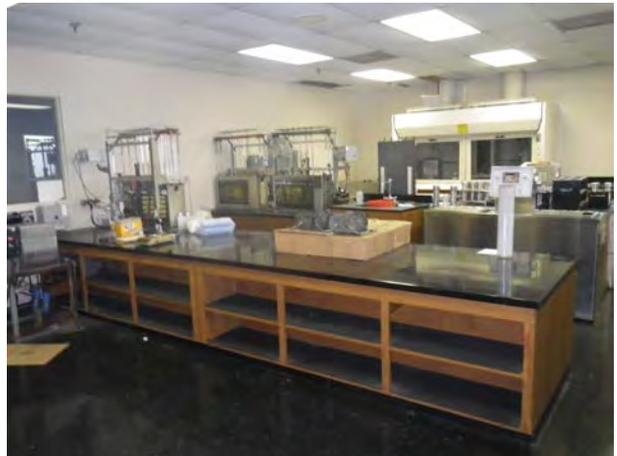
4. Typical Laboratory

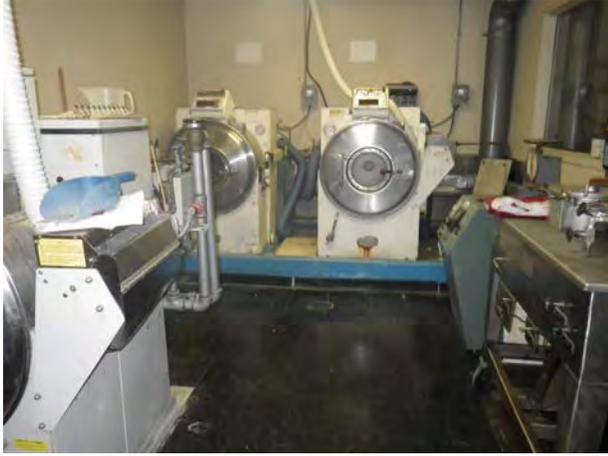
5. Laundry

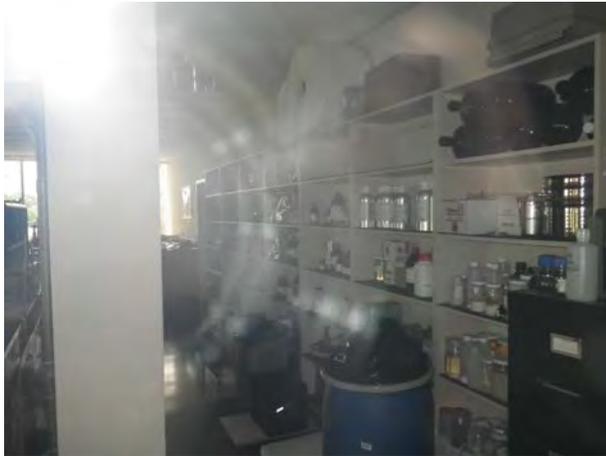
7. Typical laboratory chemical storage

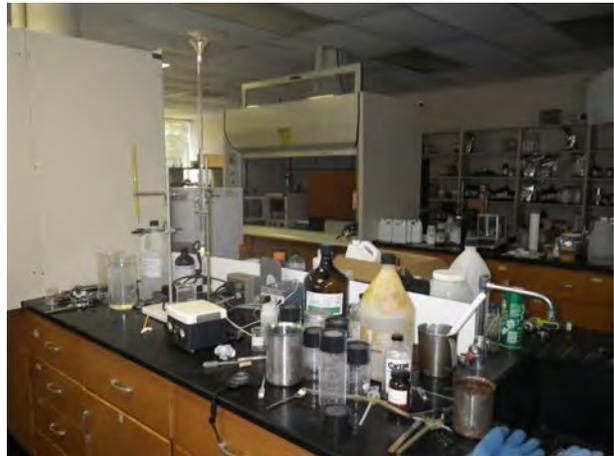
8. Paper Laboratory

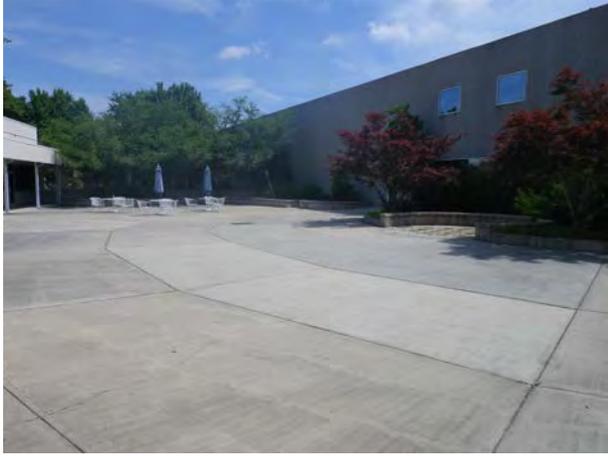
9. Internal Courtyard

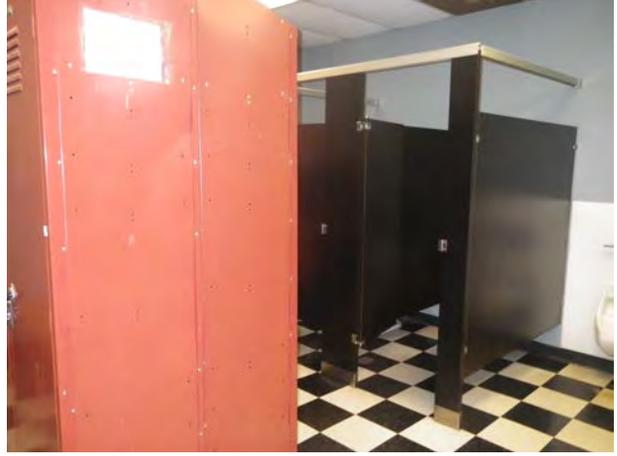
10. Typical Locker Room

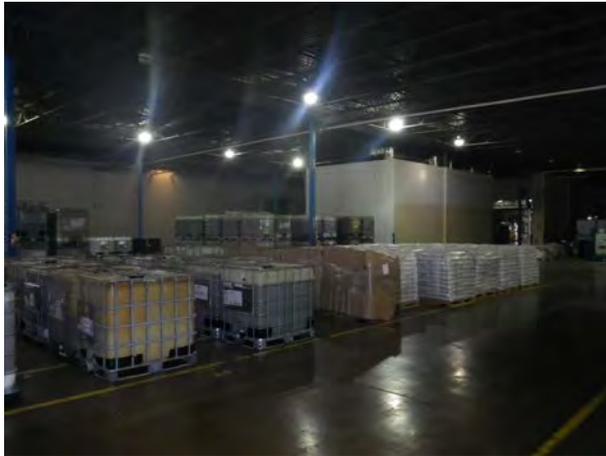
11. Tote Warehouse

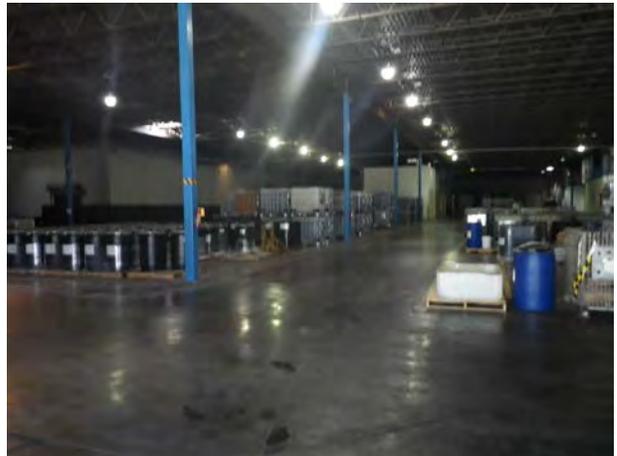
12. Drum Warehouse

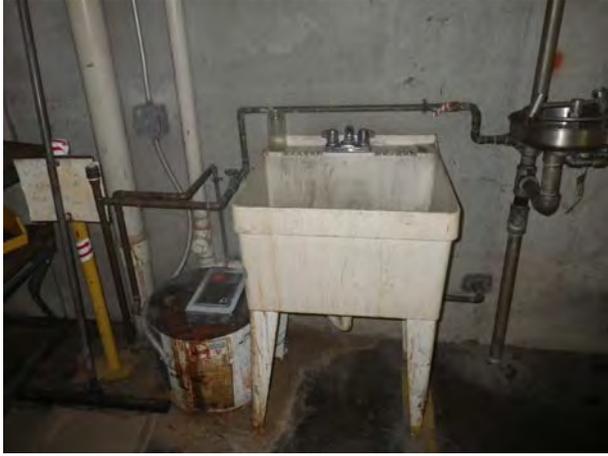
13. Warehouse Shop Sink

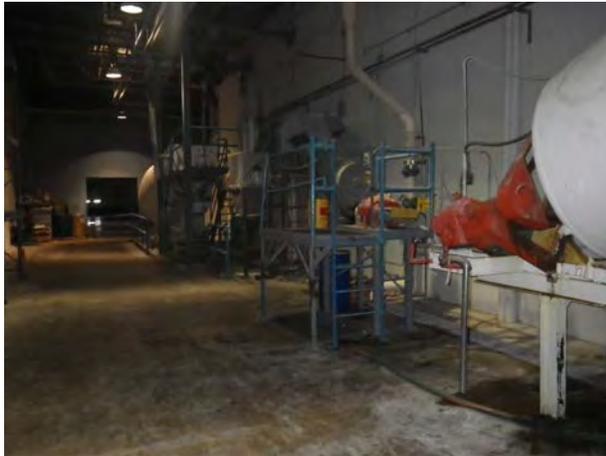
15. Powder blending

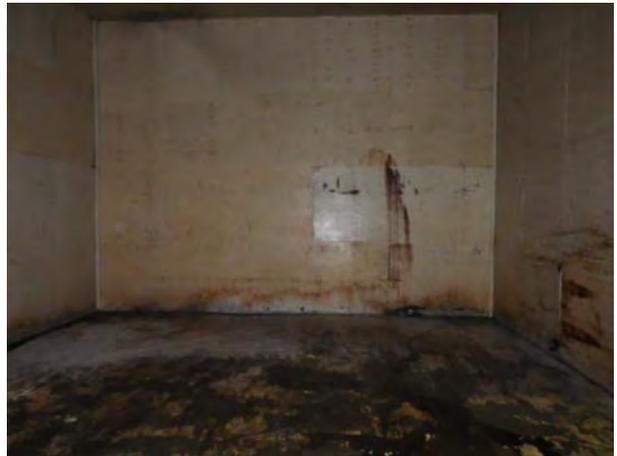
16. Typical Hot Room

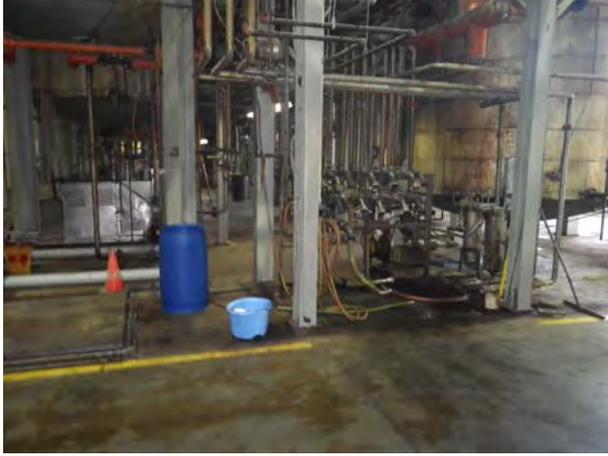
17. Formulation Area

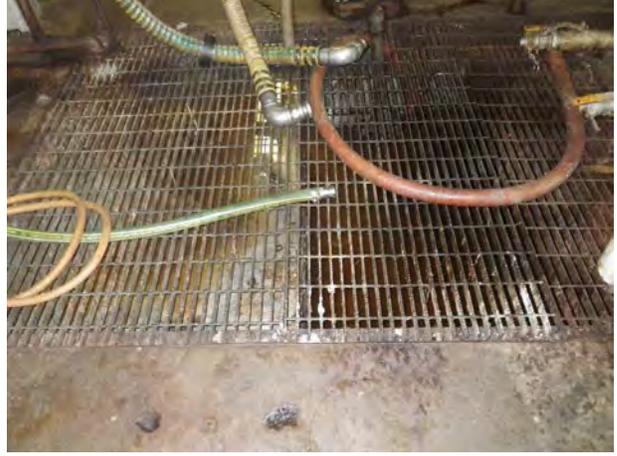
18. Drain/Sump at Formulation Area

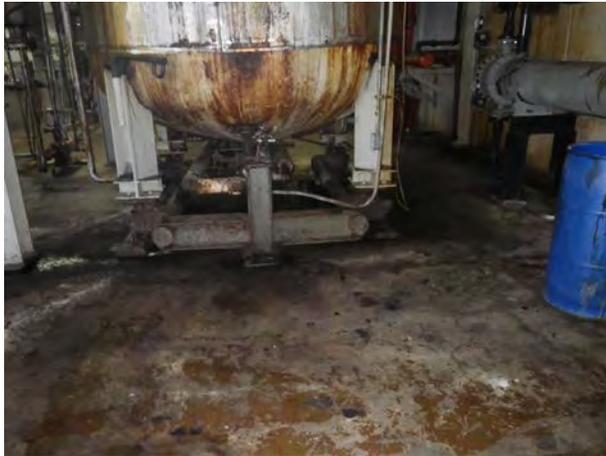
19. Typical tank at Formulation Area

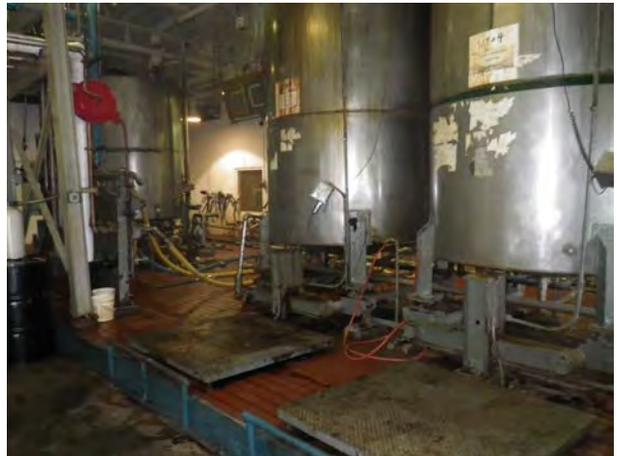
20. Container weighing station

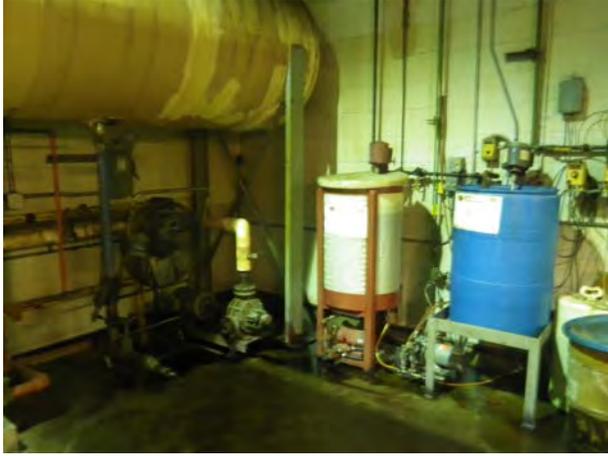
21. Boiler Room

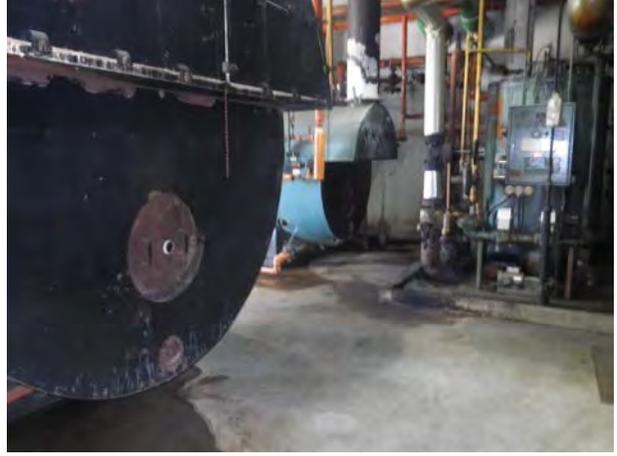
22. Boiler Room

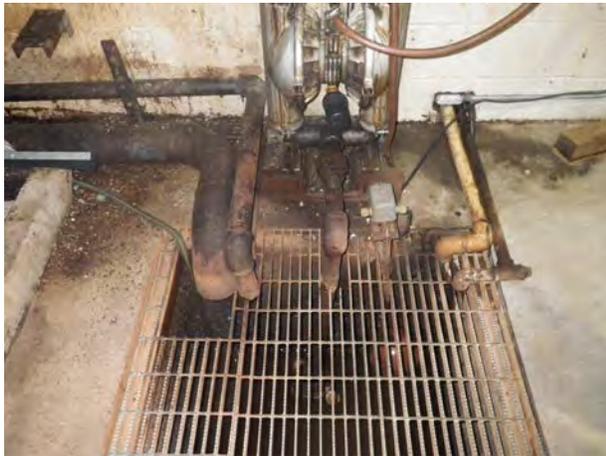
23. Floor Drain, Boiler Room

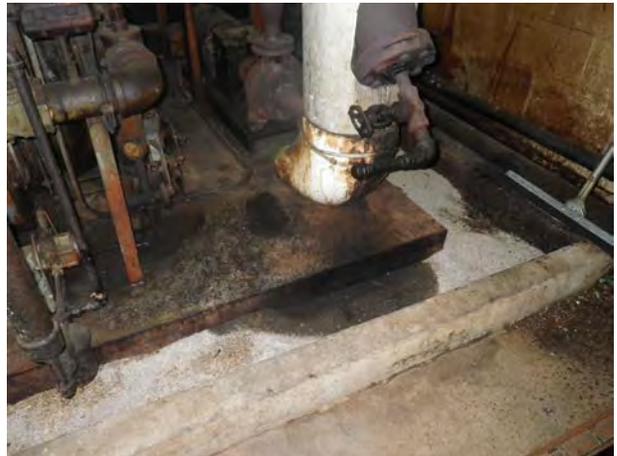
24. Old Air Compressor Room

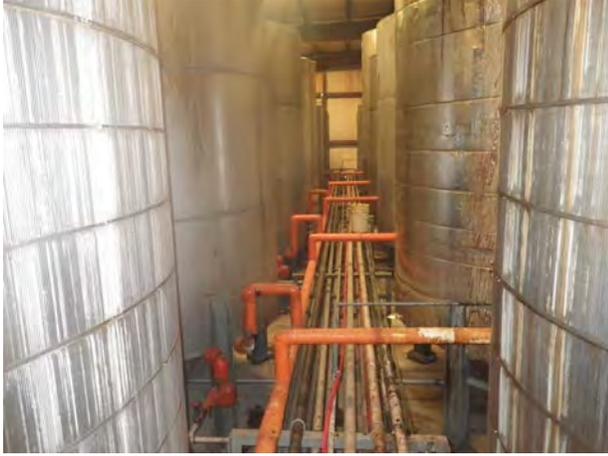
25. Typical interior tank farm

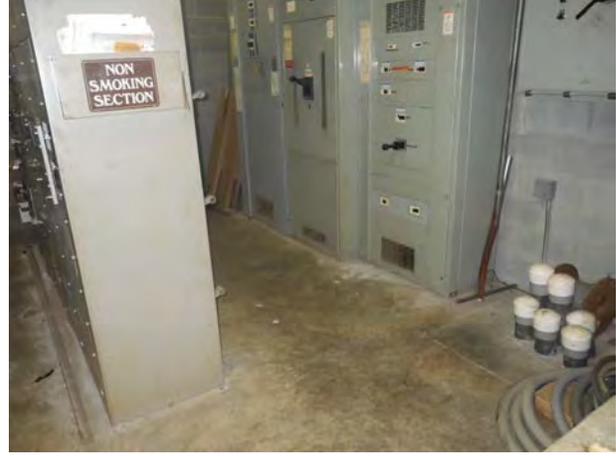
26. Interior electric room

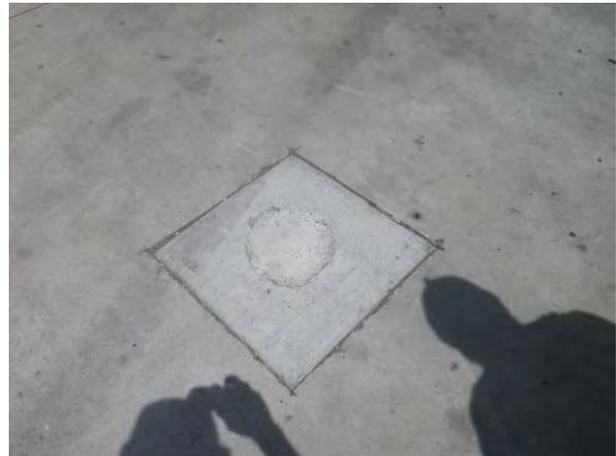
28. Former monitoring well, south of Bulk Loading

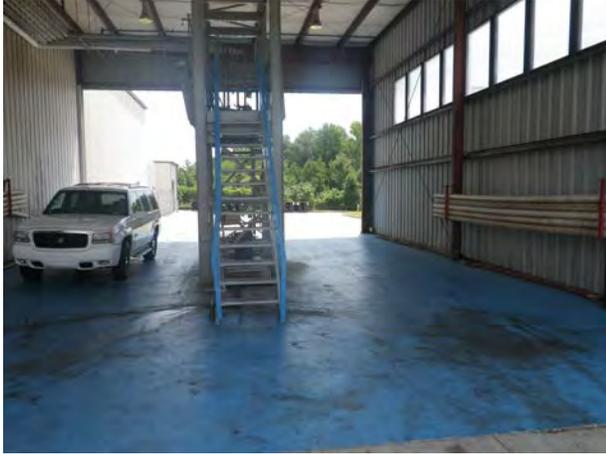
29. Bulk Loading

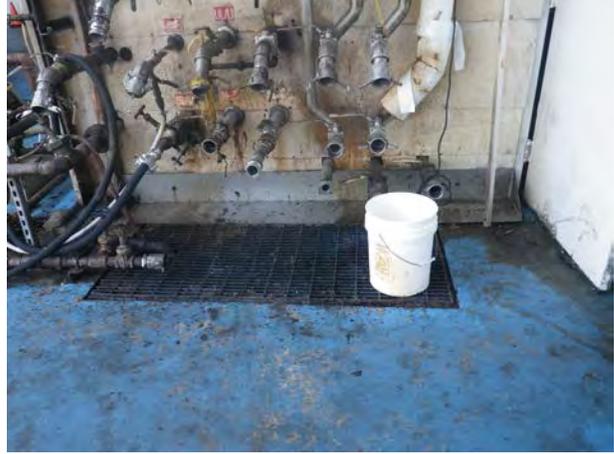
30. Bulk Loading Floor Drain

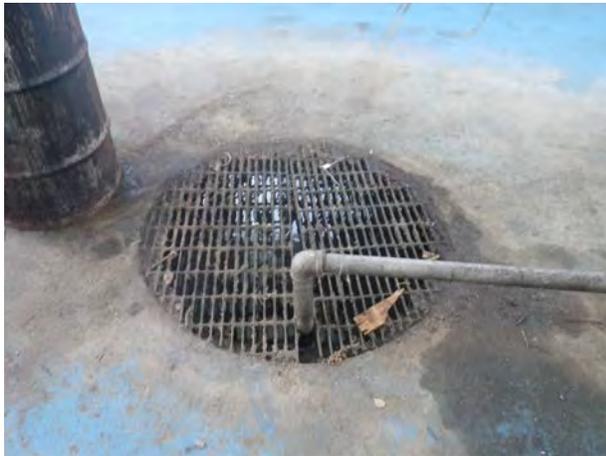
31. Bulk Loading Sump

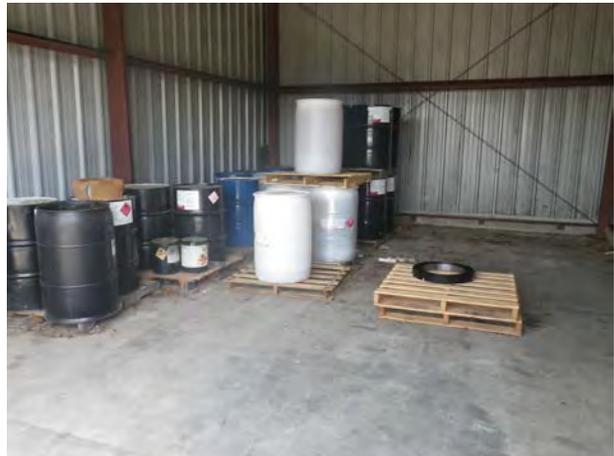
32. Flammable Storage Building

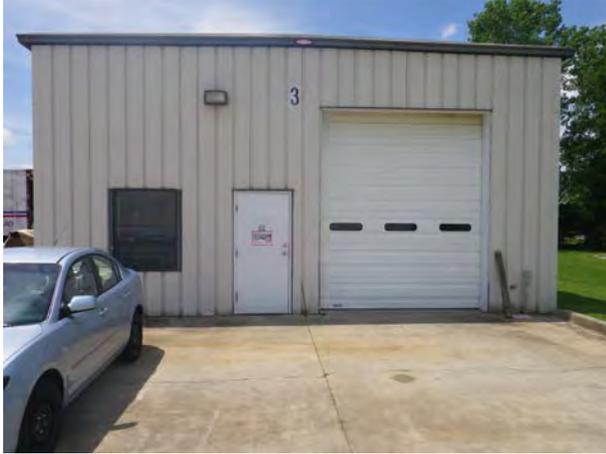
33. Mechanic Building

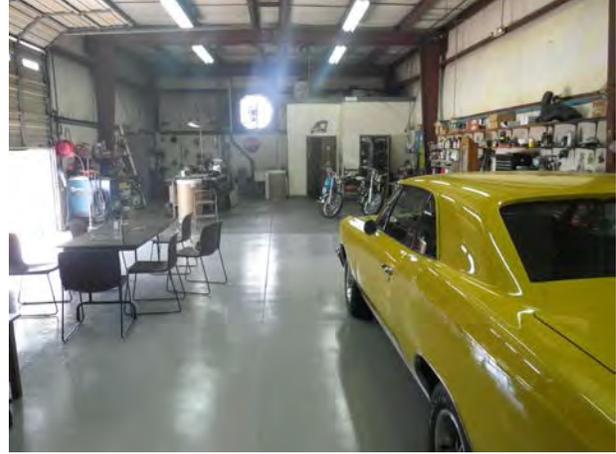
34. Mechanic Building Interior

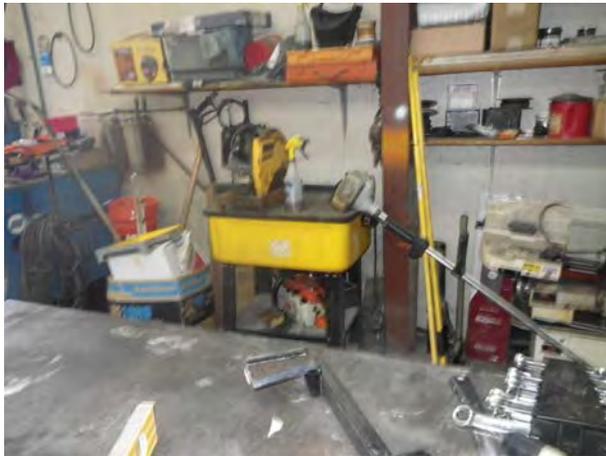
35. Parts washer in Mechanic Building

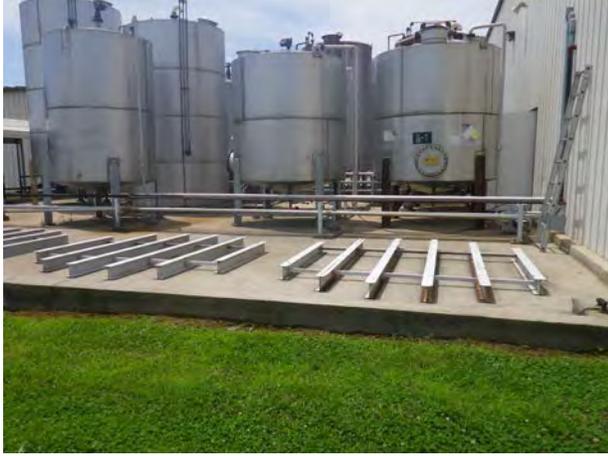
37. Exterior Tank Farm

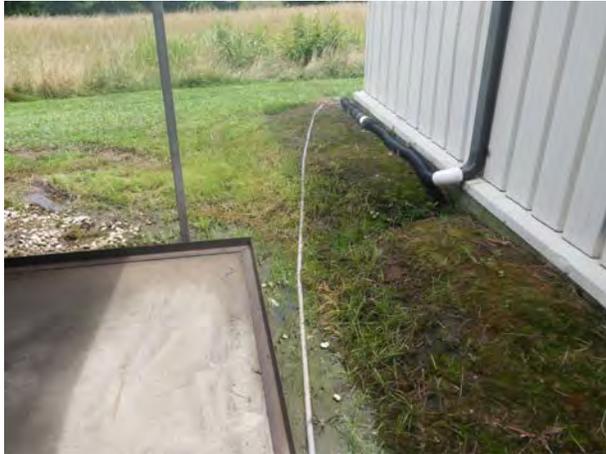
39. Exterior Tank Farm Sump
Trash Pump hose discharges to
grassy swale

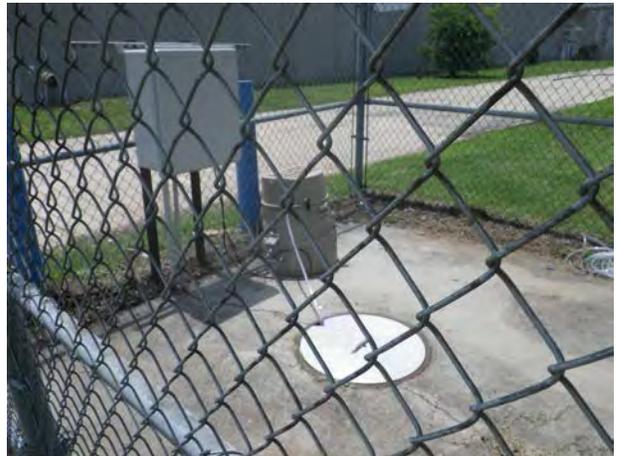
40. Site/Municipal sewer
connection with sampler

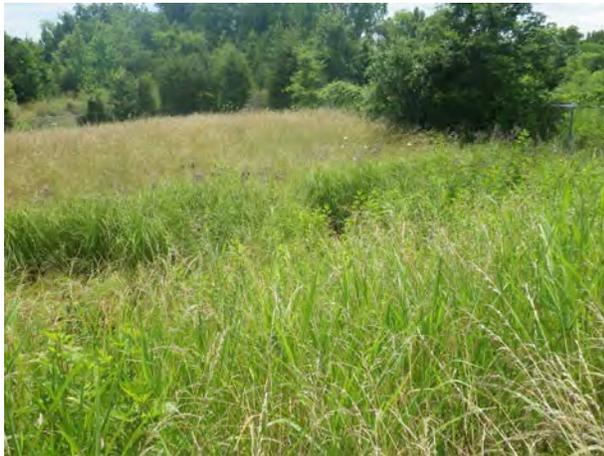
43. Grassy swale

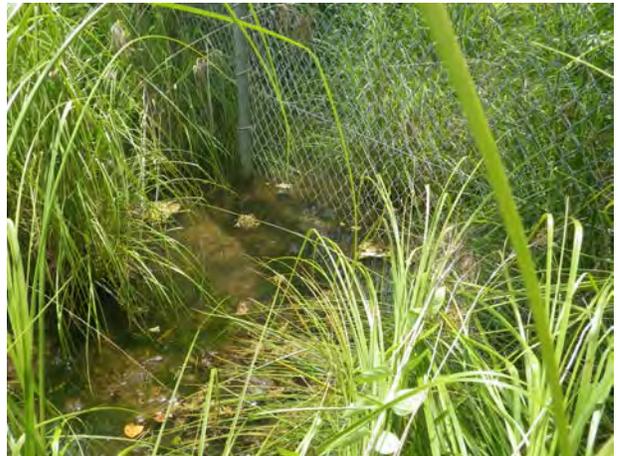
44. Standing water where grassy swale meets fenced retention pond

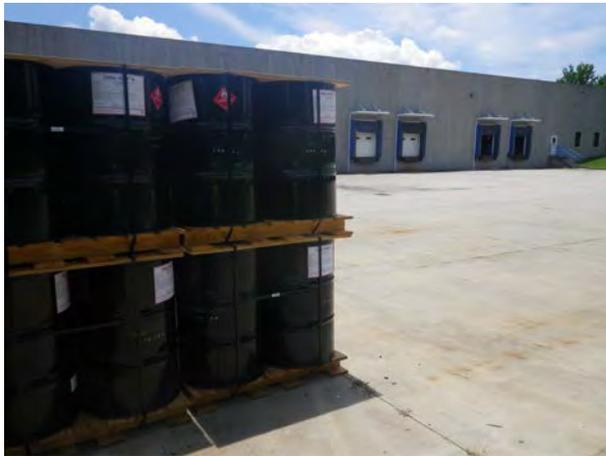
47. North Drum Staging

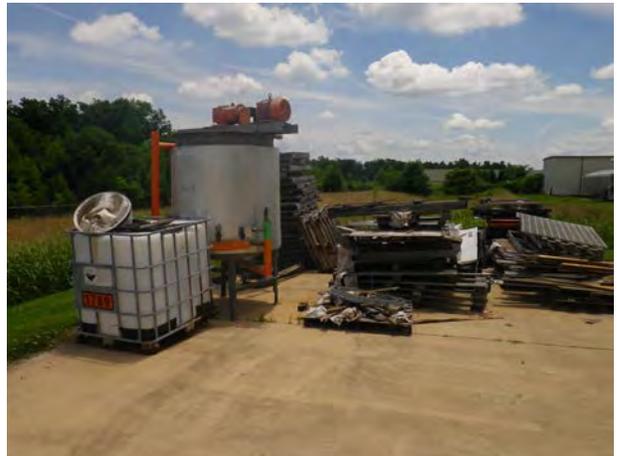
48. East Waste Material Storage

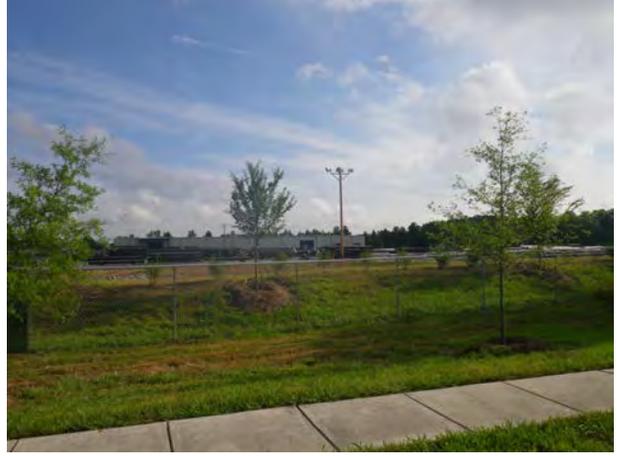
53. Subject Property retention pond discharge at Virkler Drive

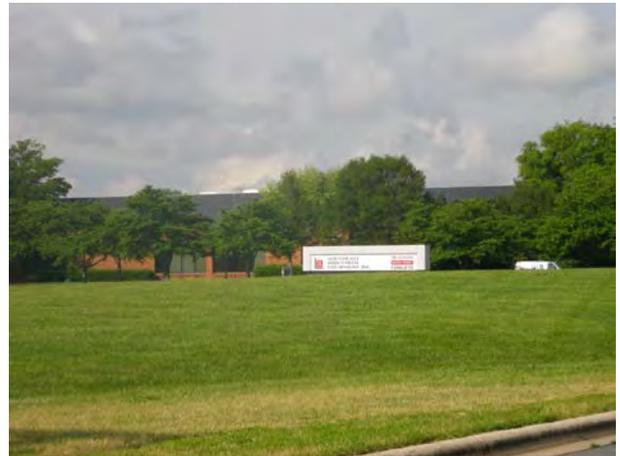
59. Adjacent Property West –
Aplix – monitoring stations,
purpose undetermined

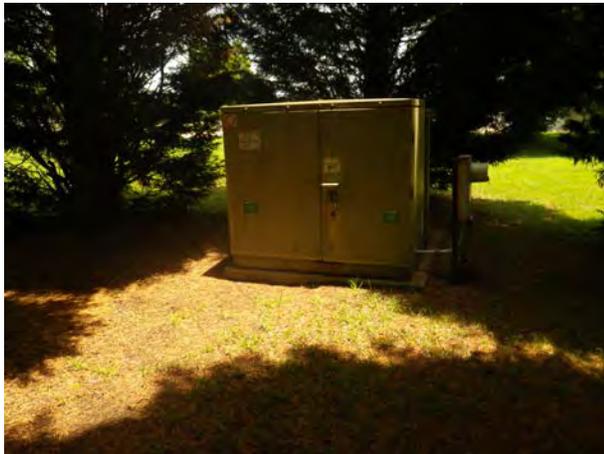
67. Typical Utility Pad-mounted transformer – north side, Subject Property, outside fence

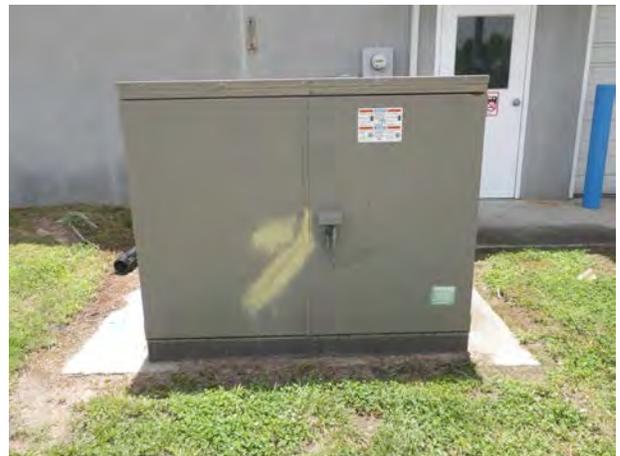
68. Typical Utility Pad-mounted transformer – north side, Subject Property, inside fence
